# **Report on Oil/Diesel leaking from shipwrecks in Chuuk Lagoon**

**August 17, 2008**

**by Dr Bill Jeffery**

This is a brief report on one aspect of the Team 1, 2008 project work, being a report on the oil/diesel seen to be leaking from two sites, *Hoyo Maru* and *Rio de Janeiro Maru*. A more comprehensive report on all Team 1, 2008 outcomes will be produced and provided to the Chuuk Department of Marine Resources and the Chuuk Historic Preservation Office.

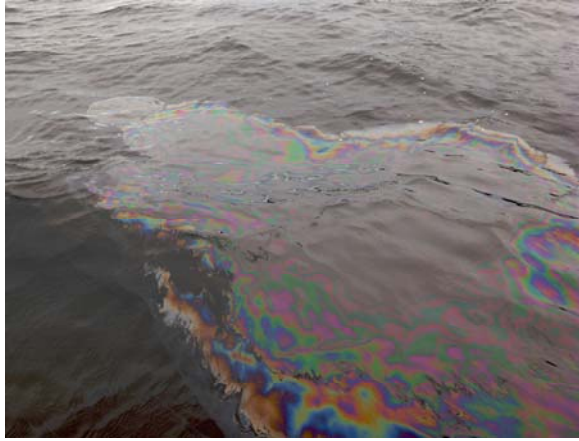
Figure 2: Oil/diesel bubbling to the surface

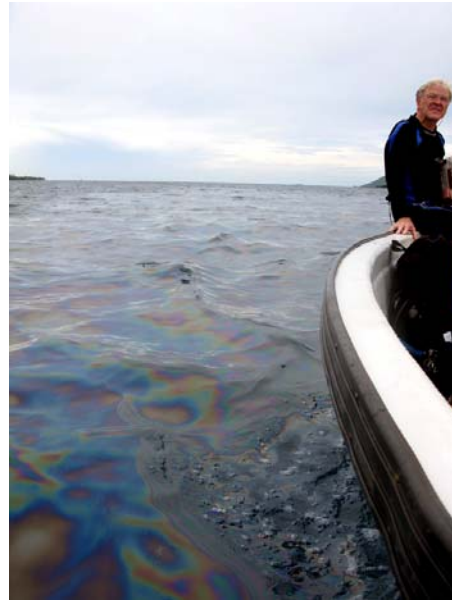
Figure 3: The slick on the surface, looking back to its origin—the south-east

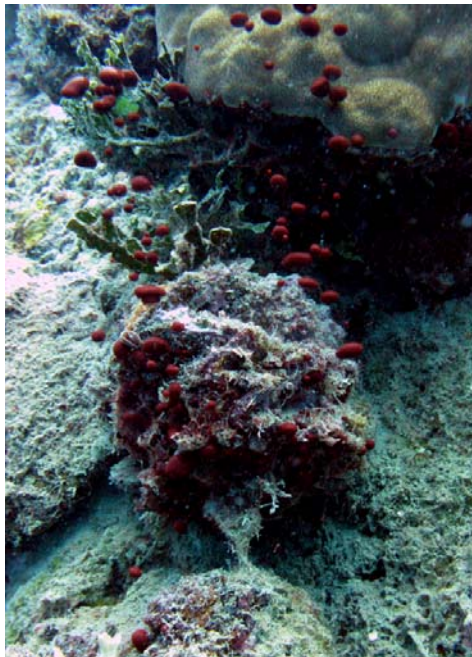
Figure 4: Oil/diesel seen bubbling out of the shipwreck

Divers investigated the source of the oil/diesel and it was found to be a small area on the port side of the vessel, possibly at a junction of hull plates, and only a few metres above the keel (Figures 4 and 5). The ship is lying upside down on the seabed and the hull is broken at about the start of the bridge; the leaking is a further 12 metres back along the length of the vessel (see Figure 6).

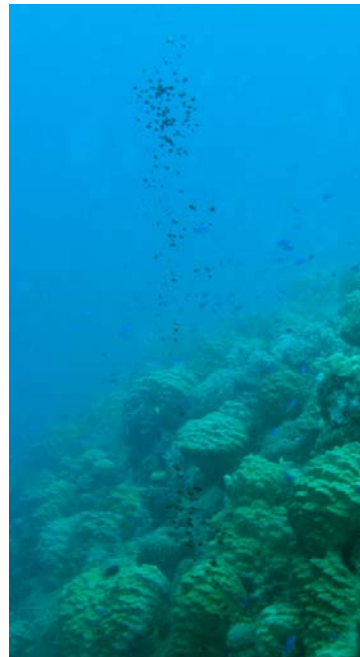
Figure 5: Oil/diesel rising from shipwreck (Photographs by Tammy Chan, Project Dive Master)

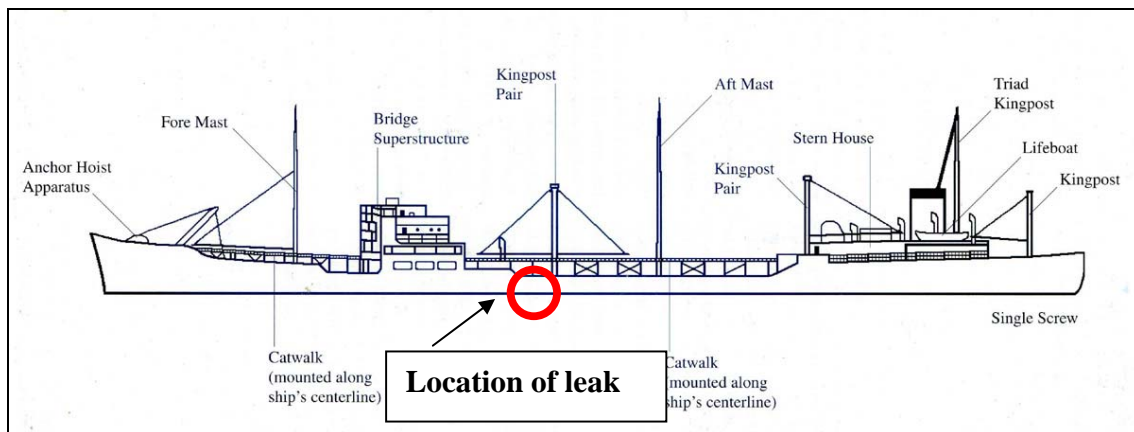
Figure 6: Side view of *Hoyo Maru* showing the approximate location of the leak

*Hoyo Maru* is powered by a single diesel engine and used as an oil tanker with a carrying capacity of 95,000 barrels (3,990,000 gallons) of oil (Bailey 2000: 356). The engine of the *Hoyo Maru* is well aft of the leak but fuel tanks for the engine could be in this vicinity, although it is more likely that this is where the oil was stored. Plans of the ship or similar ships should be consulted to confirm what type of oil/fuel is stored in this location.

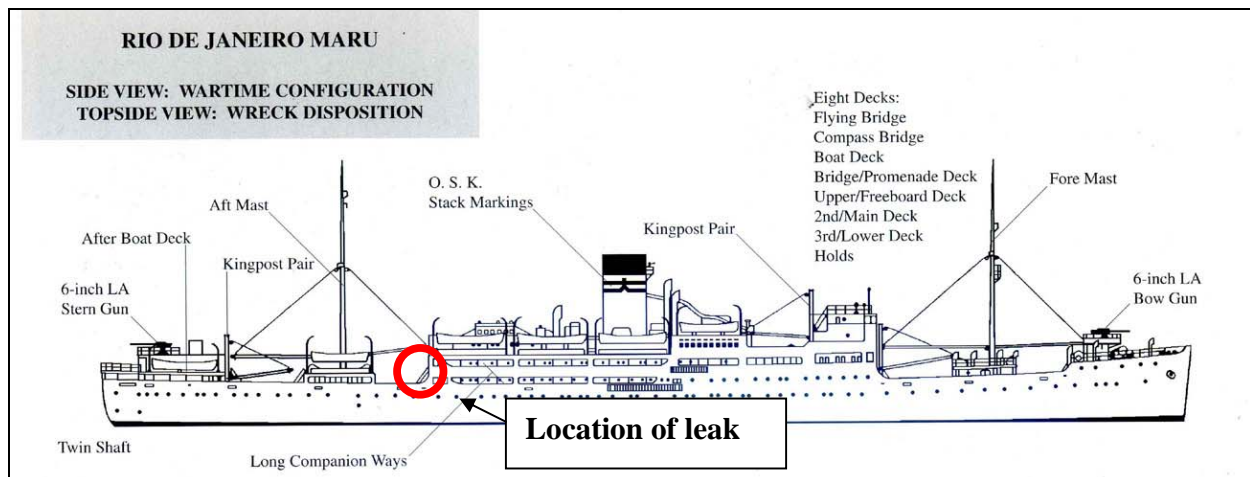
On a subsequent recreational dive by two of the Earthwatch volunteers on *Rio de Janeiro Maru* (located south east of Uman) on August 8, they noticed a small slick of oil/diesel on the sea surface. Tracking the source of the slick to the shipwreck, they found a few bubbles rising from shipwreck (see Figure 7). The ship is lying on its starboard side and a pool of oil/diesel is collecting under the gunwale of the port side

and occasionally spills over as the pool increases in size. *Rio de Janeiro Maru* was converted from a passenger vessel to a submarine tender by the Japanese navy. It was powered by twin diesel engines.

Figure 7: Side view of *Rio de Janeiro Maru* showing approximate location of leak.
