**EU-SOPAC (EDF9) Project Report 80
Reducing Vulnerability of Pacific ACP States**

**NAURU TECHNICAL REPORT
RAINWATER HARVESTING:
ASSET CONDITION SURVEY OF DOMESTIC INFRASTRUCTURE
13th February to 23rd February 2007**

August 2007

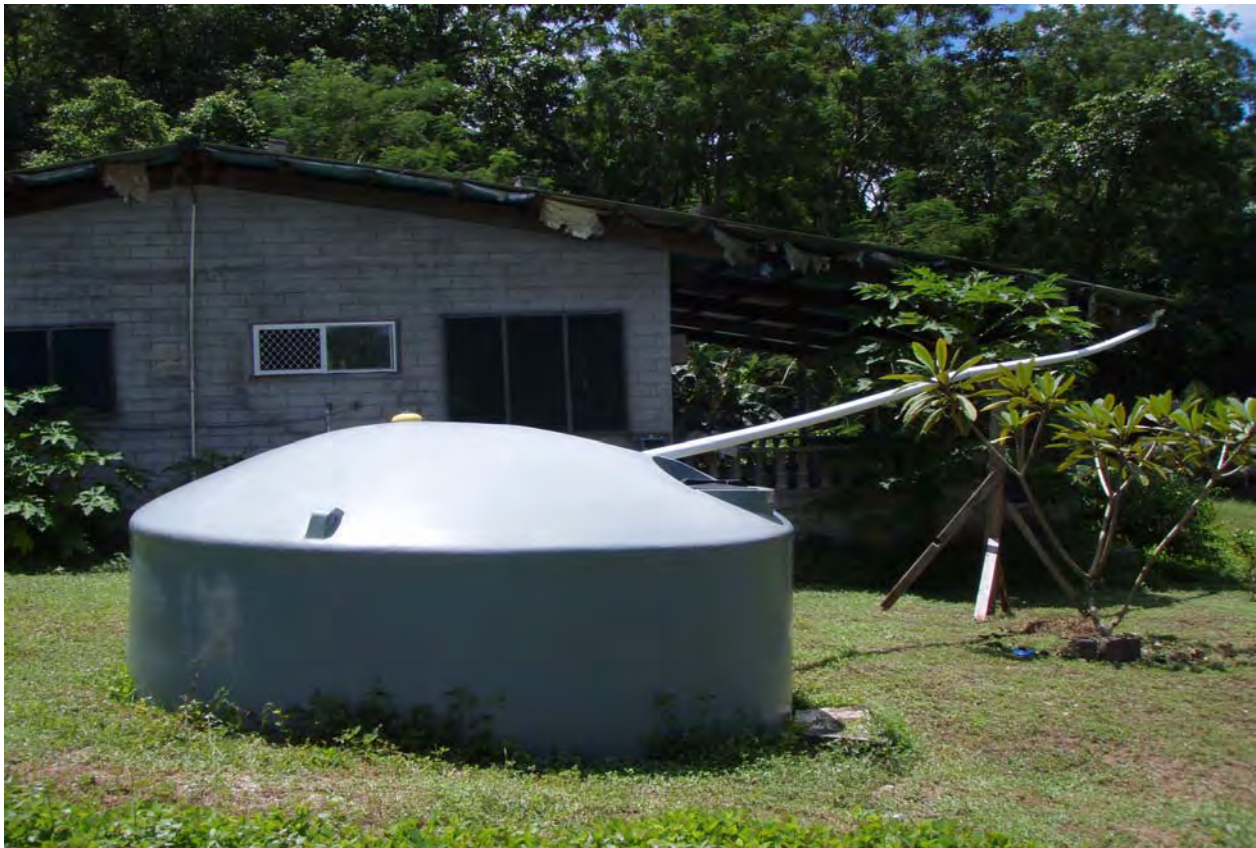
Plastic water storage tank emplaced partially below ground level, Buada, Nauru.

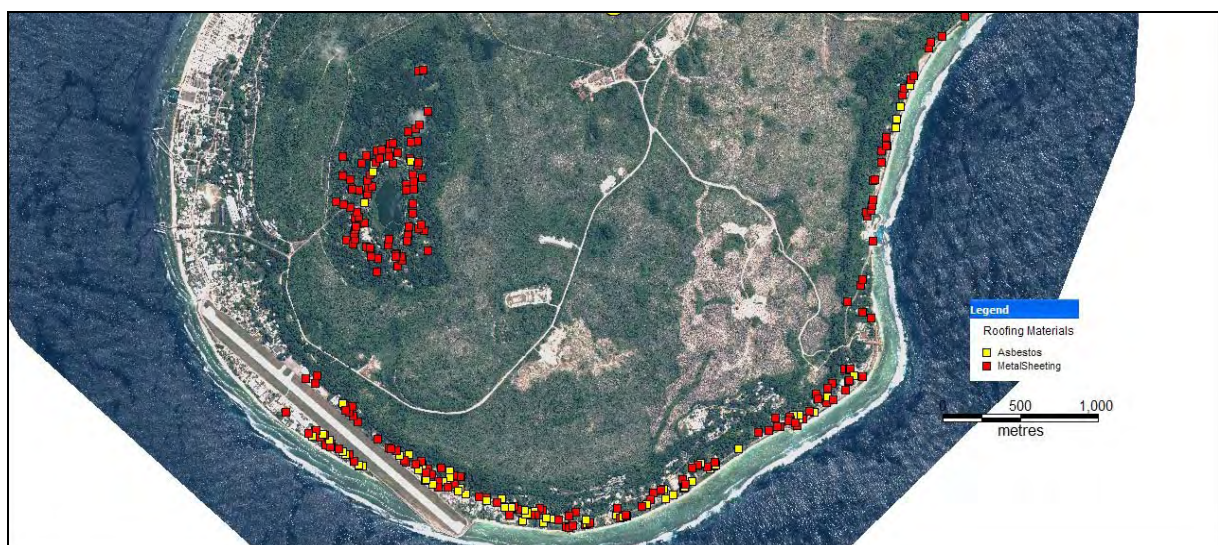
Figure 15. Types of roofing materials.

The spatial distribution recorded for the two types of roofing materials is shown in Figure 15. It is immediately apparent that the old asbestos roofing (shown in yellow) interestingly exhibits a significant concentration within the Yaren district.

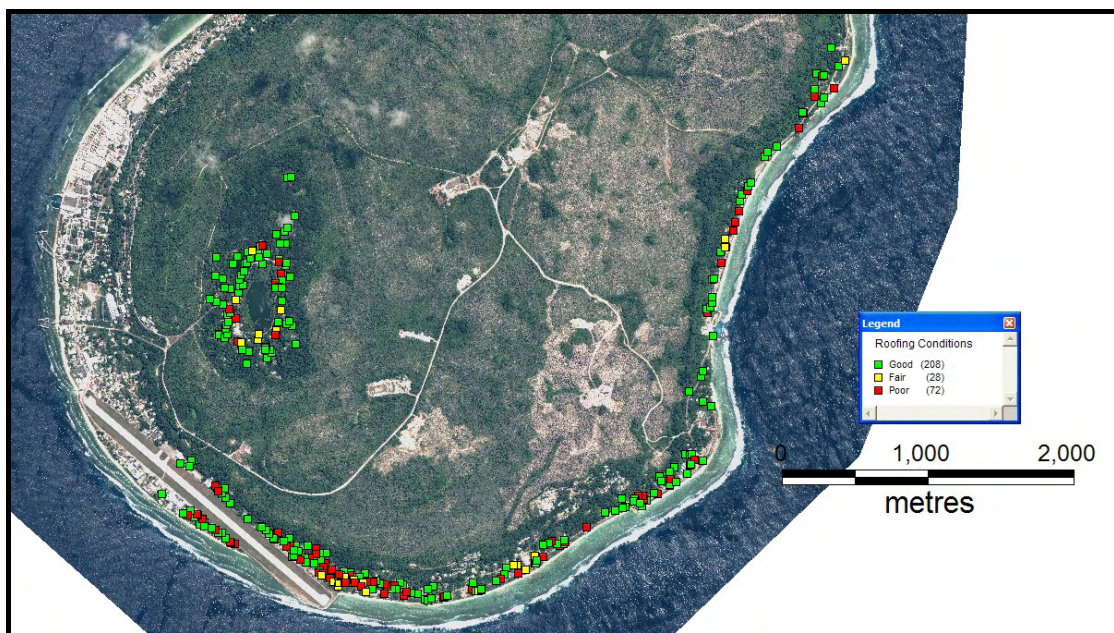
Figure 16. Condition of roofing materials.

The visible external condition of the roofing materials was also recorded as *Good*, *Fair* or *Poor*. Reference to Table 4 indicates that almost a quarter (23%) of the roofs surveyed were considered to be in a *Poor* condition. The greater majority of roofs examined (it should be remembered that the “examination” only represented a brief visual scan from a distance at ground level) appeared to be in relatively good external condition.

The spatial distributions of these categories is shown below in Figure 16 and, whilst there is a suggestion of an apparent correlation of roofing materials in *Poor* condition with the old asbestos roofing concentrated within the Yaren district, the distribution of *Poor* condition roofs also exhibits a relatively general scatter.

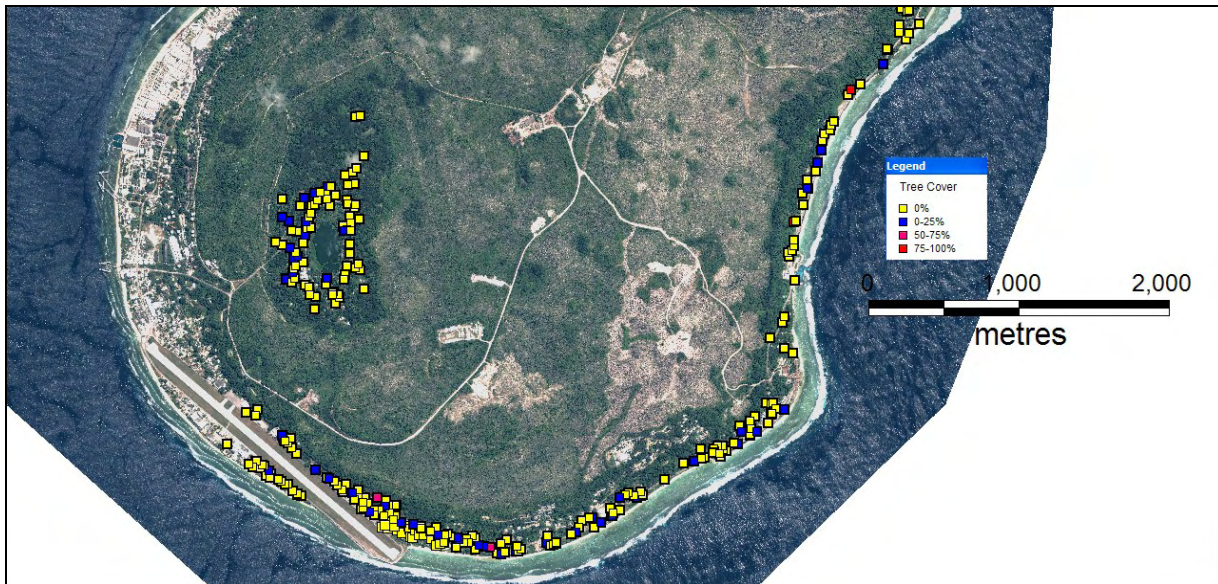
Figure 18. Vegetation Overhang.

The survey also noted when any vegetation was seriously overhanging the roof area, as the close proximity of tree canopy cover not only reduces, via interception, the amount of rainfall that can reach a roof (thereby lessening the potential resource for capture and subsequent storage), but can also create significant other problems due to leaf, fruit or branch debris blocking guttering and downpipes. Adverse water quality impacts can also result due to biological decay (taint/colour/taste) of leaf matter and encouraging microbiological contamination from insects, bird and bat droppings. Ocean salt aerosol carried on the wind can also get concentrated by evaporation on leaf surfaces; this will eventually get taken back into solution during rainfall events, providing an unwanted chemical (salt) input into the roofwater catchment system. Vegetation overhang was recorded by observers as a relative percentage cover. Table 6 indicates that this does not appear to be a significant problem on Nauru, with 80% of properties being free of any vegetation overhang.

The spatial distribution of vegetation overhang is shown in Figure 18. The majority of houses along the south and east coastal strip on Bottomside are sited closer to the road and coastline and tend to lie well clear of the more densely vegetated foot of the Topside escarpment. The un-mined area encircling Buada Lagoon represents perhaps the only significant area of mature, original woodland on Nauru and hence the potential for vegetation overhang is greater for houses constructed there. However, very few properties were troubled by this issue.

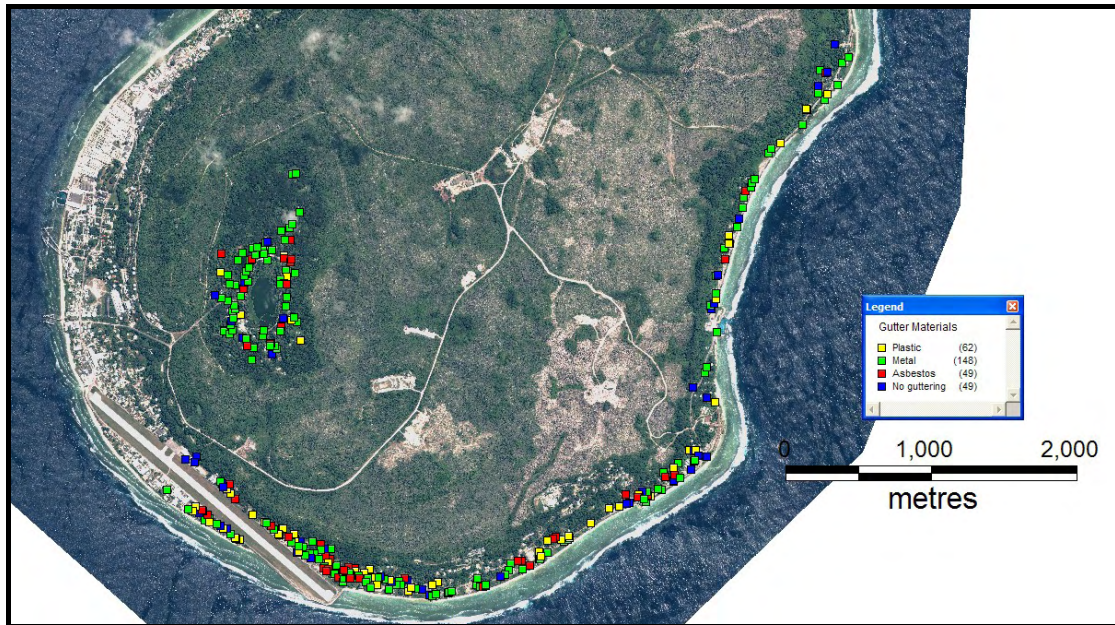
Figure 19. Gutter Materials.

The spatial distribution of gutter materials is illustrated in Figure 19, and it is apparent that there is no particular geographic pattern or concentration that might explain gutter non-availability – the properties with no guttering are well scattered and appear randomly distributed. Asbestos guttering was also observed on approximately one sixth of the surveyed properties and a reasonably distinct “remnant” concentration is again visible in the Yaren District.

The spatial distribution of the different guttering materials may also suggest a pattern of more frequent use of PVC materials along the coastal strip (eminently sensible in term of proximity to the corrosive marine environment!) compared to a more dominant application of metal guttering in Buada District.

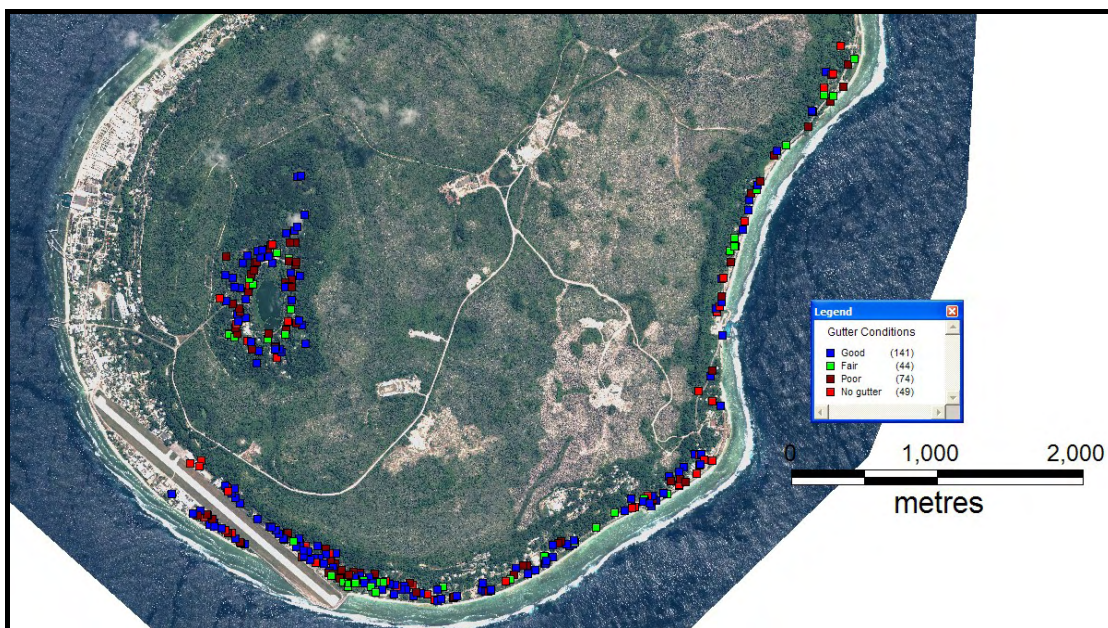
Figure 20. Gutter Conditions.

The visible external condition of the guttering materials was also recorded as *Good*, *Fair* or *Poor*. Table 8 indicates a high proportion (38%) of gutters could only be cumulatively considered in *Fair to Poor* condition. This suggests that there is significant scope for improving awareness of domestic maintenance issues.

The spatial distribution of the different guttering conditions is illustrated in Figure 20, and illustrates the widespread pattern of mediocre or absent guttering.

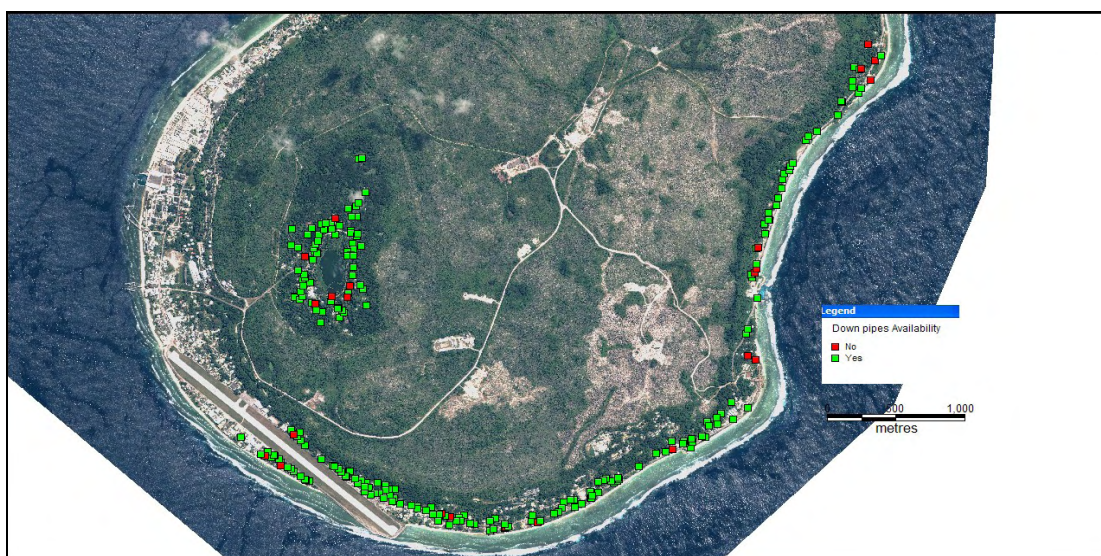
Figure 21. Properties with and without downpipes.

Table 10 reveals that plastic is effectively the sole material (85%) utilised for system downpipes and also that 10% of the domestic properties surveyed recorded downpipes as completely absent. Obviously the latter properties currently exhibit a vital “missing-link” in the rainwater catchment and transmission equation and, because of this relatively simple and basic omission, are currently unable to consider rainwater harvesting and storage.

The spatial distribution of properties with and without downpipes is illustrated in Figure 21, and there is no apparent geographic pattern or concentration that might explain downpipe non-availability – the properties with no downpipe are well scattered and appear randomly distributed.

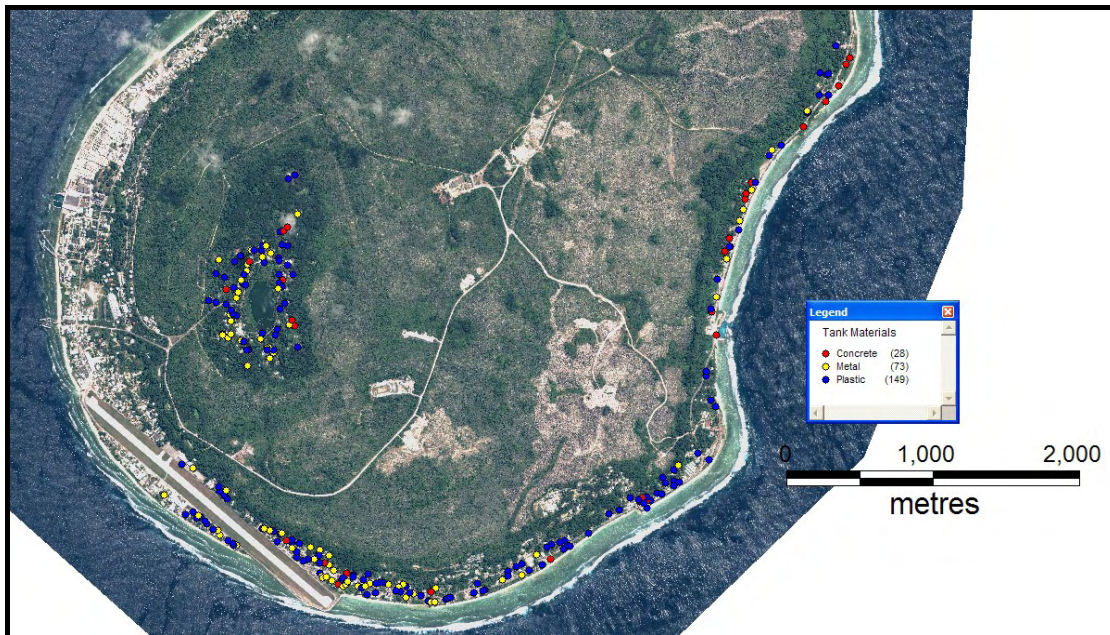
Figure 22. Tank Materials.

The spatial distribution of tank materials is illustrated in Figure 22, and it is apparent that there is a notable concentration of properties with metal tanks in Yaren District, whilst concrete appears the more dominant material in Anibare and Ijuw districts. These distributions could relate to specific, historic Aid packages targeting certain districts.

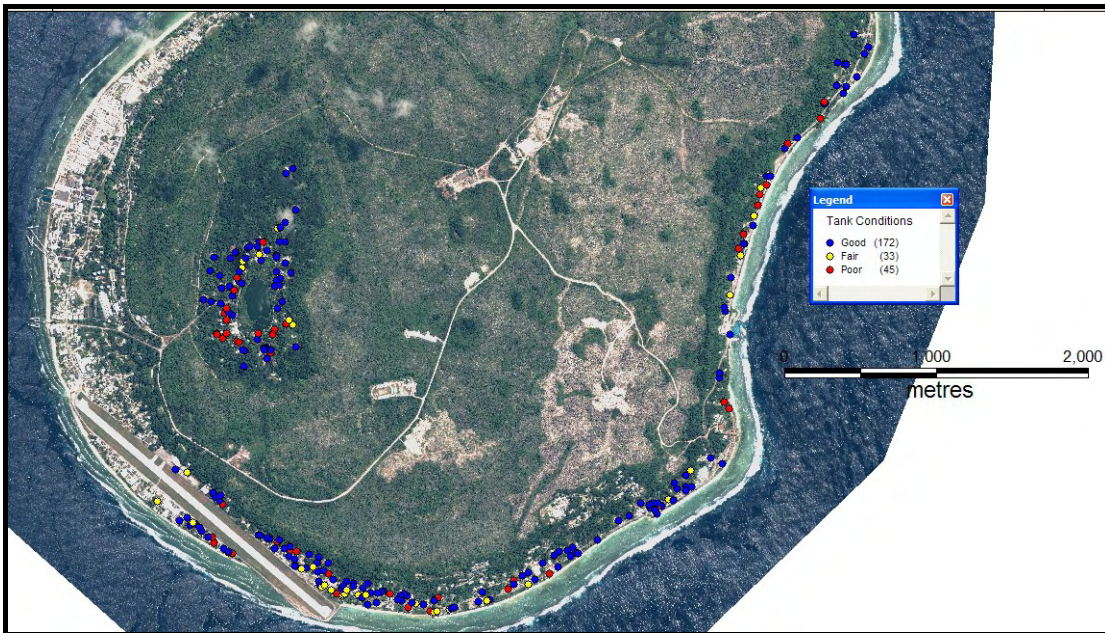
Figure 24. Tank Conditions.

Reference to Table 13 indicates that almost three quarters (69%) of the 250 observed tanks during the field survey appeared to be in a *Good* condition, with quite a high proportion (31%) only in a *Fair to Poor* condition.

The spatial distribution of tank conditions is illustrated in Figure 24, and it is apparent that the 18% of tanks recorded to be in a *Poor* condition are seemingly concentrated around Buada Lagoon and along the northern coastal strip of Anibare.
