Survey of the Regional Distribution and Status of Asbestos-Contaminated Construction Material and Waste - Best Practice Options for its Management in Pacific Island Countries

Report for the Republic of the Marshall Islands

**Prepared for the Secretariat of the Pacific Regional
Environment Programme (SPREP)**

May 2015

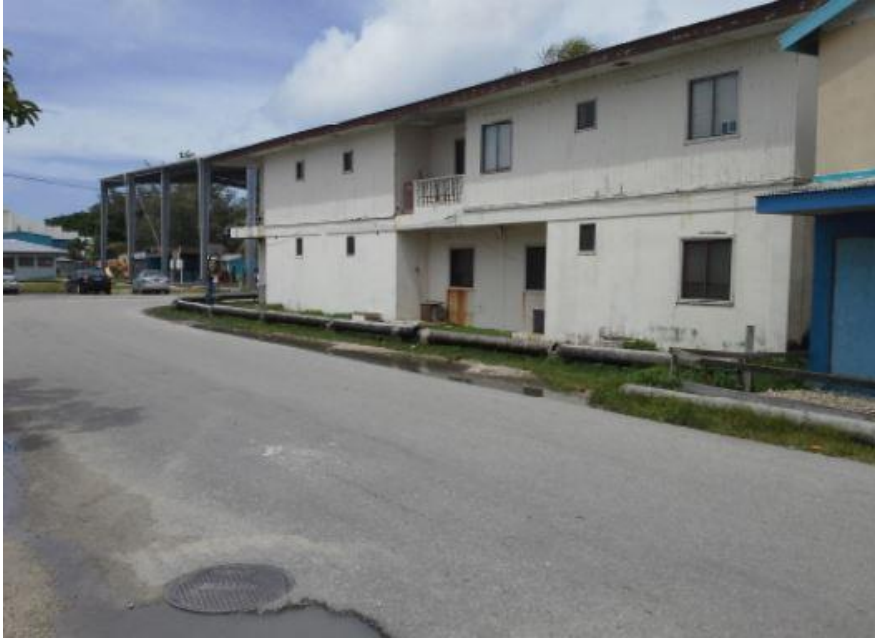
The majority of residential dwellings observed on Majuro were constructed using plywood, concrete blocks (often with cement plaster) and corrugated iron. Little or no asbestos-containing materials were observed. Photo 1 shows a typical building in Majuro.

Photo 1: typical structure in Majuro showing cement cladding

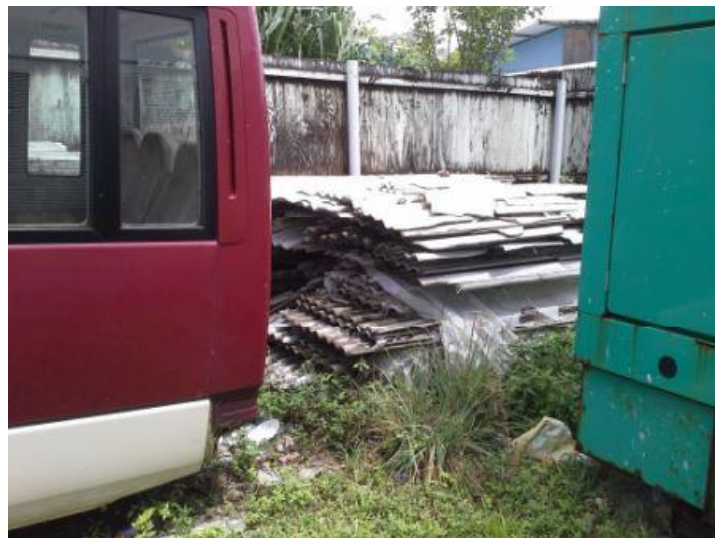
Site Name	Building Material Type	Risk Ranking Scores		
		ACM	Setting	Total Score
College of The Marshall Islands	Cement water pipes and corrugated cement roof boards	4	18	22
Ace Hardware	Corrugated cement roof	4	12	16
Vacant Residential Site	Corrugated cement roof	4	11	15
Majuro Japan Construction Company	Corrugated cement roof	3	6	9
Majuro Airport	Cement water pipes	4	3	7

Photo 2: Asbestos sheets at the College of MI

Site Name	ACM	Risk Score	Recommended Remedial Actions	ACM Area (m ²) and/or Volume (m ³)	Estimated Cost (\$ USD)
College of The Marshall Islands	Roof Boards	22	Remove to Landfill	100m ²	\$4,300
College of The Marshall Islands	Cement pipes	18	Encapsulate	60m ²	\$1,380
Ace Hardware	Cement roof boards	16	Encapsulate	400m ²	\$33,600

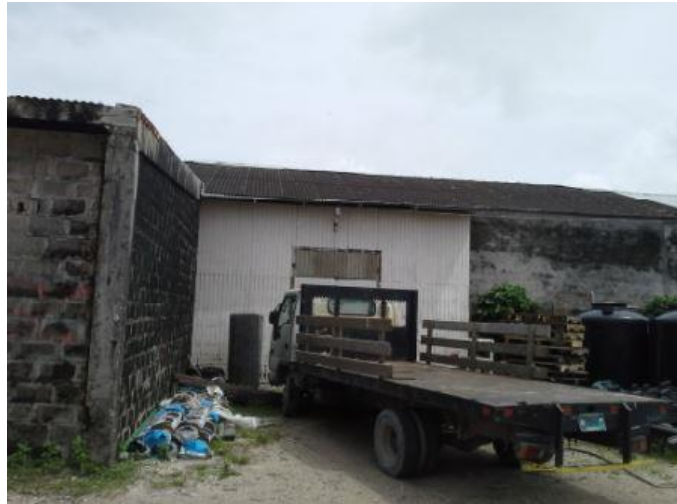
Photo 3: Asbestos roof cladding at Ace Hardware

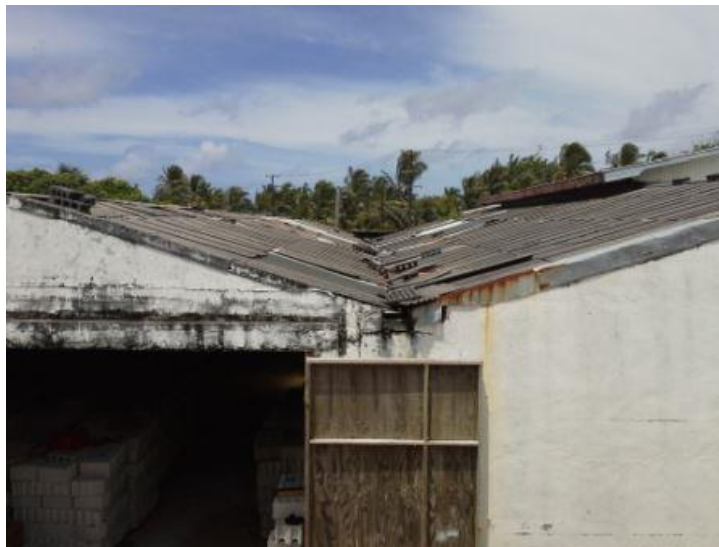
Photo 4: Damaged asbestos roof cladding at the Majuro Japan Construction Co.
