Survey of the Regional Distribution and Status of Asbestos-Contaminated Construction Material and Best Practice Options for its Management in Pacific Island Countries

Report for the Solomon Islands

**Prepared for the Secretariat of the Pacific Regional
Environment Programme (SPREP)**

May 2015

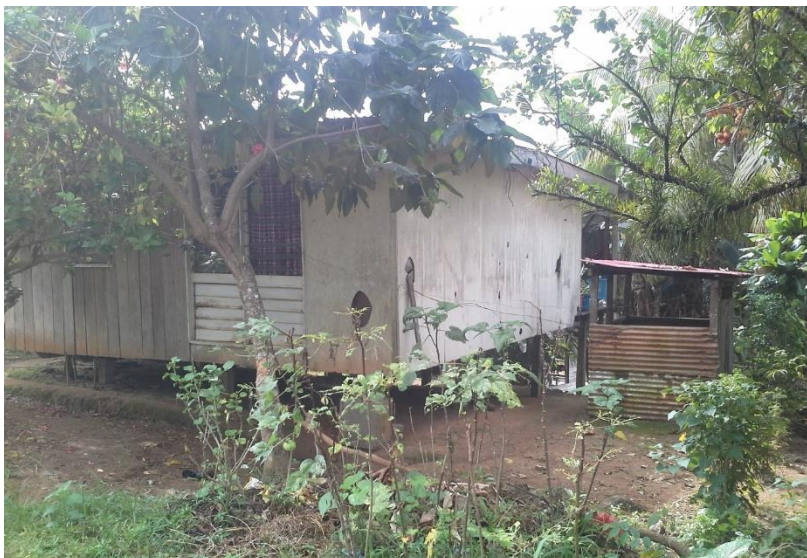
Photo 2: typical residential structure made of fibre board or PACM

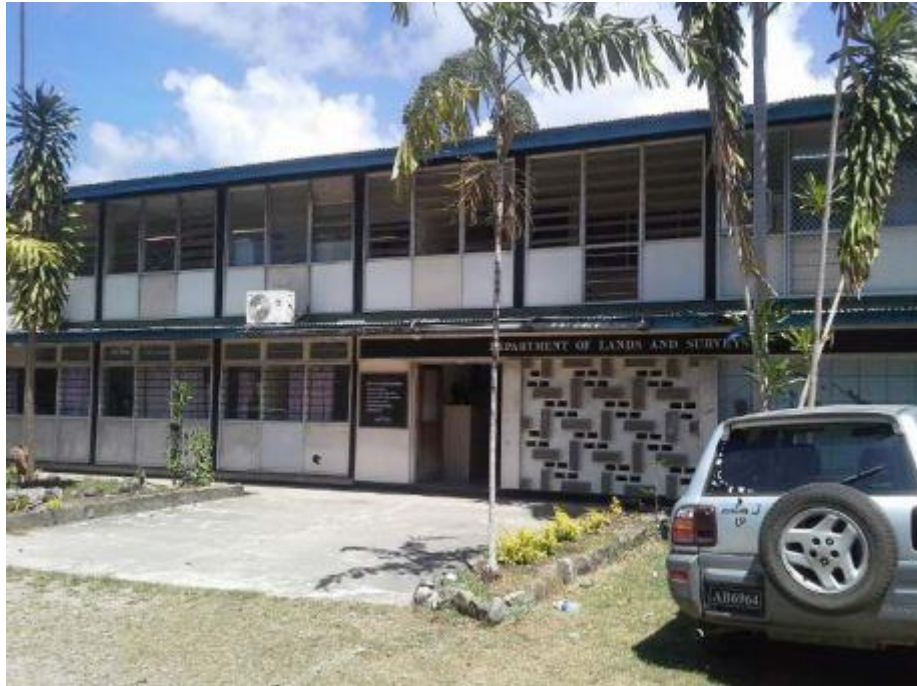
Photo 3: Lands & Survey Building – AC Panels

There are a few Government buildings that have asbestos-cement cladding in the Solomon Islands, such as the Lands and Survey Building and the Ministry of Infrastructure and Development Building in Honiara. In general, however, there is only a small amount of asbestos that was observed on non-residential buildings in the Solomon Islands.

The risk ranking scores presented in Table 9 indicate that the survey has identified one (Land & Survey building) site that poses a high risk of exposure to occupants. Photo shows the building with the fibre board cladding along the front. In addition, the Ministry of Infrastructure & Development building presents a moderate risk to human health while five sites, including residential areas, are ranked as having a low risk to the occupants. The risk assessment is based on current conditions, ACM condition and site use observed at the time of the survey. Should these change over time, reassessment of the risk presented would be required.

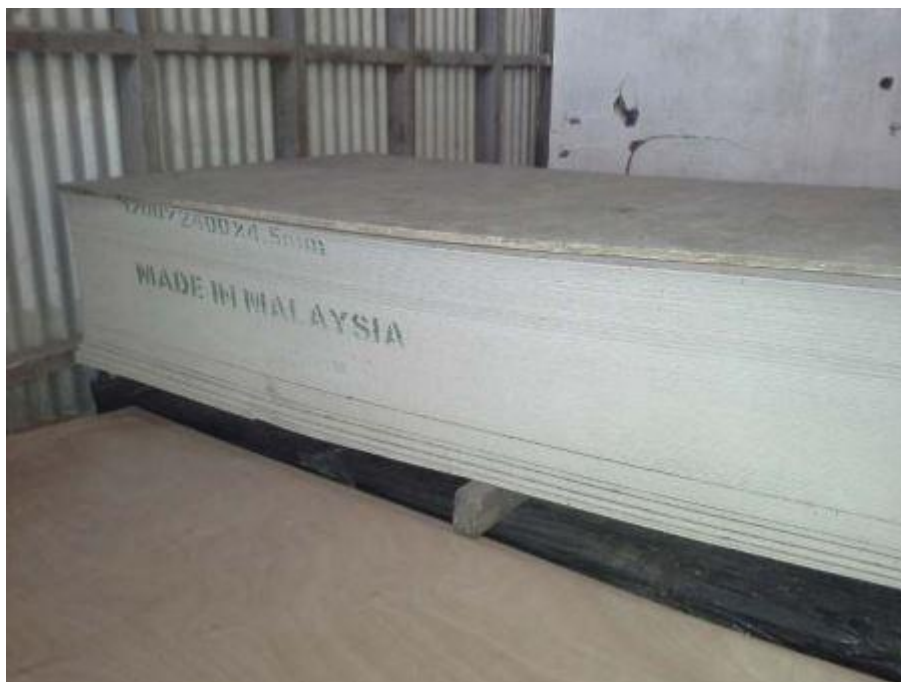
Photo 4: Asbestos cladding for sale in Gizo

It is important to note above that the ACM detected at the hardware store is new asbestos cladding that is being sold to the public for construction purposes.

A risk assessment was not carried out for the new asbestos cladding that was found on sale at a hardware store in Gizo because this could be used in a wide range of possible settings, some of which may be safe and some which may not. A photo of this material is shown in Photo 4 above, and it is recommended that the Solomon Islands Government acts quickly to have it removed from sale. In addition, any future imports should be banned.

It is also recommended that the Solomon Islands government act quickly to have the new asbestos cladding identified at a hardware store removed from sale. In addition, any future imports should be banned.

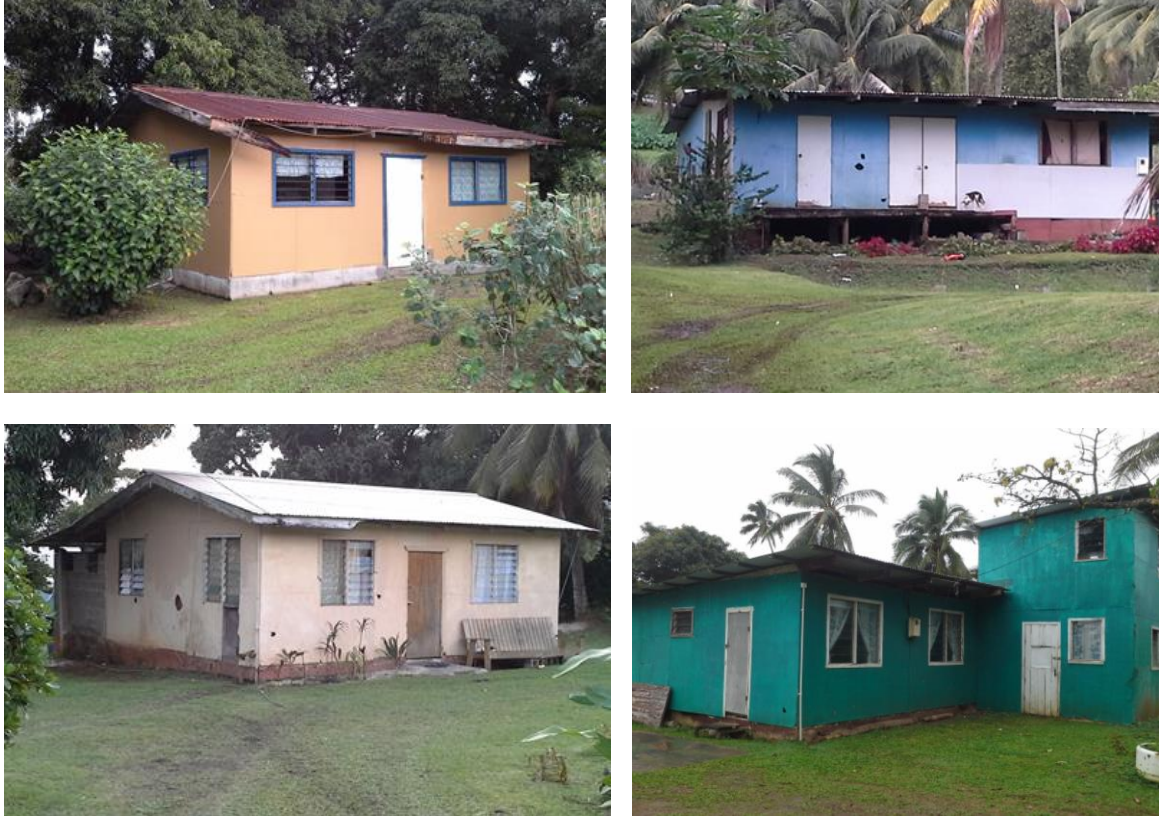
Photos 5-9 – Typical Residences with PACM Cladding
