Survey of the Regional Distribution and Status of Asbestos-Contaminated Construction Material and Best Practice Options for its Management in Pacific Island Countries

Report for the Cook Islands

**Prepared for the Secretariat of the Pacific Regional
Environment Programme (SPREP)**

May 2015

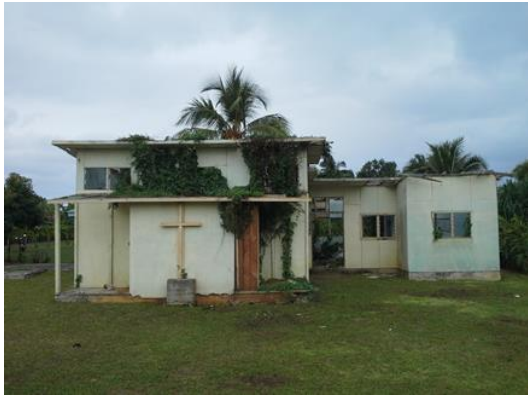
Photo 1 - Church in Aitutaki

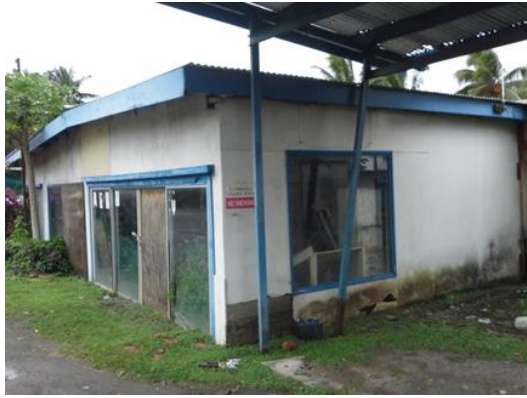
Photo 2 - Disused Shop – Arorangi, Rarotonga

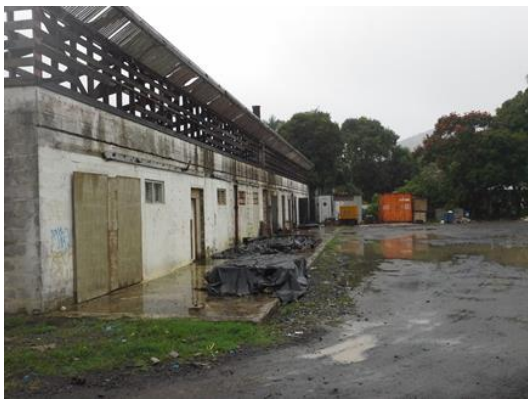
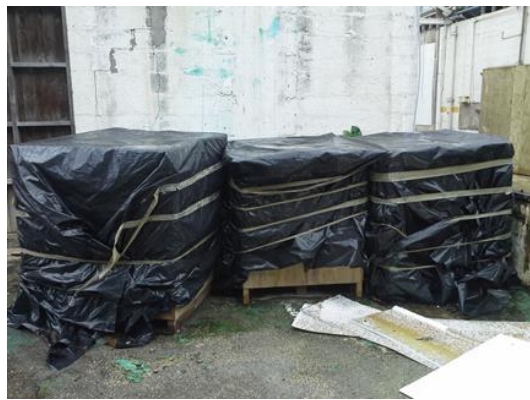
Photos 3 and 4 – Government Collection Point for ACM

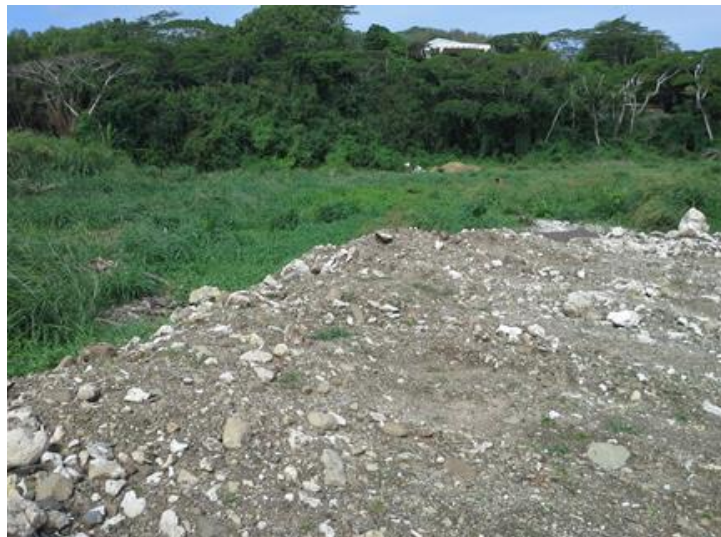
Photo 5 – Asbestos Contaminated Soil – Rarotonga Landfill

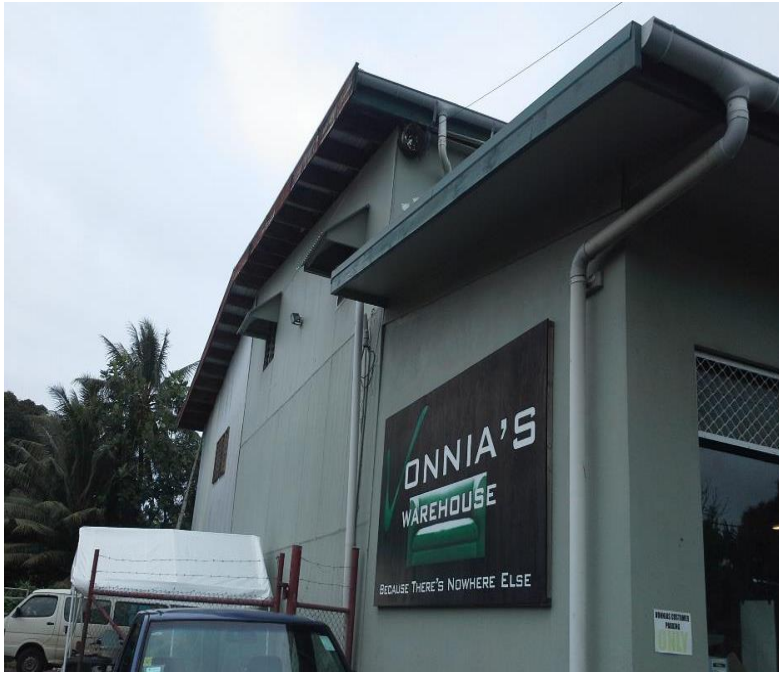
Photo 6 - Typical Commercial Building

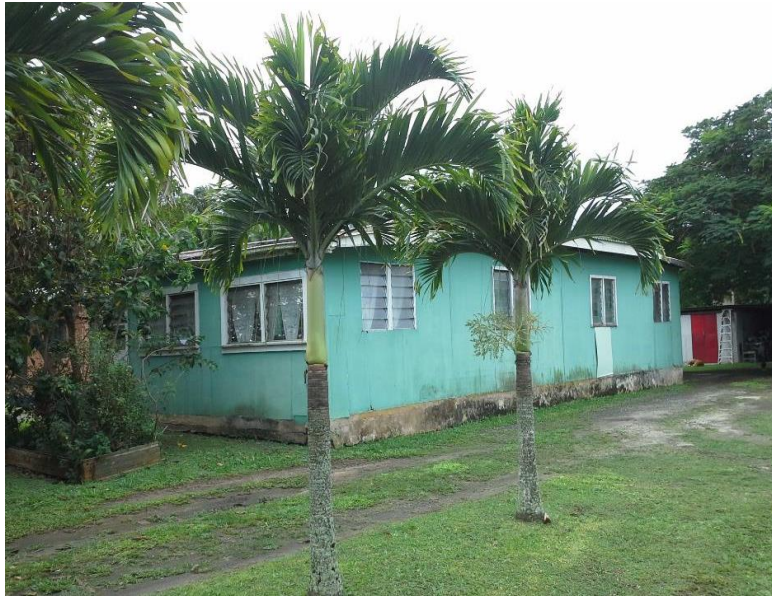
Photo 7 - Typical Private Residential Building
