# **Survey of the Regional Distribution and Status of Asbestos-Contaminated Construction Material and Best Practice Options for its Management in Pacific Island Countries**

## **Report for the Republic of Fiji**

**Prepared for the Secretariat of the Pacific Regional  
Environment Programme (SPREP)**

**May 2015**

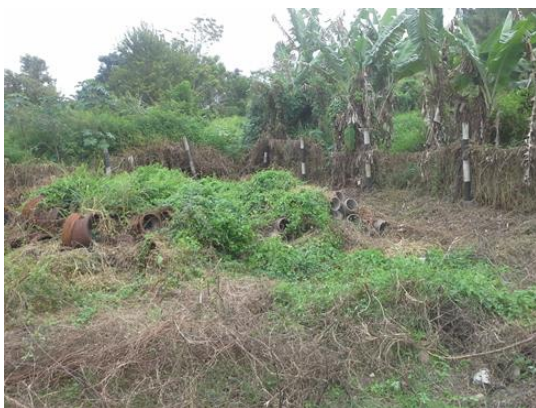
**Photo 1 – WAF Sigatoka**

Photos 1 and 2 are of Water Authority of Fiji (WAF) stockpiles. Photo 1 was taken at Sigatoka and Photo 2 was taken at Labasa.

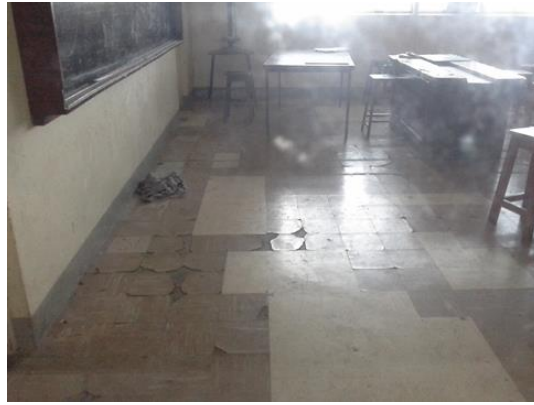
**Photos 3 and 4 – Suva Grammar School**

The photos below are of the Suva Grammar School. In Photo 3 the panels below the windows are asbestos sheeting. At the time of the visit there were about 200 of them but there was a plan to have them all removed. Photo 4 shows the broken vinyl flooring in the classrooms. This vinyl flooring contains 5% asbestos.

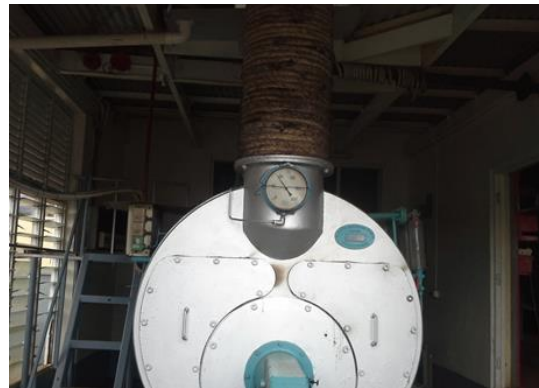
**Photos 5 and 6 – Labasa Hospital**

The photos below are of the Labasa Hospital. Photo 5 shows the sunshades. There are many such sunshades at the hospital. Photo 6 shows old fibreglass boiler pipe lagging. This lagging is 95% chrysotile asbestos.

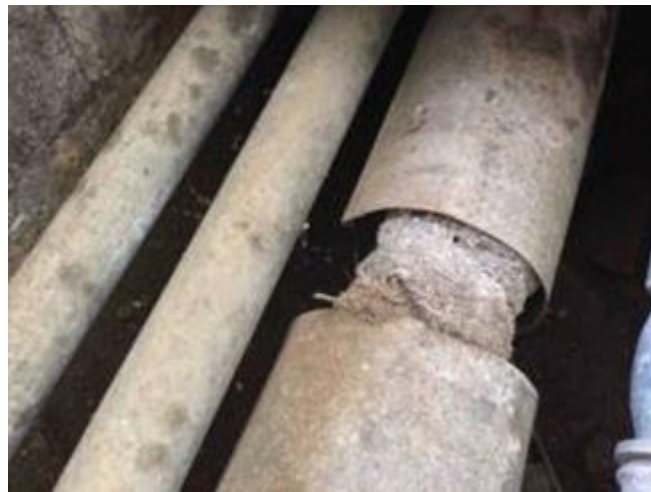
**Photos 7 and 8 – Pipe lagging in Tamavua-Twomey Hospital**

There is also extensive old asbestos remaining at the Tamavua-Twomey Hospital Complex in Suva. Photos 7 and 8 show the asbestos-lined pipe ducting that runs along ward corridors for a long distance. Photo 9 shows the old Ward 5 complex which has asbestos cladding on the outside and asbestos lining and ceilings on the inside. Friable asbestos was removed from two boiler rooms at the Tamavua-Twomey Hospital Complex as part of emergency work carried out under this project. Appendix 7 contains a report written prior to the work being undertaken, as well as the Asbestos Management Plan for the emergency work and the results of the air clearance analyses.

- A. It is recommended that the above higher priority asbestos work is carried out in Fiji and that consideration be given to removing other asbestos as per the table above. In particular the work at the Tamavua-Twomey Hospital should be completed.

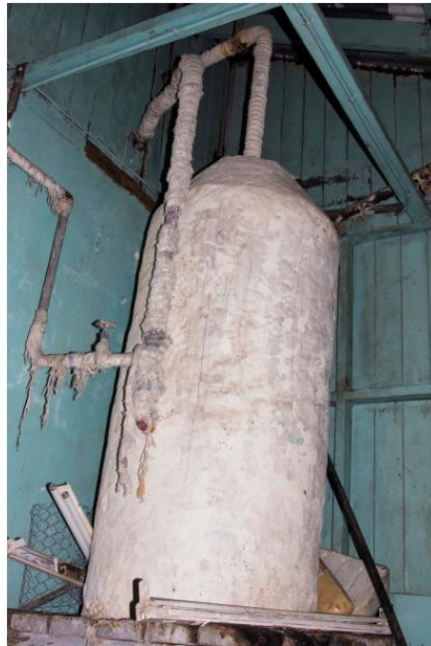
**Photo 10 – Hospital Boiler**

Photo 10 below shows a boiler and associated piping at the Tamavua-Twomey Hospital with friable asbestos lagging. There are also six hot water header tanks and associated piping in the roof space with friable asbestos cladding.

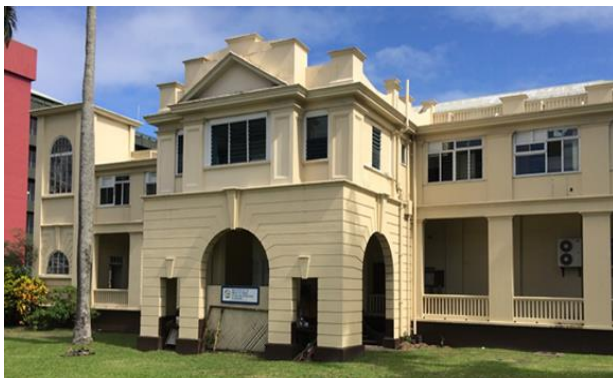
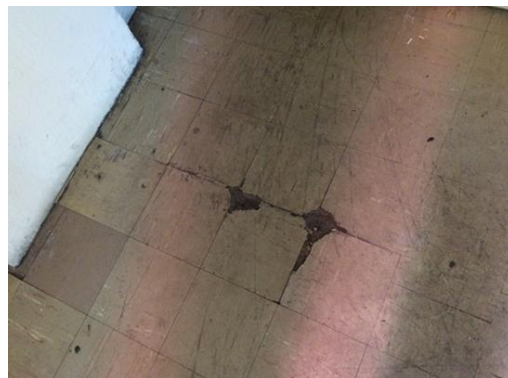
**Photos 11 and 12 – Stephens Building, Suva**

Photos 11 and 12 show the Stephens Building in the Suva CBD and the vinyl flooring in this building. These pictures were taken before the building was demolished. The results that established that the vinyl floor contained asbestos were available at an early stage of the demolition but the demolition still proceeded with no precautions taken to protect workers or the public. An investigation was carried out and the resulting report is contained in Appendix 8. There was no additional clean-up work undertaken but air monitoring for asbestos was carried out and no air-borne fibres were detected.

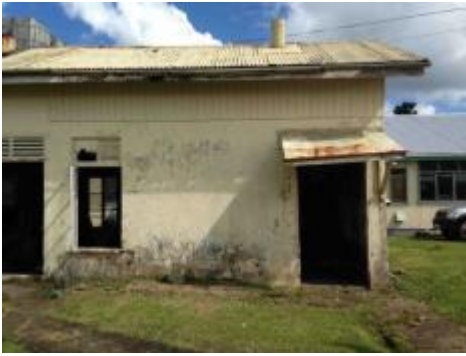
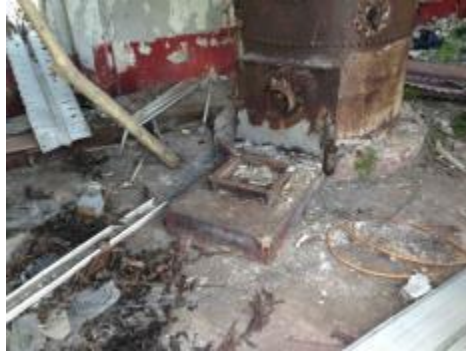
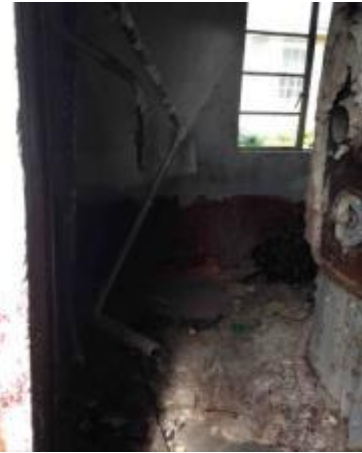
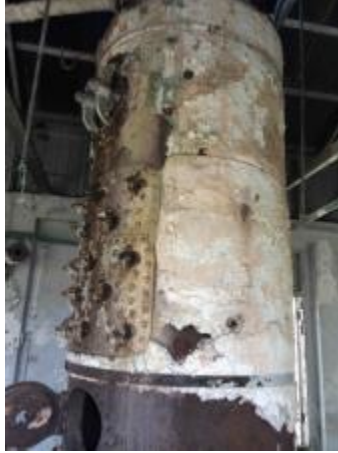
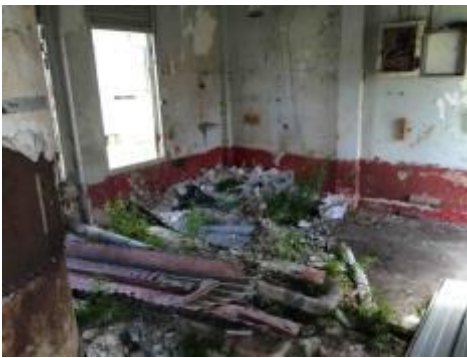
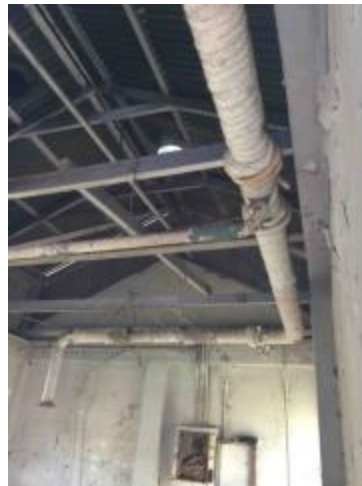
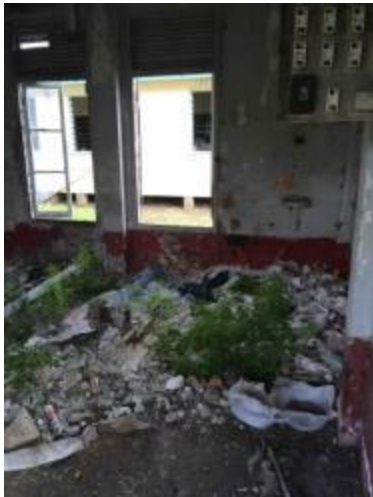
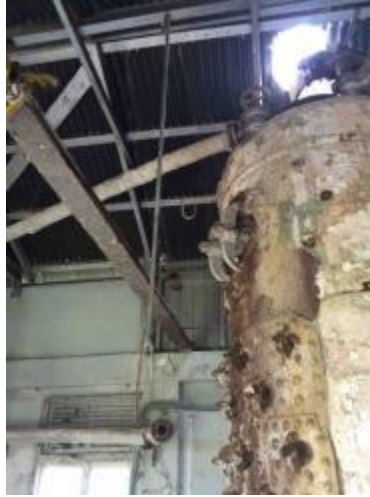
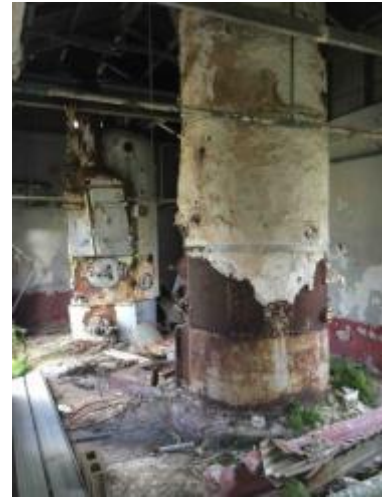
##### 2.1 Derelict Room

This room is shown in the following nine photos. The room is open with windows facing towards the hospital. Broken down lagging is on two vessels and strewn over the floor. Rope lagging is coating some pipes. If this lagging is confirmed as asbestos, especially blue asbestos, then this is a serious situation that needs to be addressed urgently.

The situation is a serious one that needs to be addressed urgently. If some or all of the material described above proves to be asbestos, which seems likely, based on previous information and the experience of the SPREP consultants, then urgent action is needed. Much of the hospital and its grounds may be contaminated with asbestos.

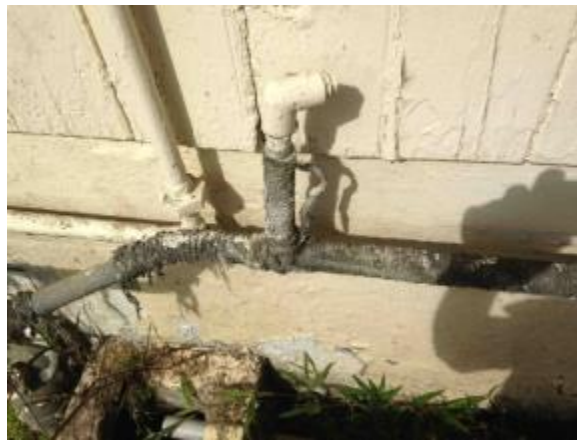
## 2.2 Exterior Rope Lagging

Rope lagging in a deteriorating condition covers pipes that are attached to walls in numerous locations as shown in the following four photos. Rope lagging of this type has commonly been made from asbestos.

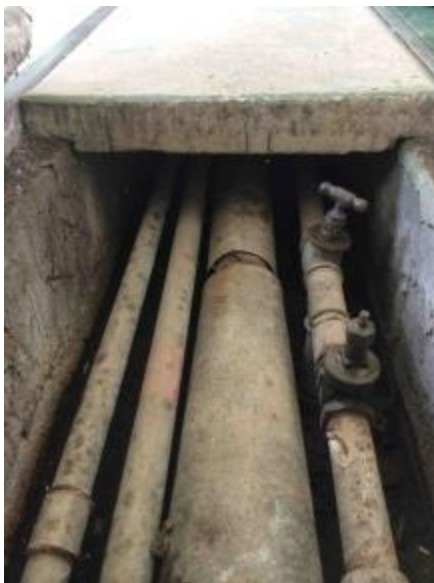
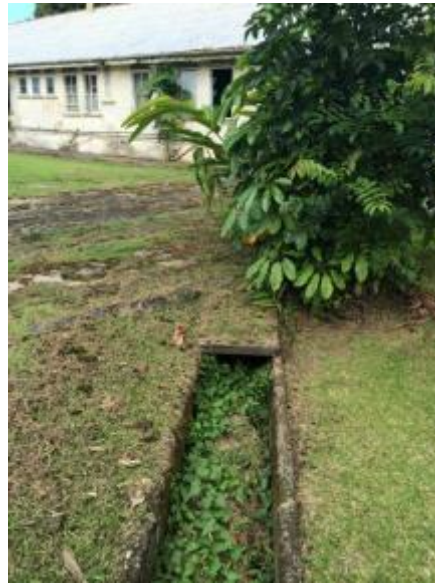
### 2.3 Exterior Ducting

Pipes encased in lagging runs through a large network of ducting through the grounds of the hospital. This is shown in the following two photos.

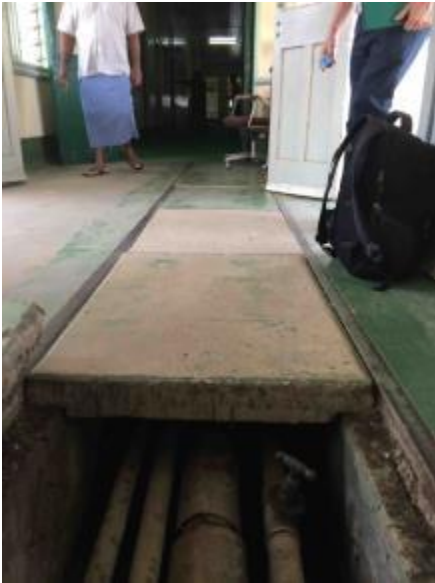
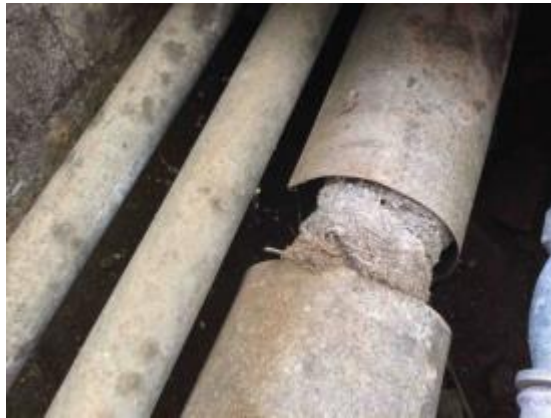
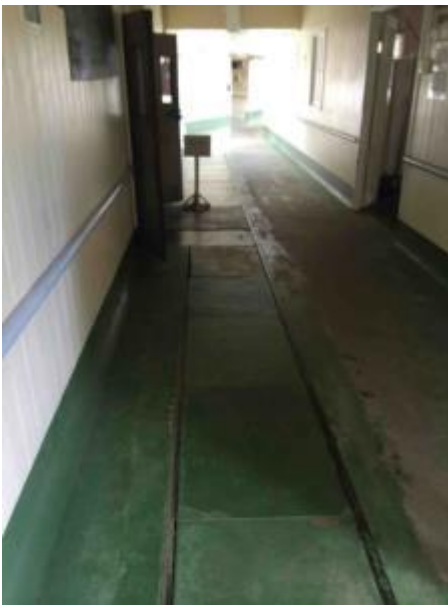
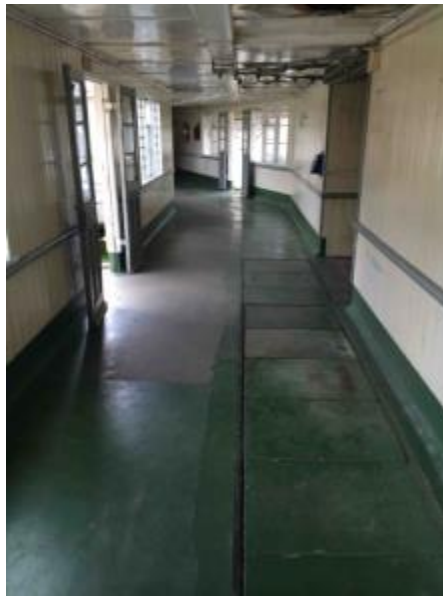
### 2.4 Internal Ducting

Pipes encased in lagging run through ducts in a network of corridors inside the hospital as shown in the following four photos. Lagging on the largest pipe is the rope lagging that has commonly been made from asbestos.

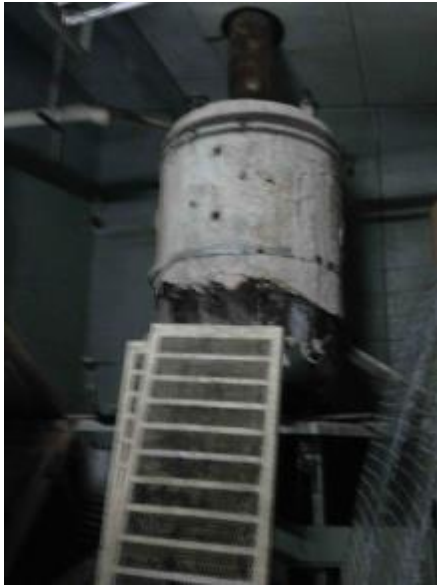
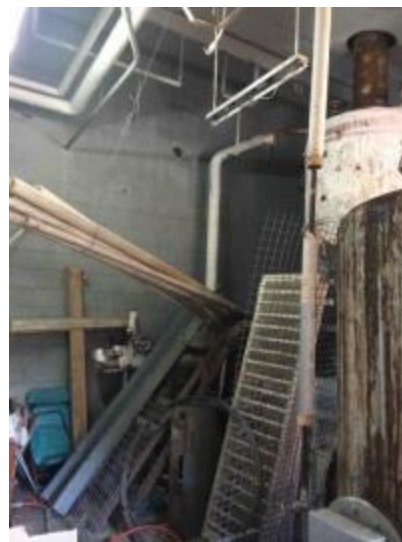
## 2.5 Old Boiler Storage Room

There is an old boiler room in the newer part of the hospital that is currently being regularly used as an equipment storeroom as shown in the four photos below. If the lagging on these old vessels is asbestos (especially blue asbestos) then this is another serious matter that needs to be addressed urgently. Lagging debris is spread on the floor of this room and the equipment stored in the room may be taken all round the hospital.

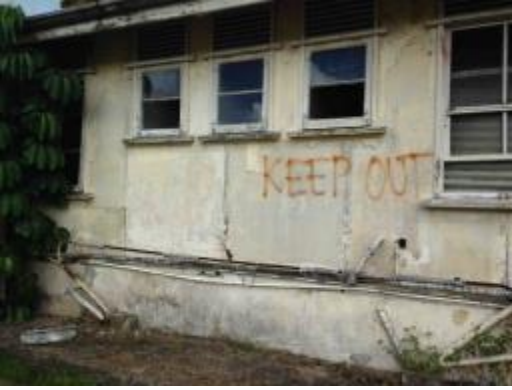
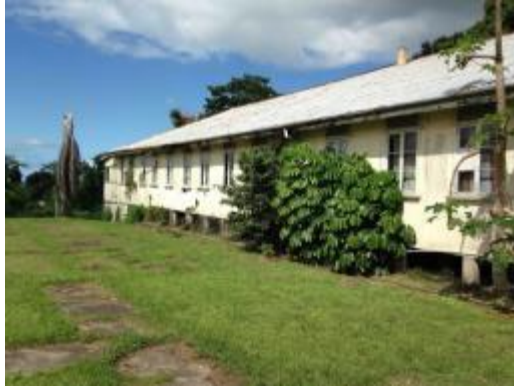
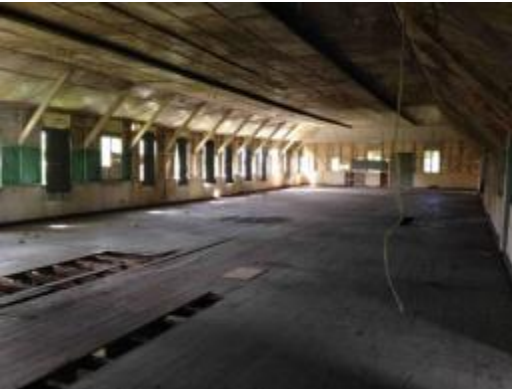
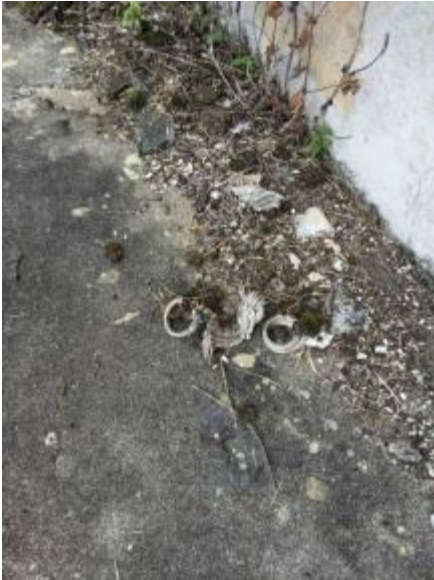
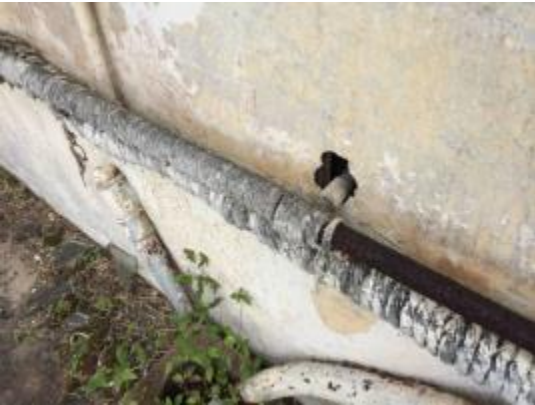
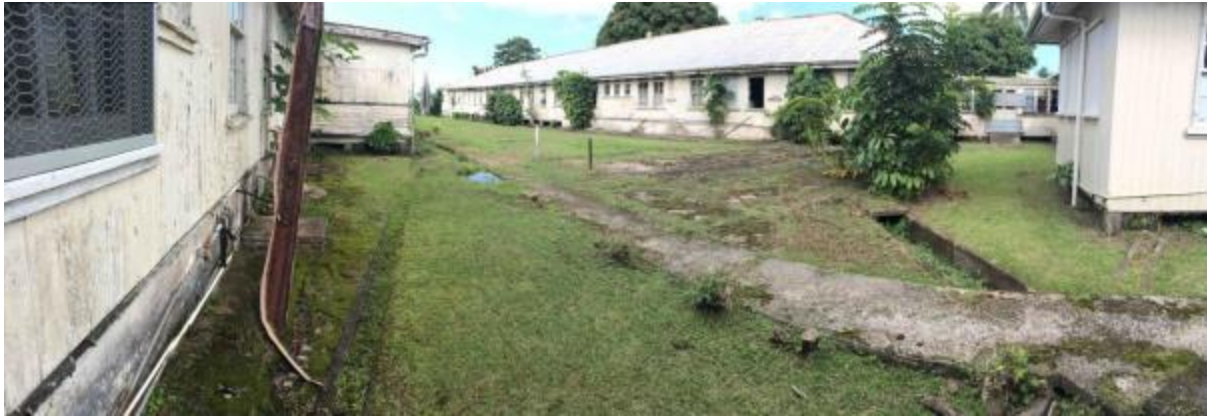
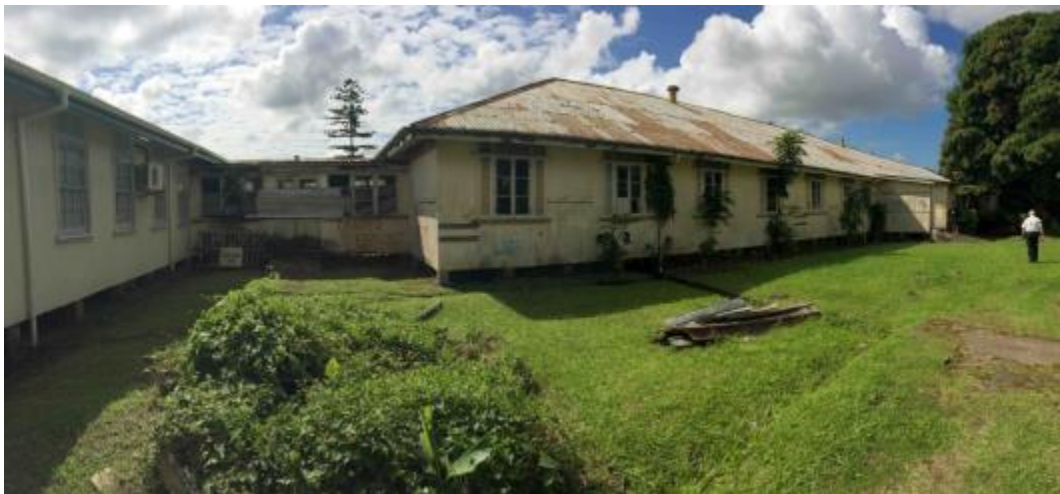
## 2.6 Old Ward 5

The old Ward 5 is known to be an asbestos building and “Keep Out” warnings have been painted on the building. It is a large old building as shown in the seven photos below. There is asbestos cladding on the outside and the internal walls are also understood to be asbestos. A network of pipes hang off the side of the building that are covered in very deteriorated rope lagging, some of which has fallen to the ground.

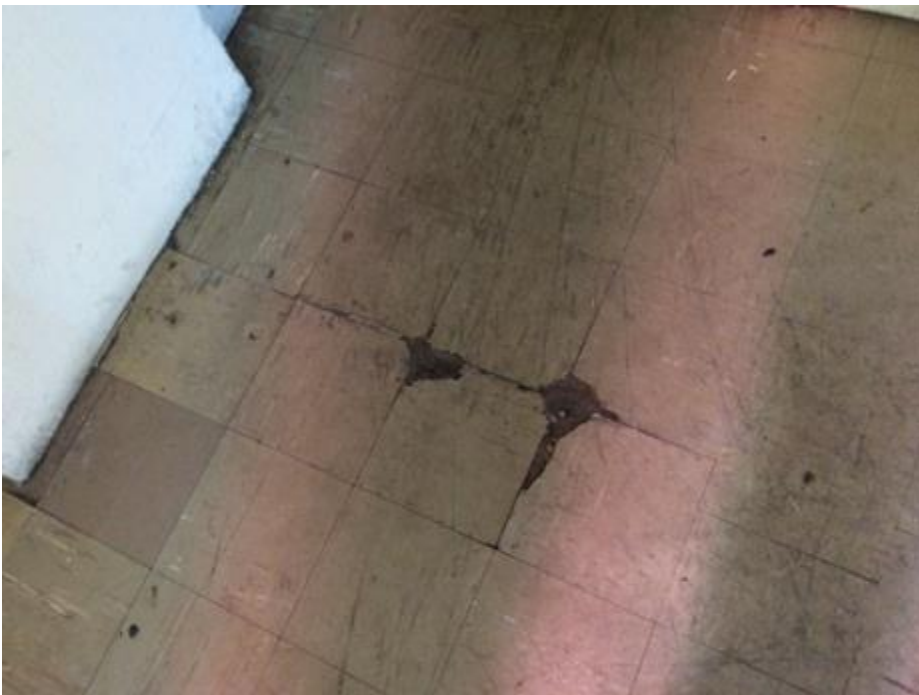
Photograph 2: Damaged ground floor vinyl floor tiles sampled 16 July 2014.

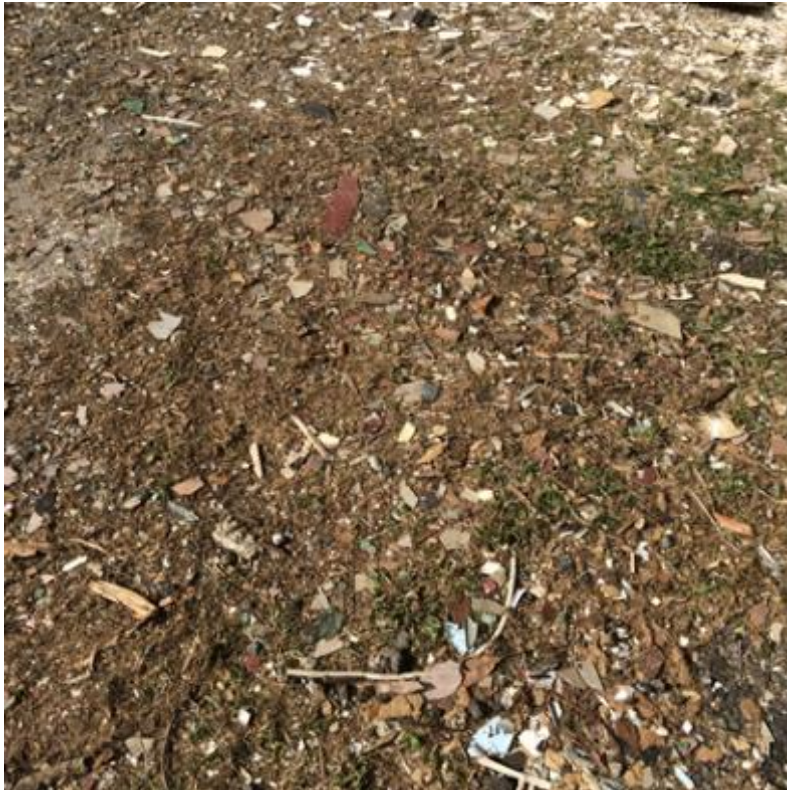
Pieces of floor tiles varying in size from approximately 5 - 150 mm were observed on the ground (see photograph 4) on all four sides of the building covering an area of approximately 100m<sup>2</sup>. A small downstairs room was observed to still contain vinyl floor tiles. No renovation staff were observed to be wearing suitable PPE for a site containing damaged asbestos materials.

Photograph 4; vinyl floor and other misc. building material on ground to north of building.

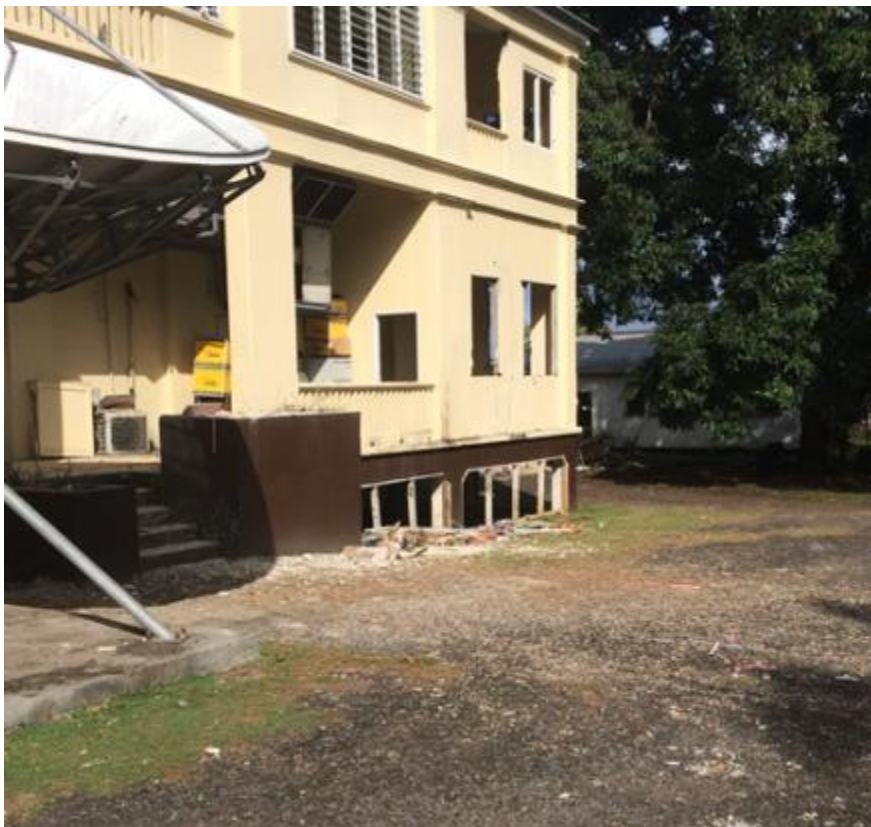
Photograph 6; acm vinyl floor tiles on ground adjacent to north facing façade
