# **Survey of the Regional Distribution and Status of Asbestos-Contaminated Construction Material and Best Practice Options for its Management in Pacific Island Countries**

## **Report for the Sovereign Republic of Kiribati**

**Prepared for the Secretariat of the Pacific Regional  
Environment Programme (SPREP)**

**May 2015**

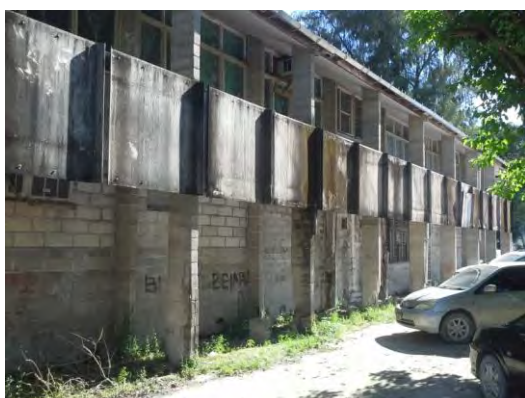
**Photo 1 – Ministry of Fisheries**

Photo 1 shows sunshades at the Ministry of Fisheries and Photo 2 shows loose – Old Powerhouse – loose fibreboard at the rear of the old Powerhouse.

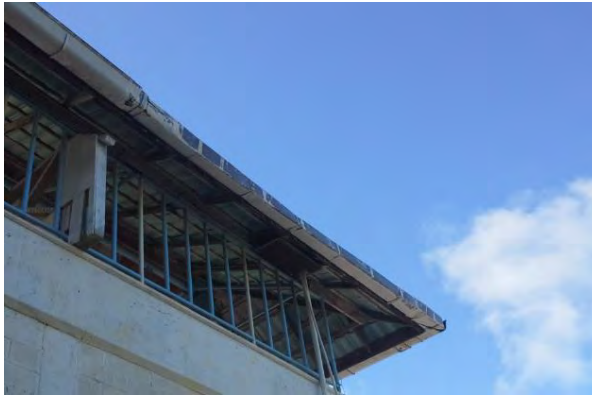
**Photo 3 – Kiribati Community Club**

Photo 3 below shows the AC guttering at the Kiribati Community Club. Photo 4 below shows AC cladding at Bobotin Kiribati Ltd.

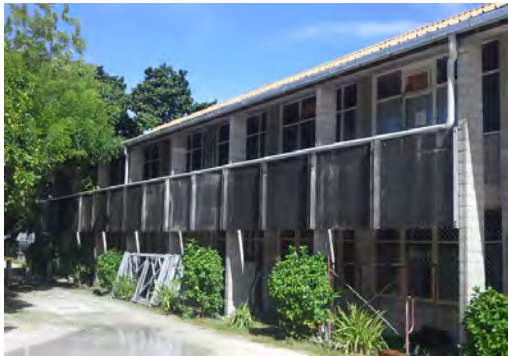
**Photo 5 – Ministry of Finance**

Photo 5 below shows the sunshade panels at the Ministry of Finance and Photo 6 shows the AC guttering at Bonriki International Airport.

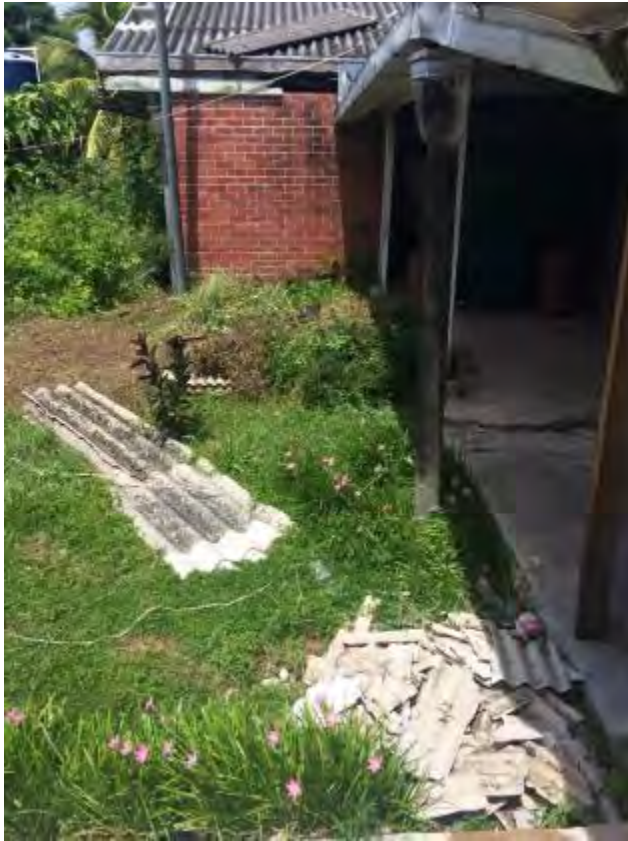
**Photo 7: Banaba Hospital; Damaged ACM roof sheets and loose ACM**

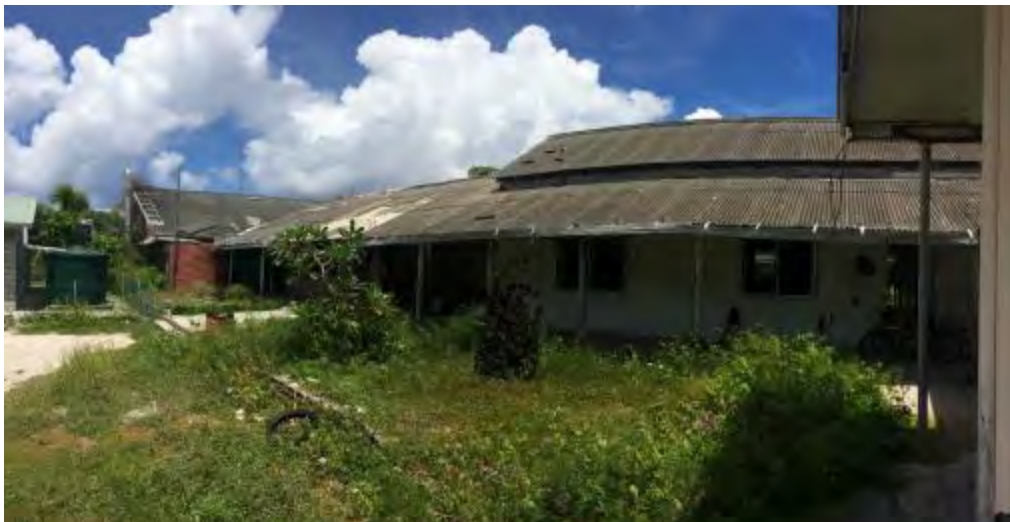
**Photo 8: Banaba Hospital – ACM Roof**

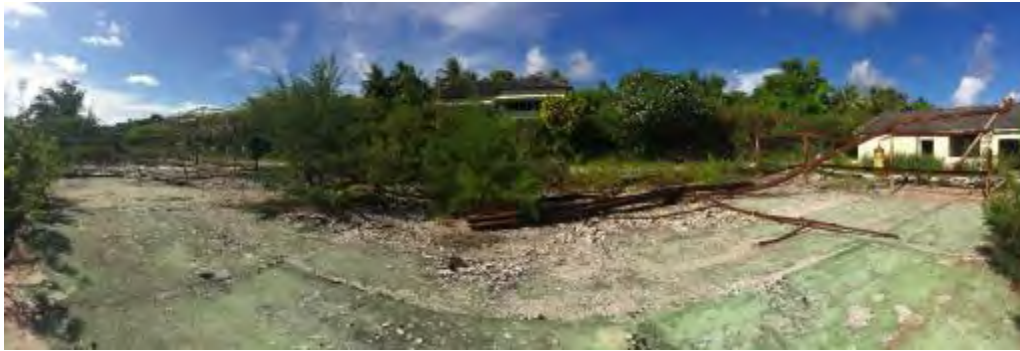
**Photo 9: Warehouse 4; fire damaged structure previously containing PACM. Site covered in ACM fragments. Public roadway in background.**

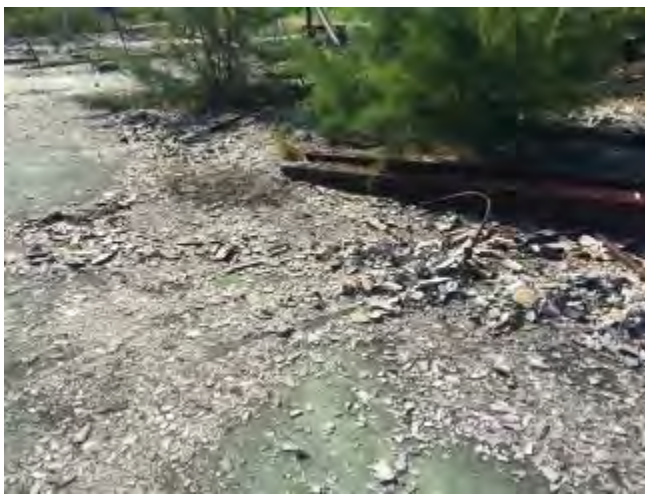
**Photo 10: Warehouse 4; view of ACM debris**

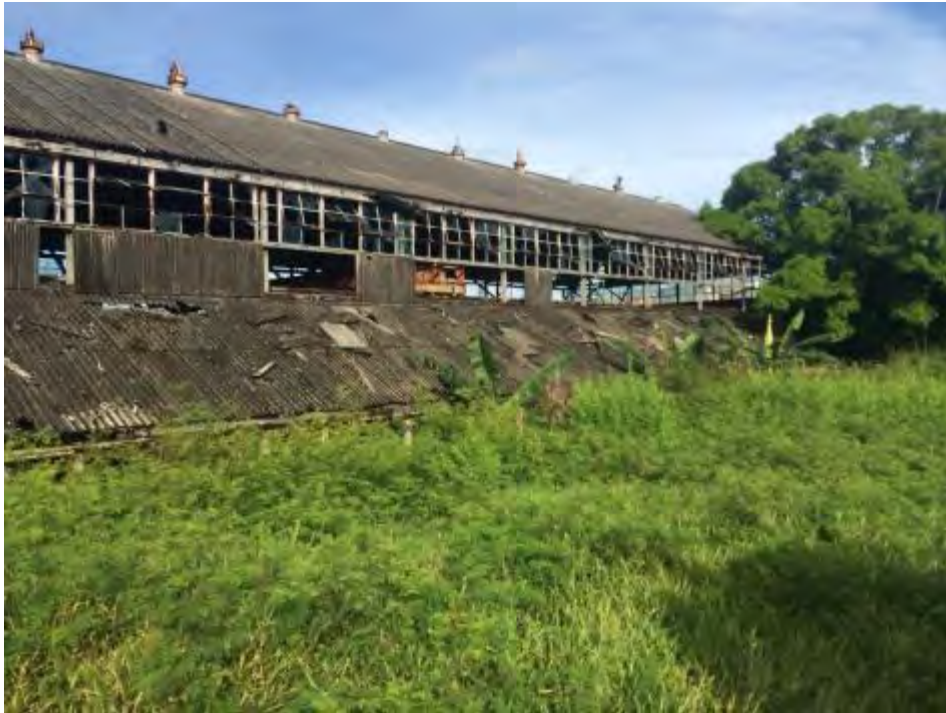
**Photo 11: Banaba former power house. ACM Roof**

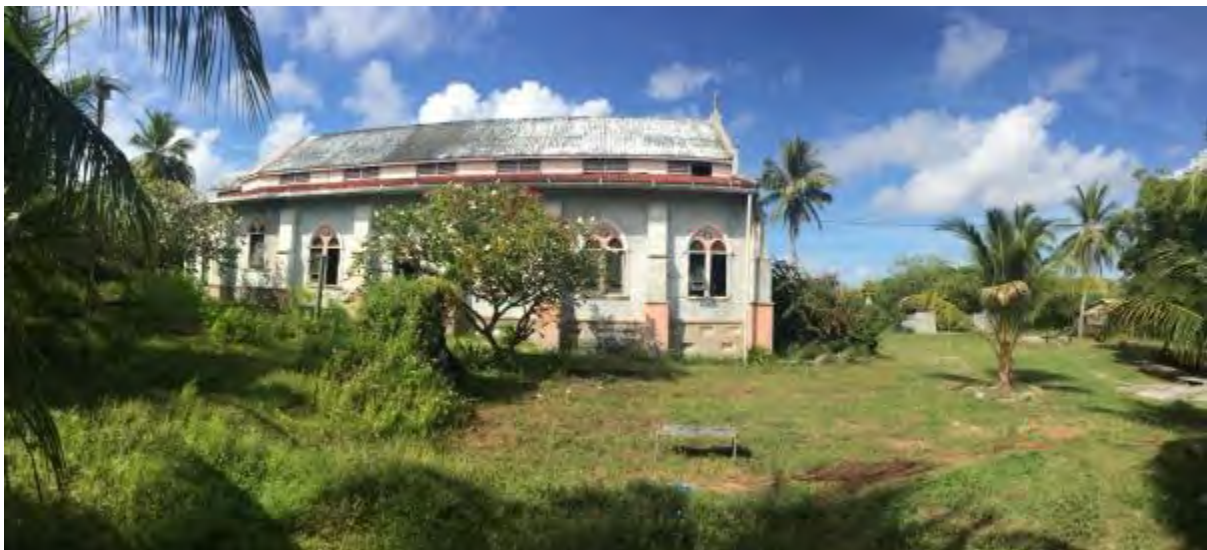
**Photo 12: Catholic Church in Fatima village with ACM Roof**

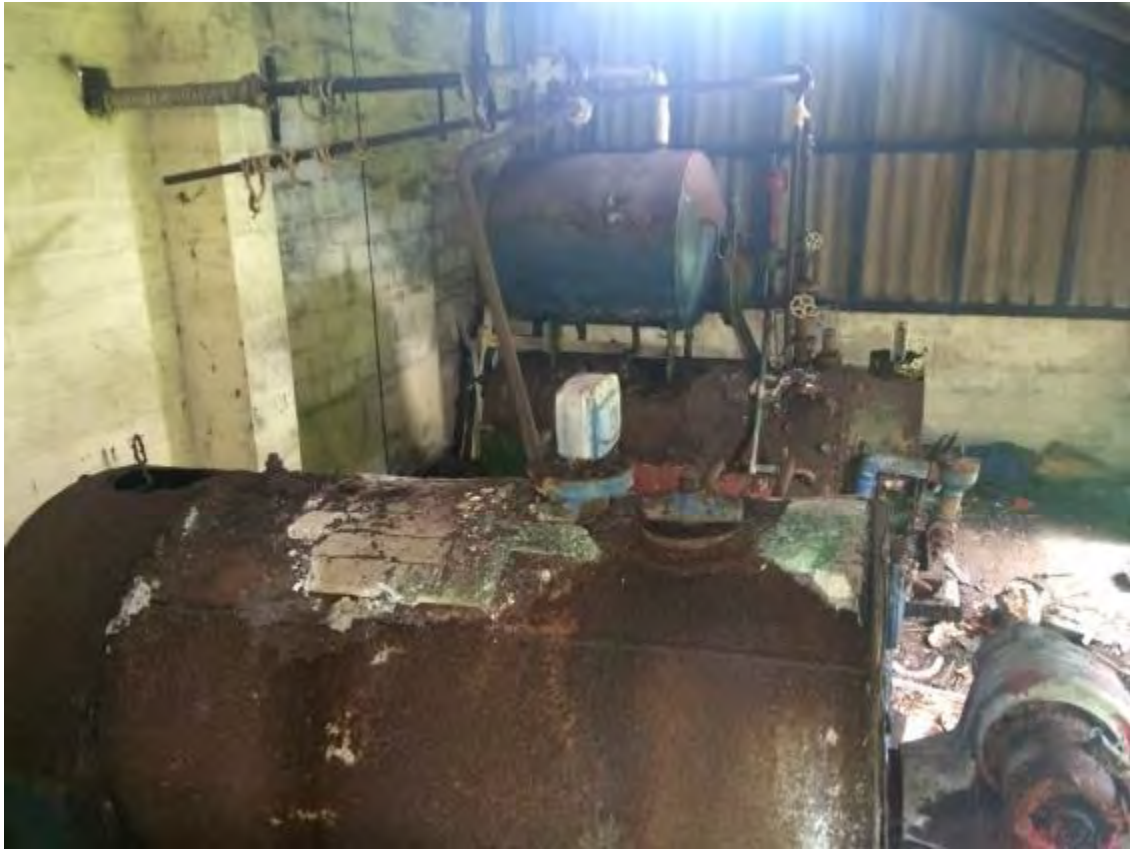
**Photo 13: Residential property 18, boilers with ACM lagging**

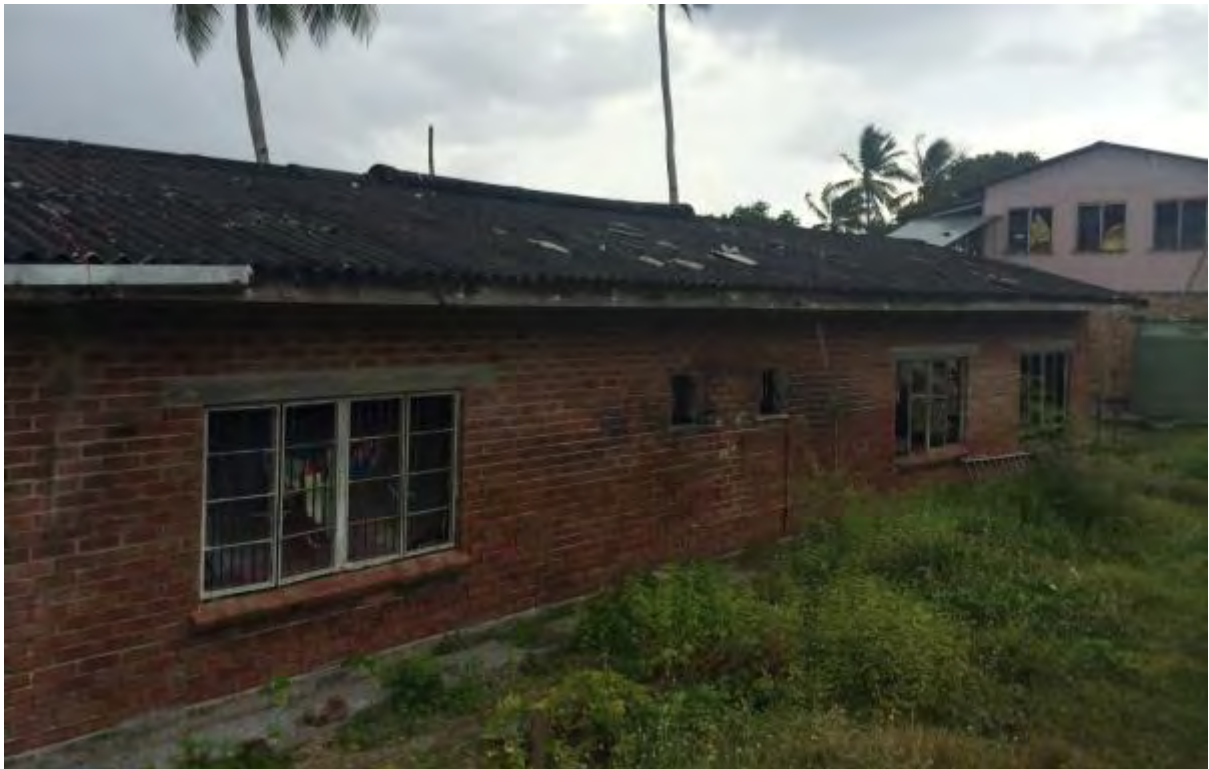
**Photo 14: Banaba school, ACM roof and cladding on brick building.**

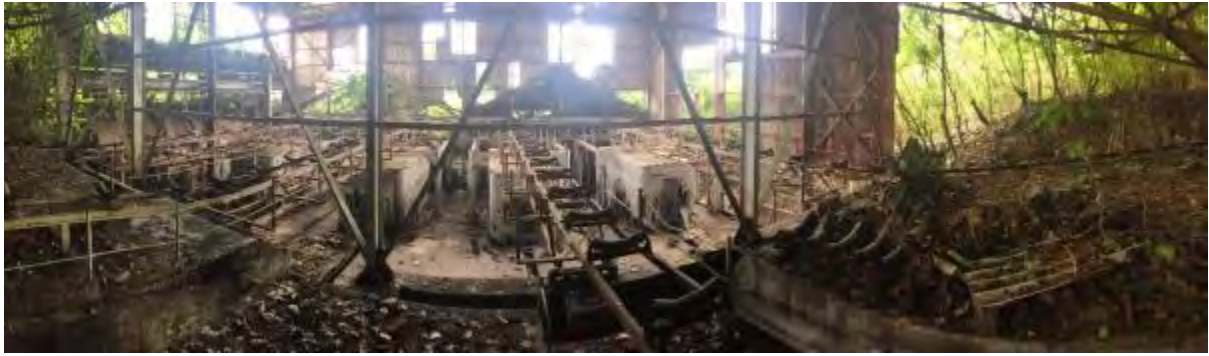
**Photo 15: Former phosphate processing plant. In disrepair with significant ACM scattered across entire site.**

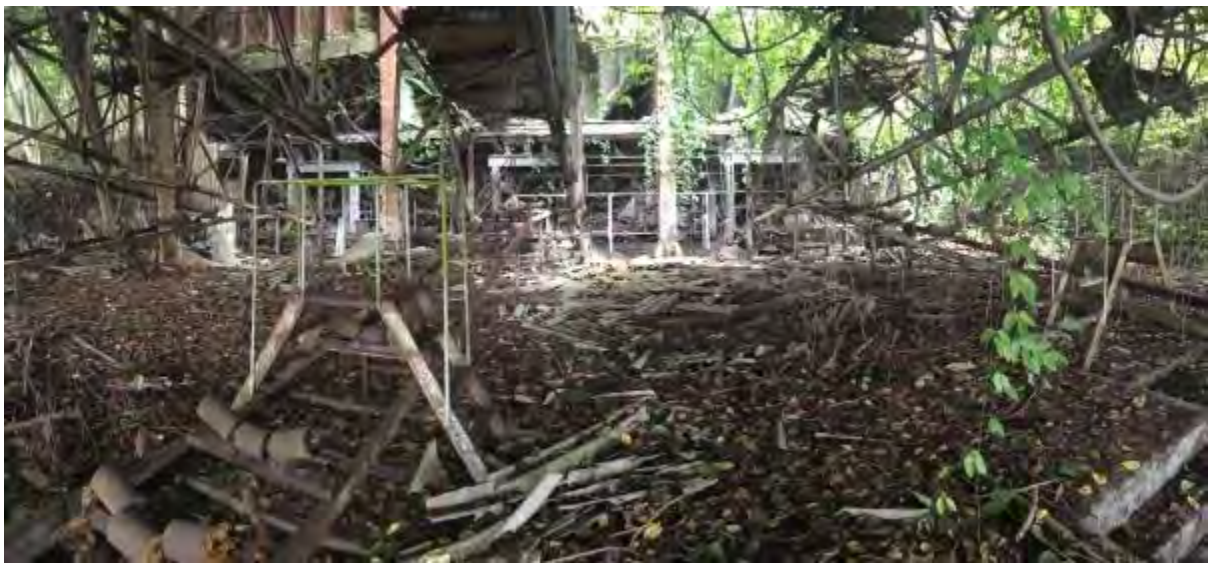
**Photo 16: Former phosphate processing plant. View towards hoppers at rear**

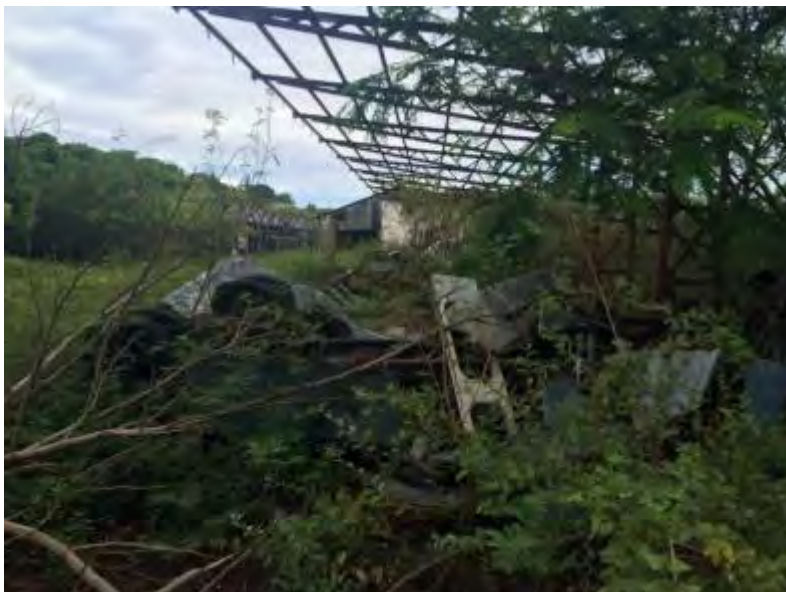
**Photo 17: Former mechanical repair workshop building with no cladding or roof**

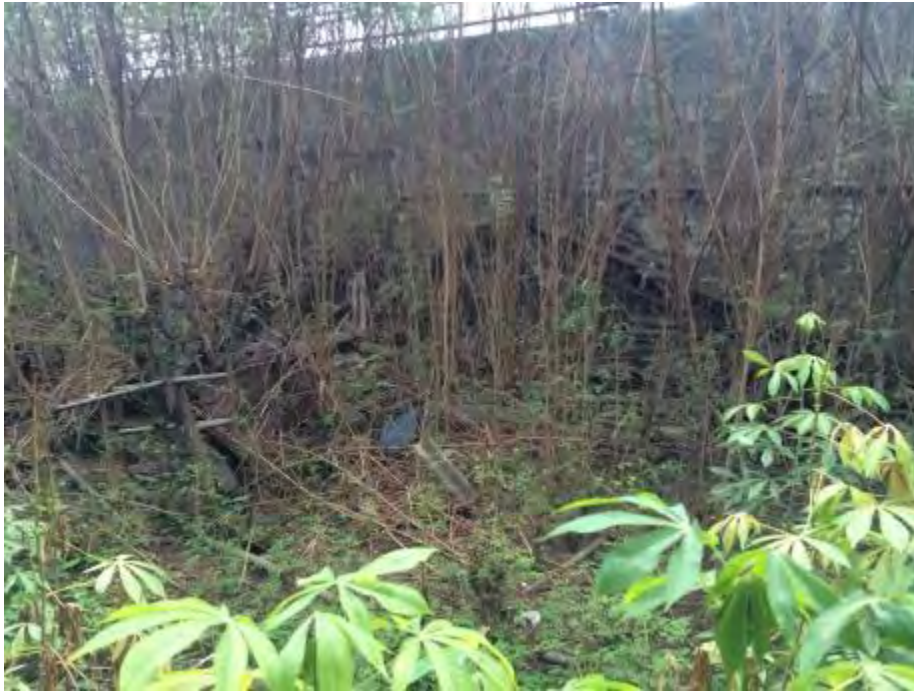
**Photo 18: Adjacent and down gradient of former mechanical repair workshop building**

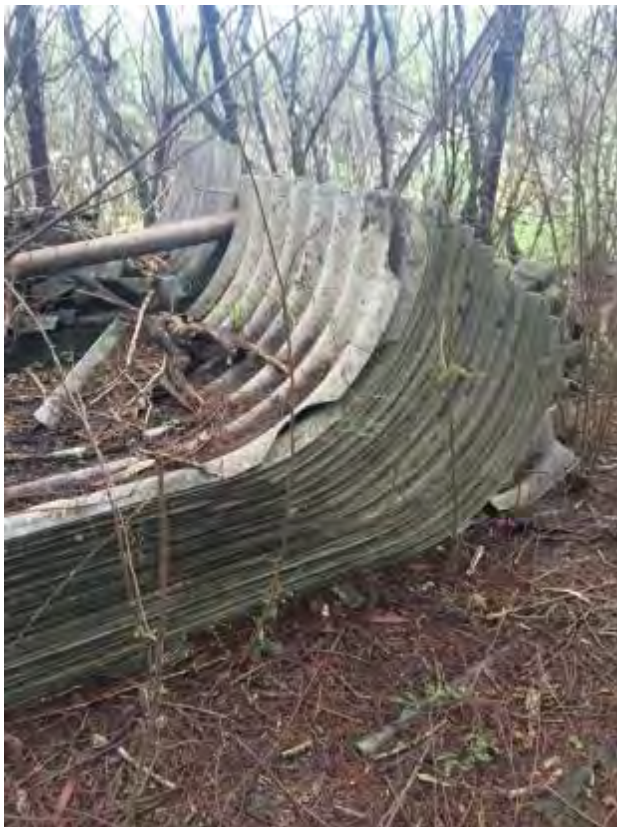
**Photo 19: ACM stockpile behind mechanics to south**

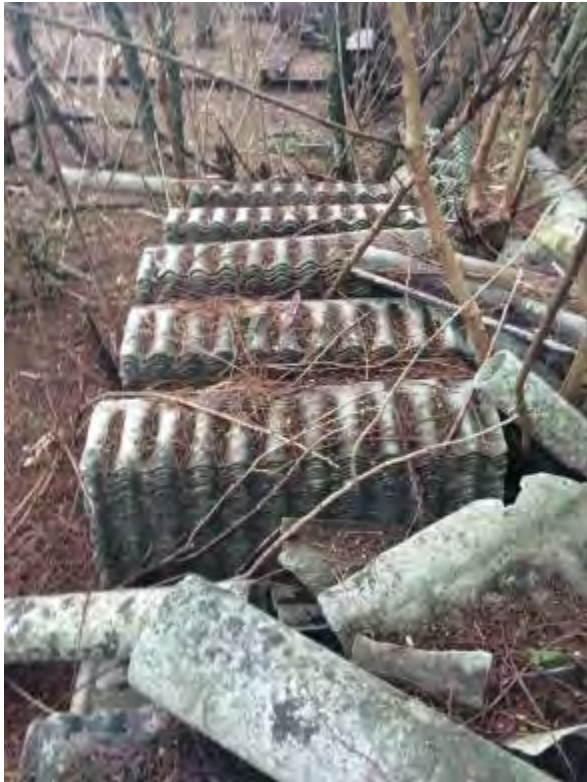
**Photo 20: ACM stockpile behind mechanics to south**

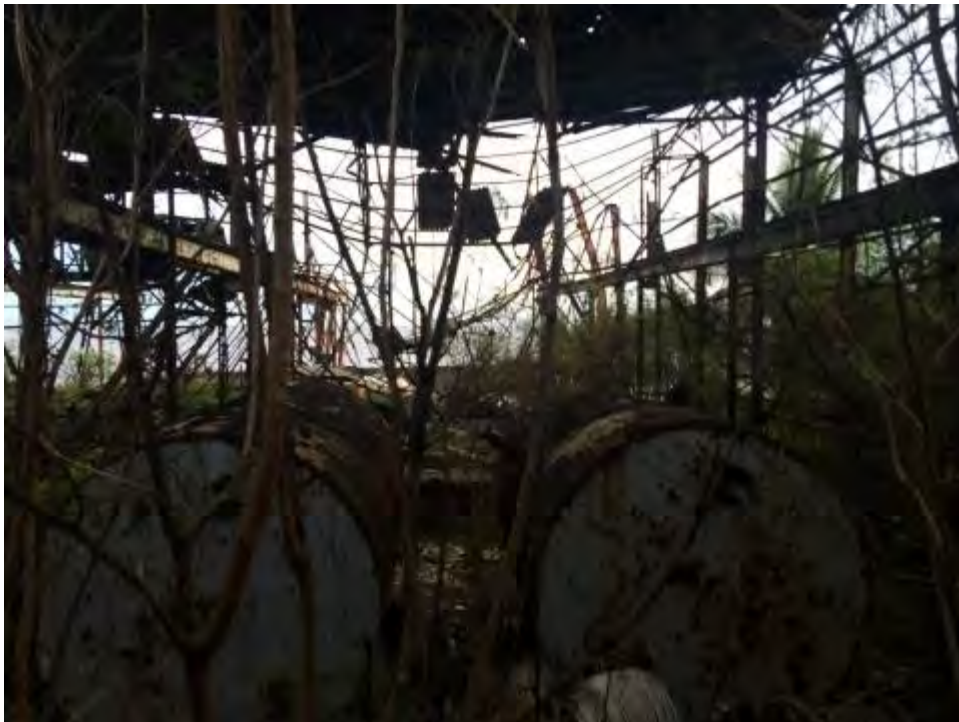
**Photograph 21: Warehouse 7 by wharf – another badly damaged building with ACM scattered across site.**

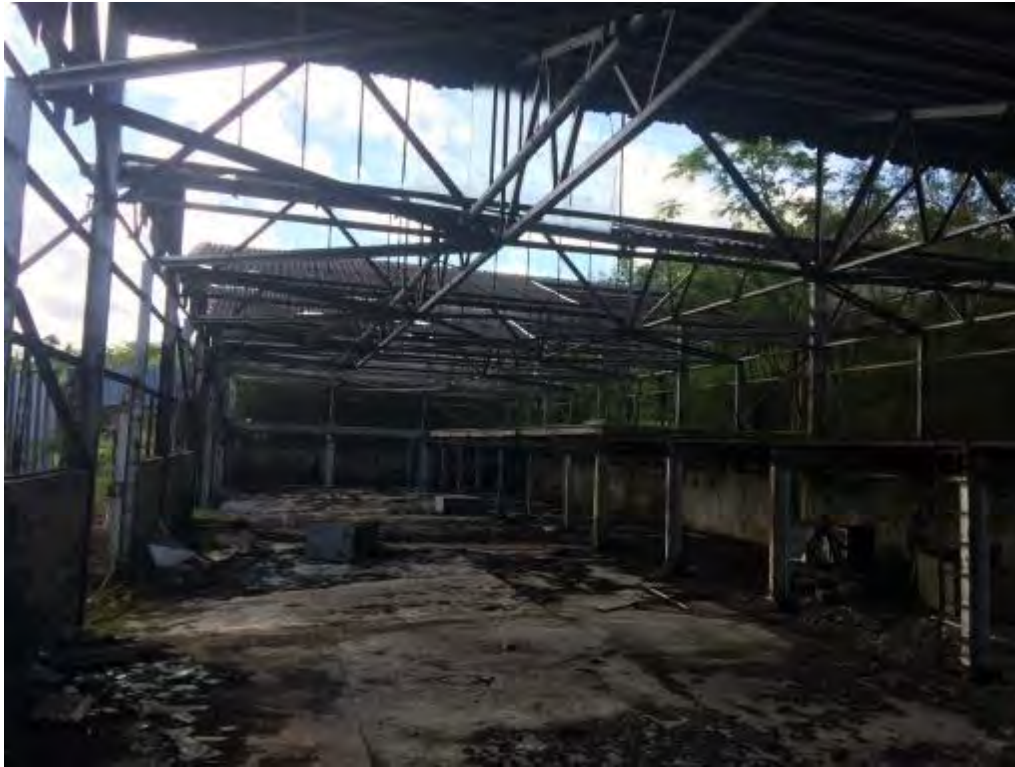
**Photo 22: Warehouse 3 – badly damaged ACM roof and walls.**

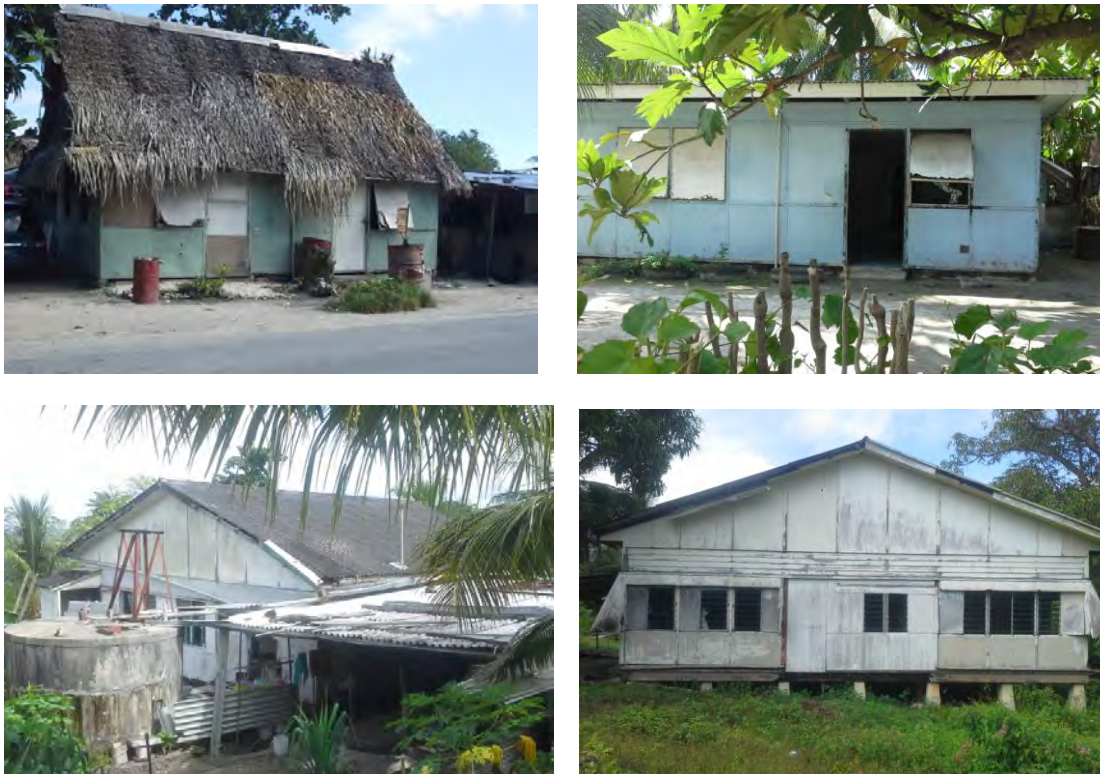
**Photos 23-26: Typical South Tarawa Houses**

cement board. Photos 23-26 below show typical houses in South Tarawa with fibre cement cladding.

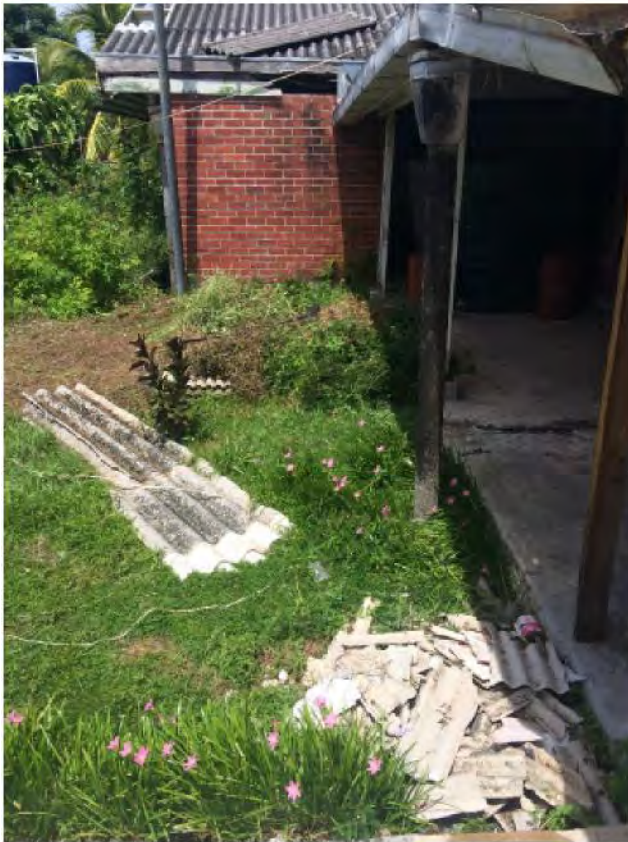
Photograph 1: Banaba Hospital; Damaged acm roof sheets and loose acm

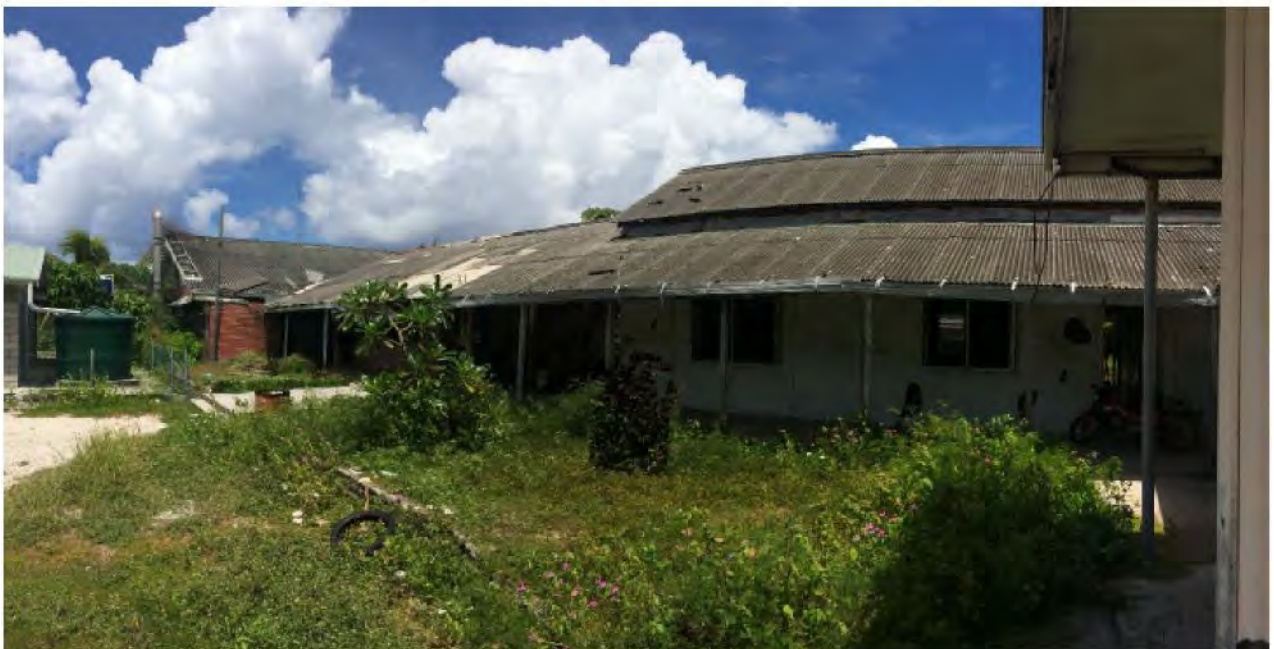
Photograph 2: Banaba Hospital – acm roof.

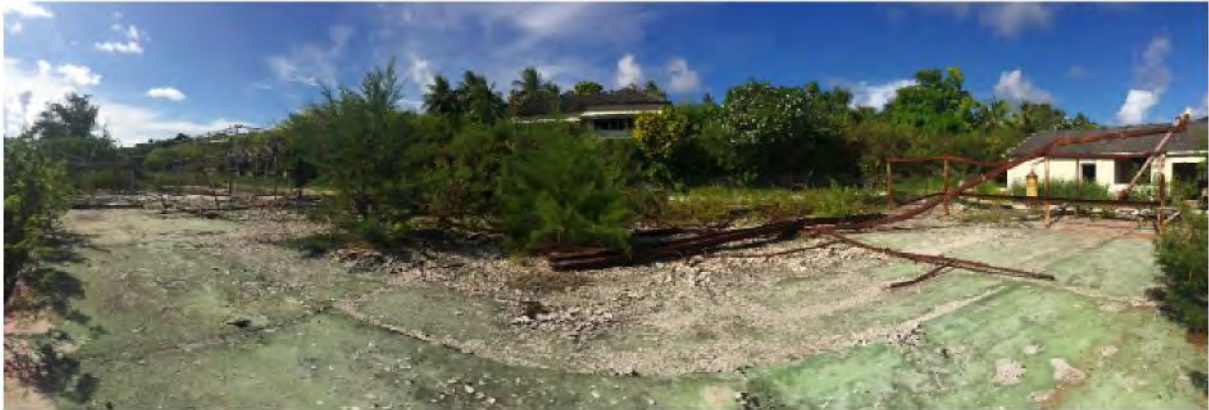
Photograph 3: Warehouse 4; fire damaged structure previously containing pacm. Site covered in acm fragments. Public roadway in background.

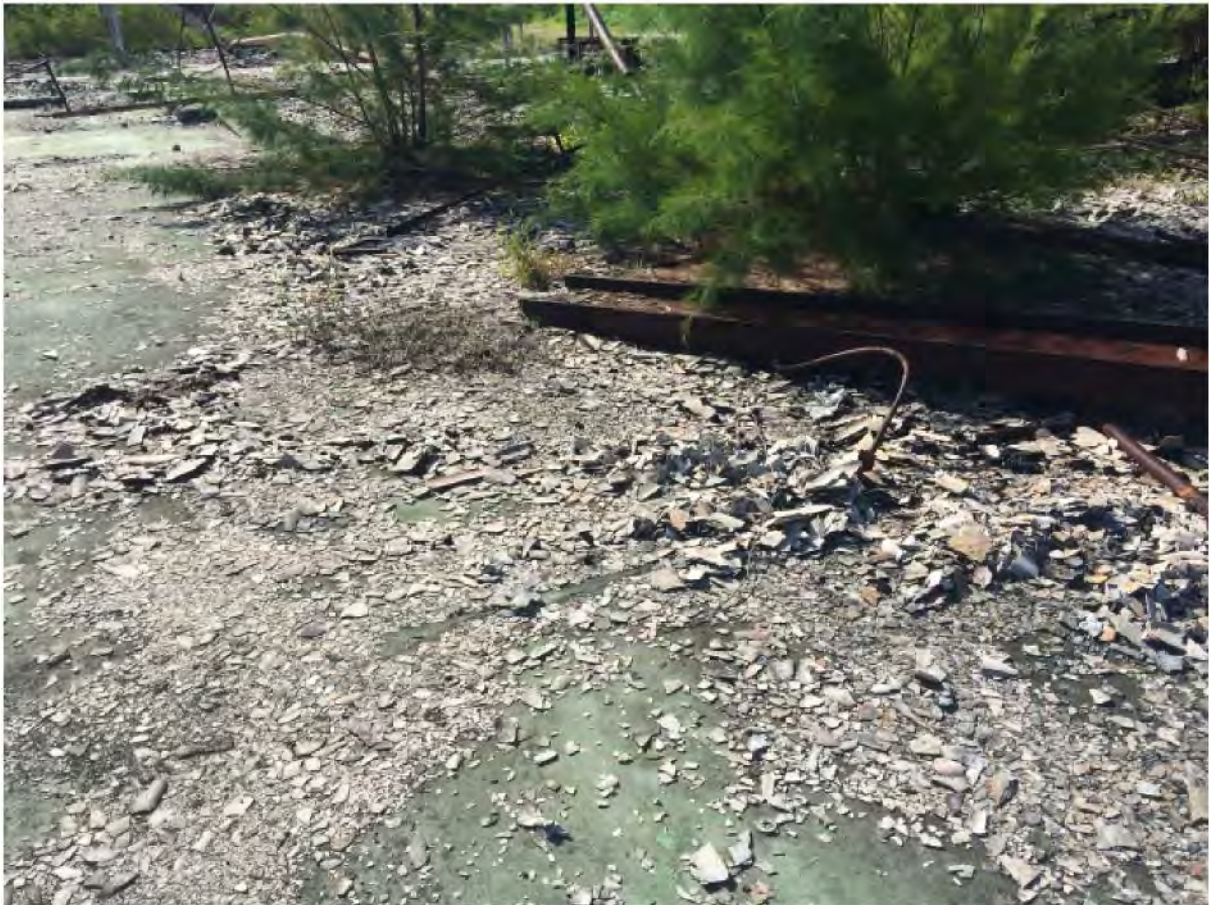
Photograph 4: Warehouse 4; view of pacm debris.

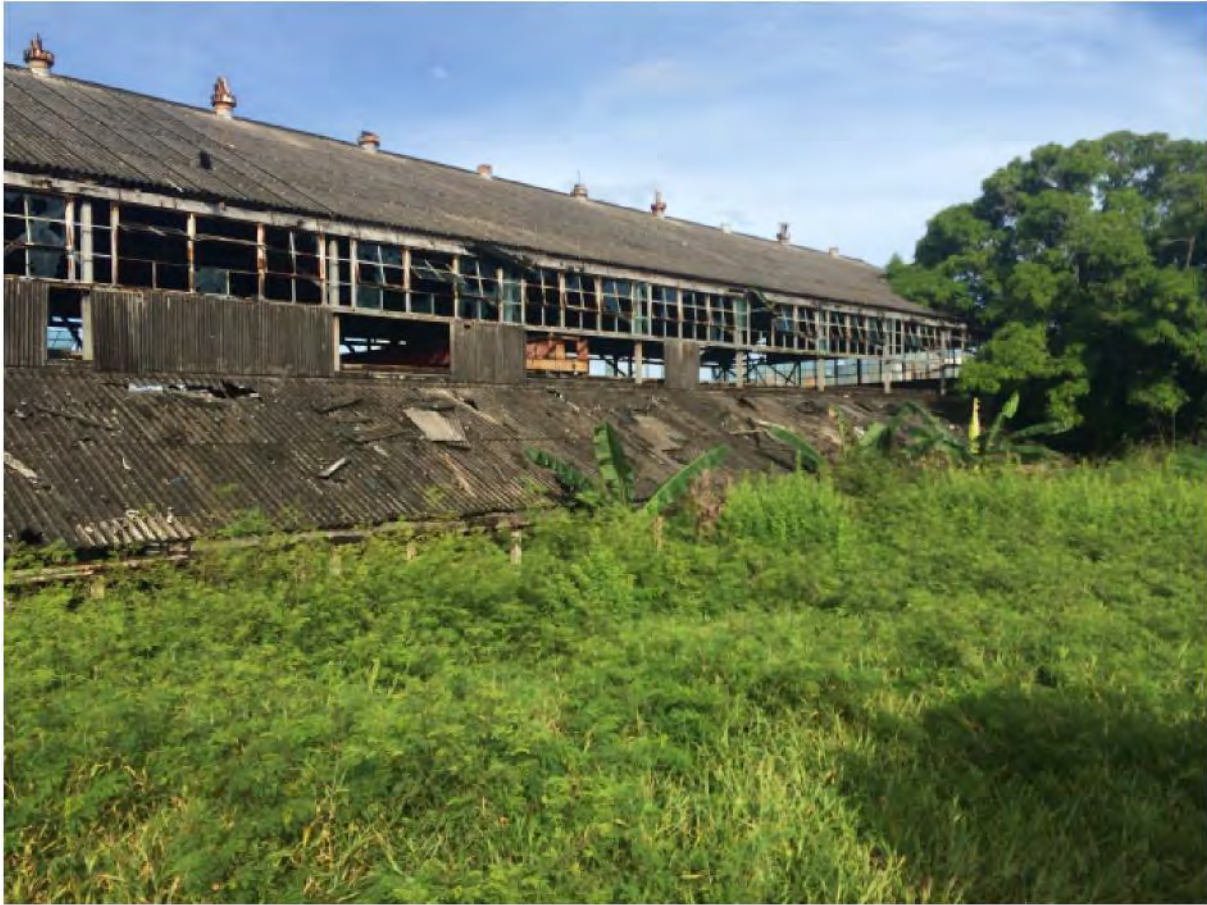
Photograph 5: Banaba former power house. pacm roof.

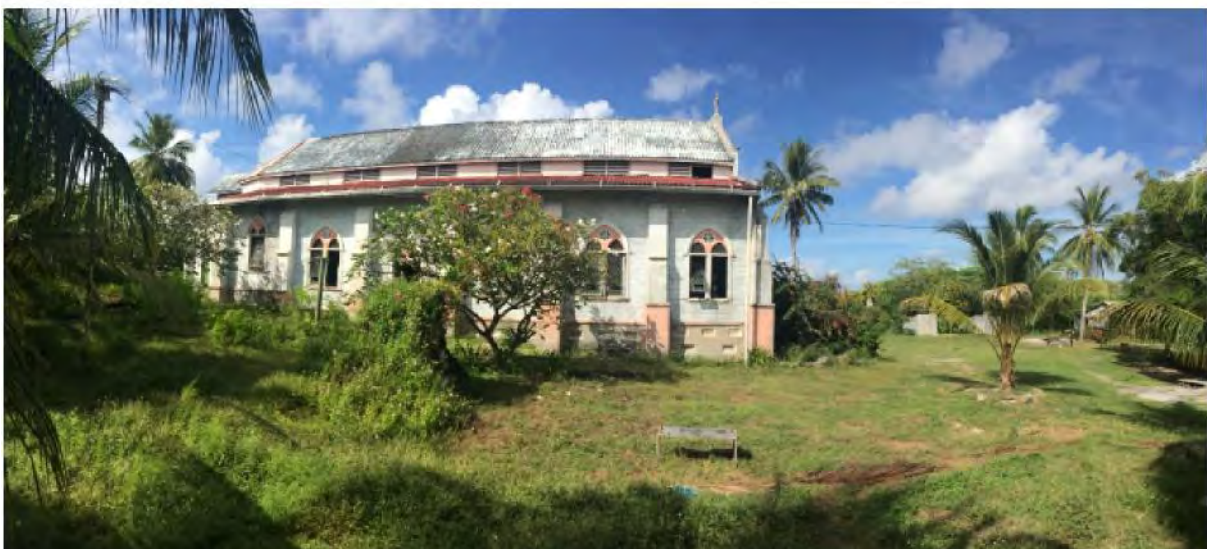
Photograph 6: Catholic Church in Fatima village with pacm roof.

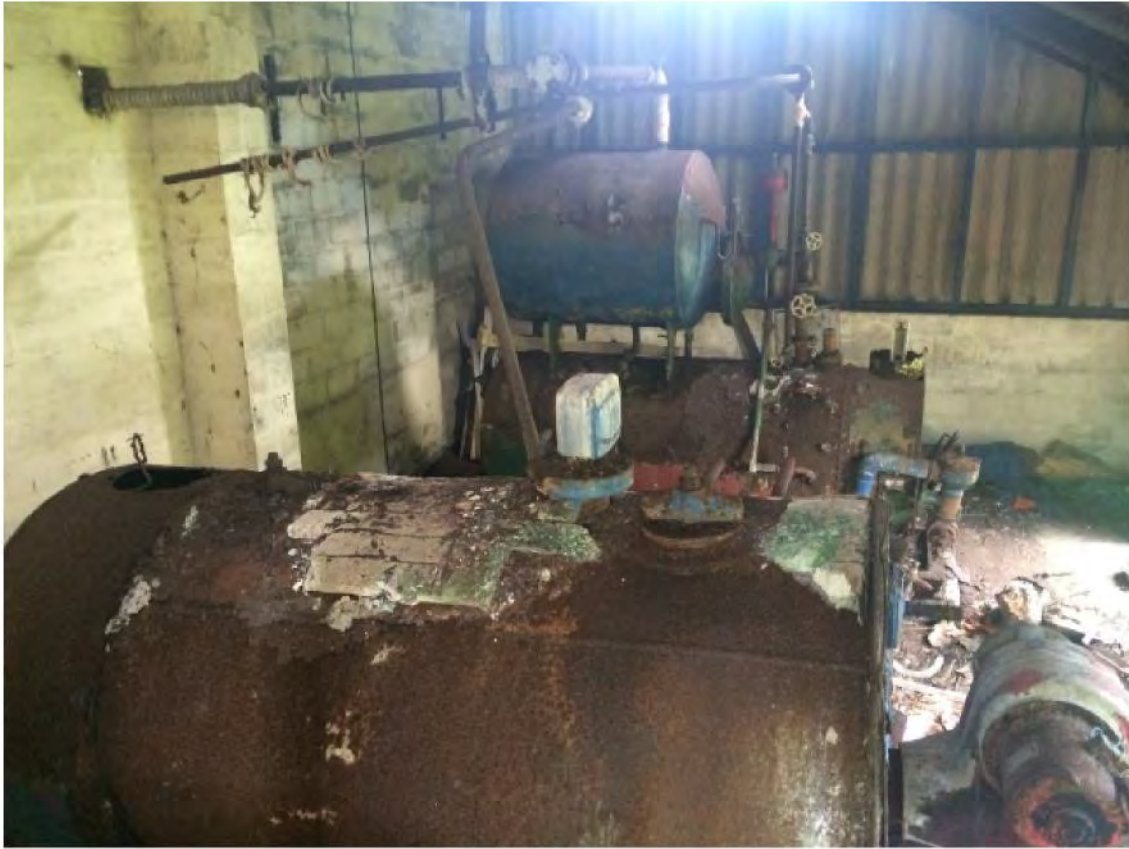
Photograph 7: Residential property 18, boilers with pacm lagging.

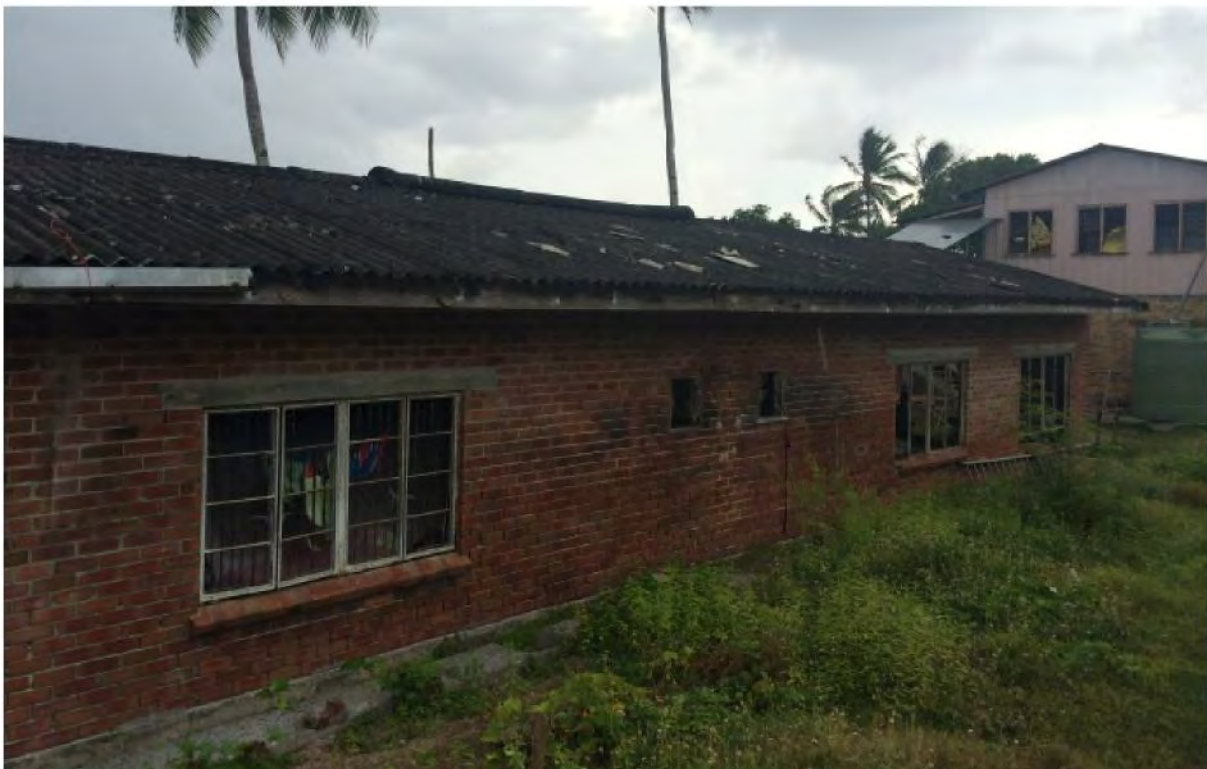
Photograph 8: Banaba school, pacm roof and cladding on pink building.

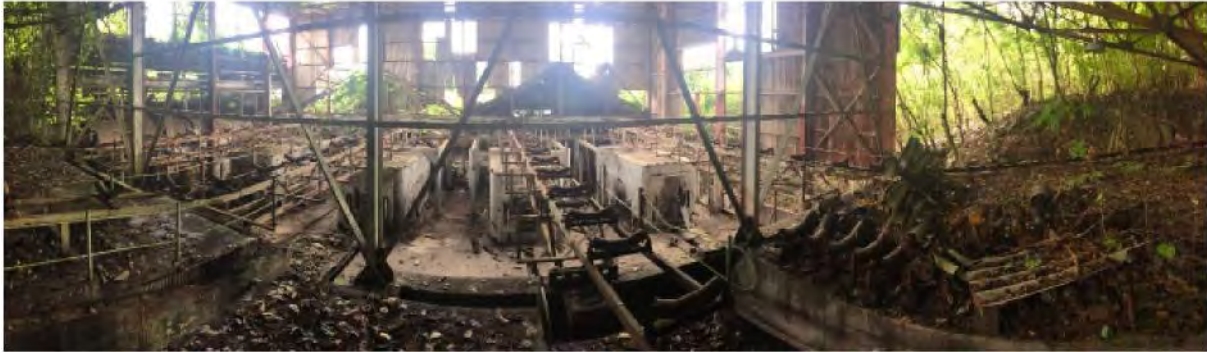
Photograph 9: Former phosphate processing plant. In disrepair with significant pacm scattered across entire site.

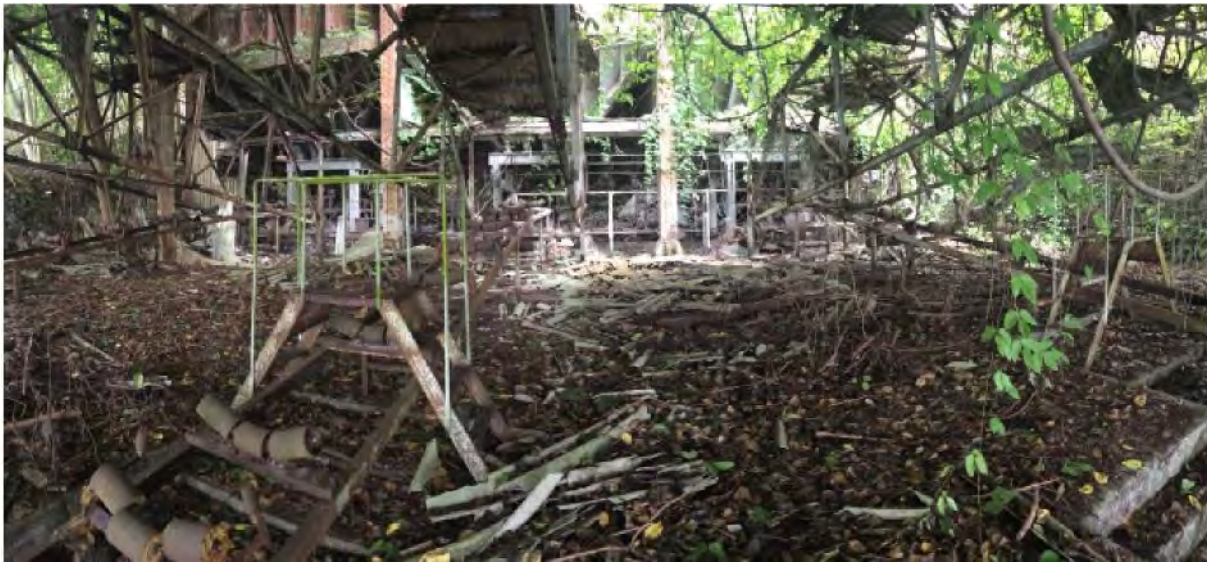
Photograph 10: Former phosphate processing plant. View towards hoppers at rear.

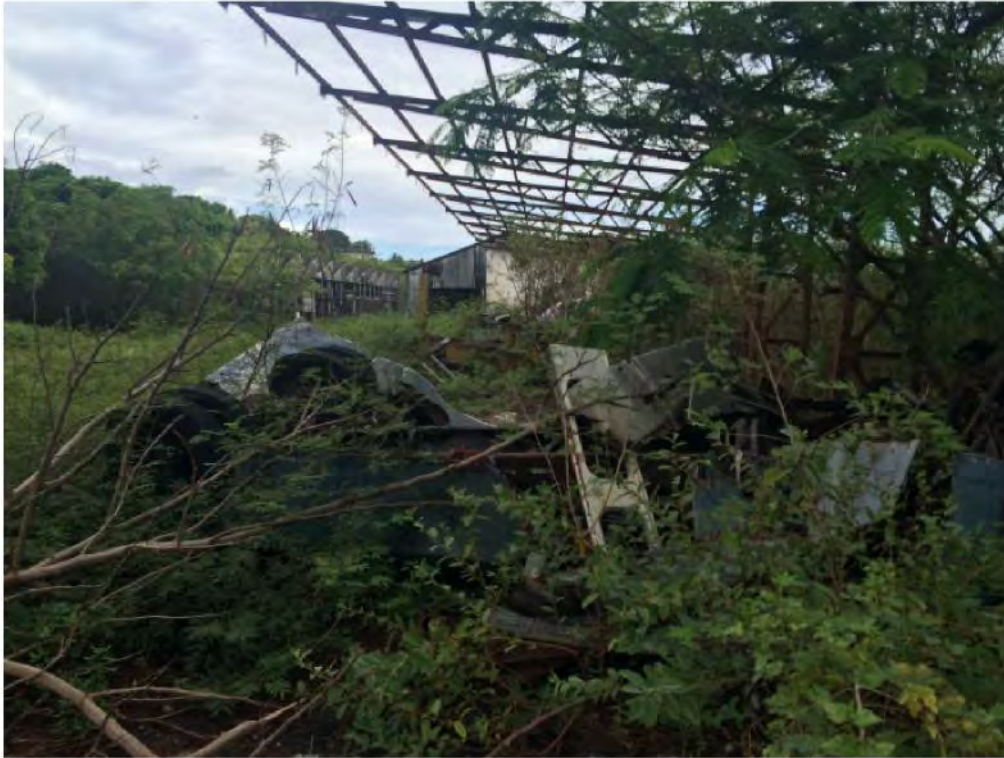
Photograph 11: Former mechanical repair workshop building with no cladding or roof.

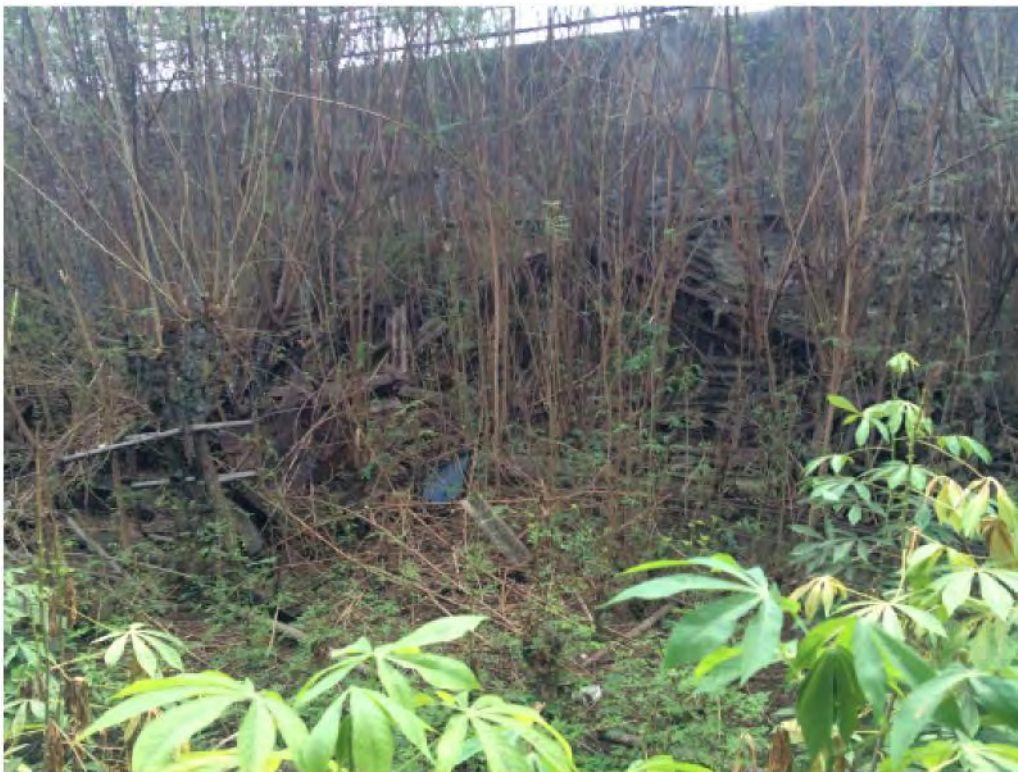
Photograph 12: Adjacent and down gradient of former mechanical repair workshop building.

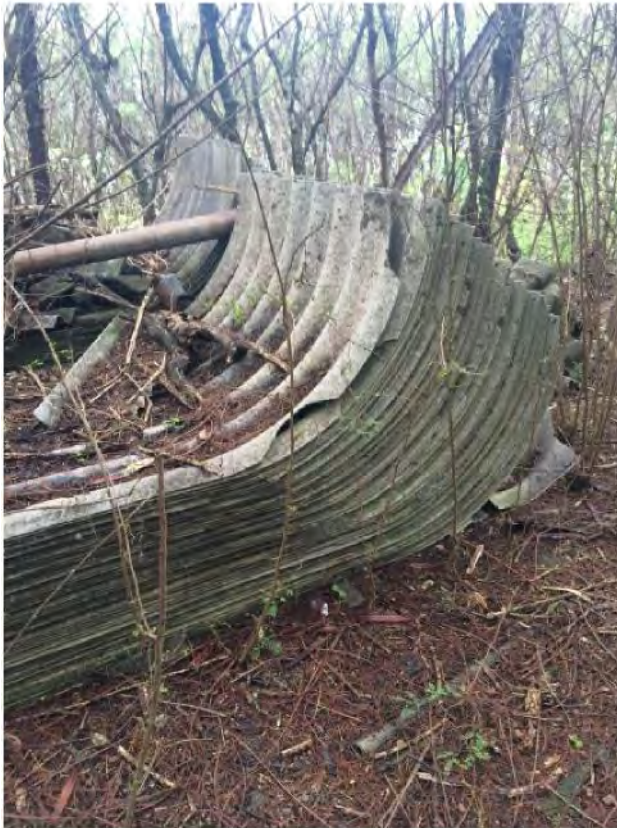
Photograph 13: pacm stockpile behind mechanics to south.

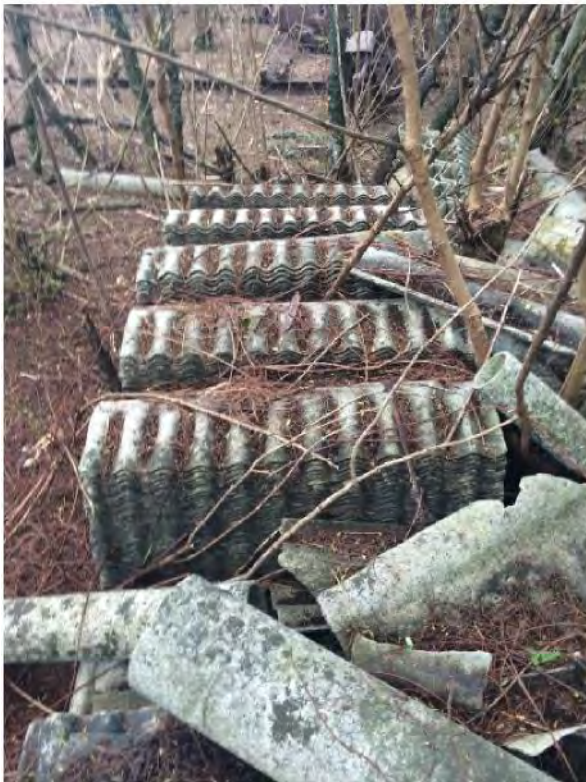
Photograph 14: pacm stockpile behind mechanics to south.

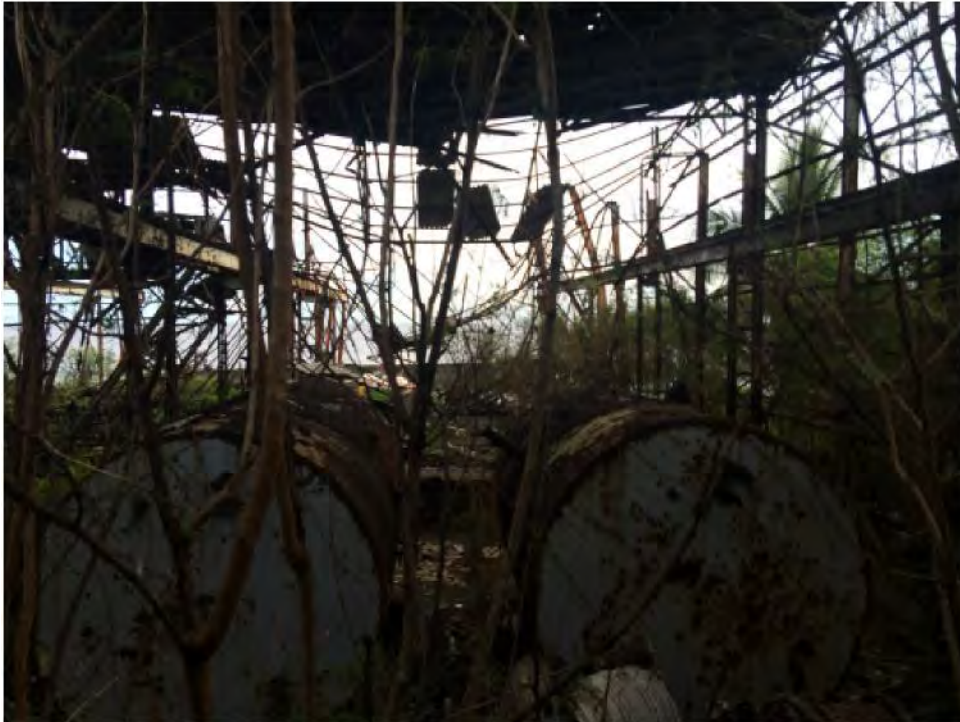
Photograph 15: Warehouse 7 by wharf – another badly damaged building with acm scattered across site.
