# **Survey of the Regional Distribution and Status of Asbestos-Contaminated Construction Material and Best Practice Options for its Management in Pacific Island Countries**

## **Report for the Sovereign Republic of Kiribati**

**Prepared for the Secretariat of the Pacific Regional  
Environment Programme (SPREP)**

**May 2015**

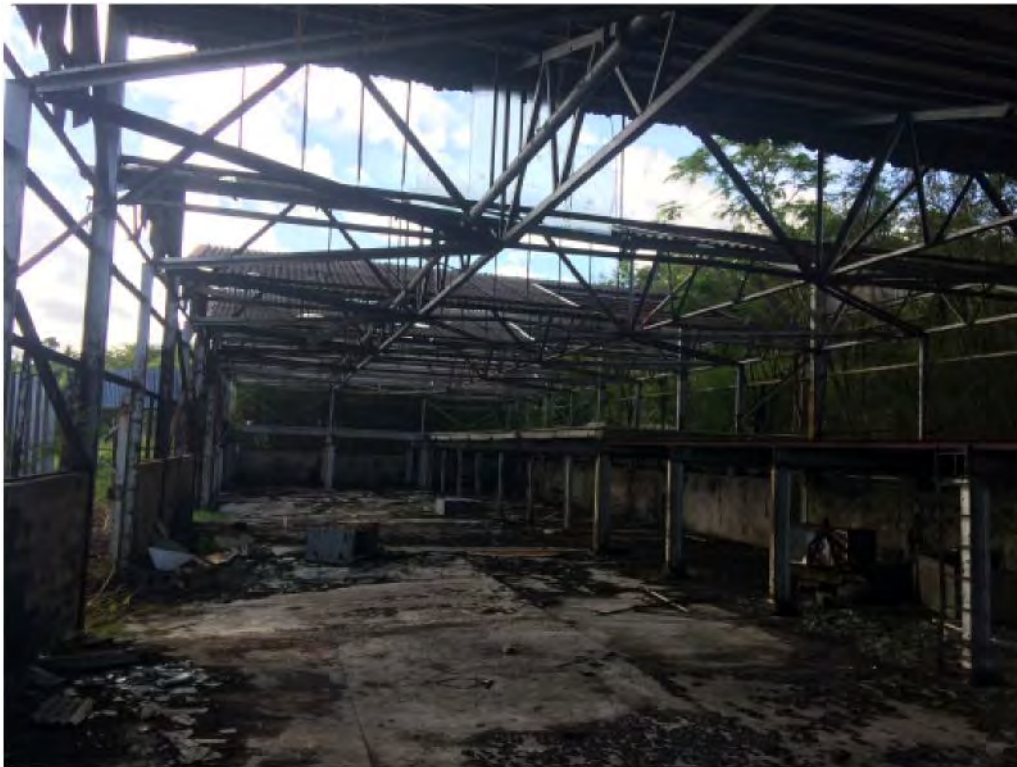
Photograph 16: Warehouse 3 – badly damaged pacm roof and walls.

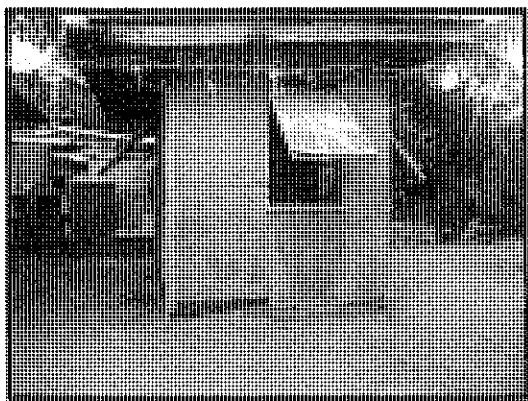
A Grade E House in Betio at St Betero, Temakin that has asbestos contained materials in its exterior wall claddings is shown in Figure 2. The house condition is deteriorating with holes and paintings worn out hence need immediate renovation to avoid asbestos fibres from being exposed to air which then could easily inhaled by occupants. In Figure 3, pieces of exterior wall claddings are depicted to show how asbestos fibres could be easily blown away and inhaled by occupants.

**Figure 2. Grade E – Kitchen with asbestos used in exterior walls as heat and fire retardant**

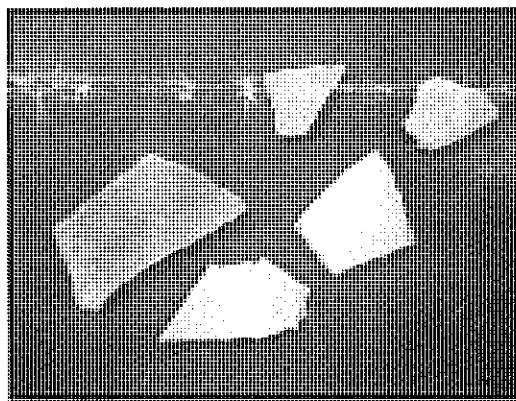
**Figure 3. Fragments of wall claddings contained with asbestos fibres**
