# **Survey of the Regional Distribution and Status of Asbestos-Contaminated Construction Material and Best Practice Options for its Management in Pacific Island Countries**

## **Report for the Republic of Palau**

**Prepared for the Secretariat of the Pacific Regional  
Environment Programme (SPREP)**

**May 2015**

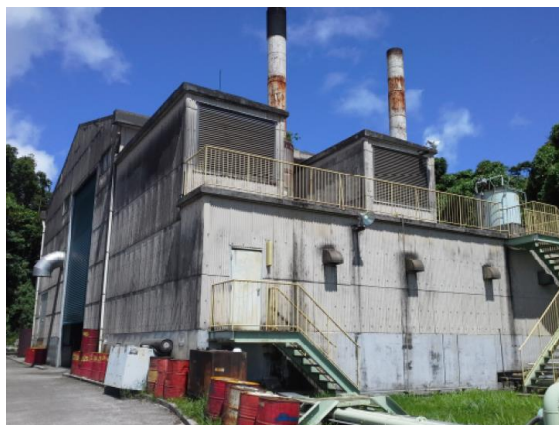
**Photo 1 – Malakal Power Station New Generator Building**

1. **Malakal Power Plant** - The generator building at the rear of the power station contains exterior corrugated roofing and cladding that tested positive for asbestos (chrysotile 8%). This was a relatively new building and was about 15 years old. The total area of asbestos material is about 2000m<sup>2</sup>. The building is shown in Photo 1 below and is in reasonable condition.

Location	Type	Recommended Action	Area (m <sup>2</sup> )	Cost/m <sup>2</sup>	Total Cost	Risk Ranking
Malakal Power Plant	Cladding	Cladding is 15 years old from Japan - Encapsulation is appropriate but need to do both sides	2000	50	100000	8

- h. The Malakal project should be regarded as an asbestos project with the use of suitable relevant protocols, and the encapsulant should be carefully chosen. There are several local contractors who could undertake this work and it is recommended that prices be obtained from them.

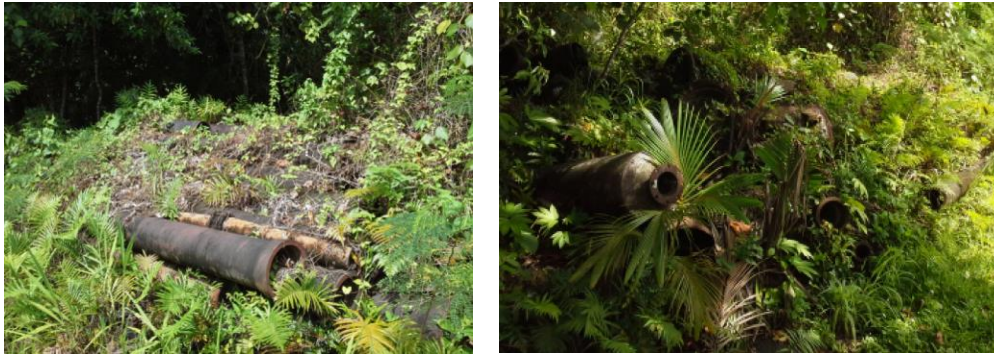
**Photos 2 and 3 – Old Asbestos Pipes at Palau Water Treatment Plant**

2. **Palau Water Treatment Plant, Airai** – Quite a large number of old asbestos water pipes (Chrysotile 12%) are stored at the water treatment plant as shown in Photos 2 and 3 below. It is difficult to estimate how many as they are covered by vegetation. They appear to be in reasonable condition although some may be broken, in which case a site clean-up will be needed.

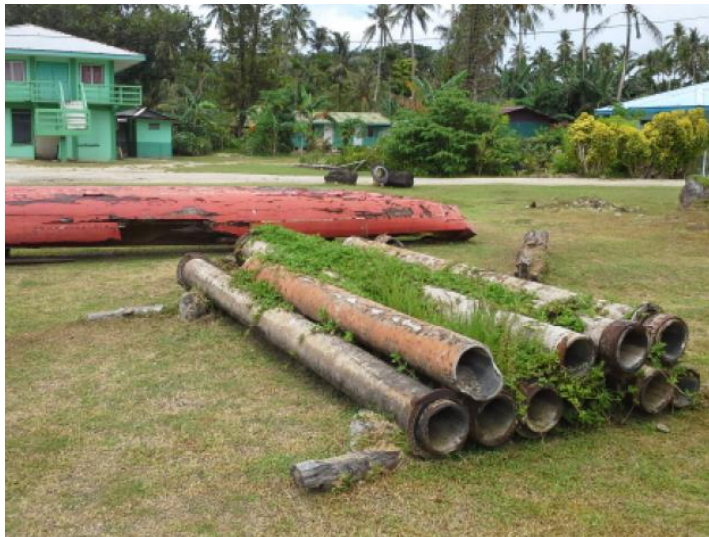
**Photo 4 – Old Pipes in reserve in Ngiwai Village**

- 3. Public Reserve in Ngiwai** – Several asbestos-cement pipes (Chrysotile 12%) were discovered in a public reserve in Ngiwai Village (see Photo 4 below). They are damaged and in poor condition.

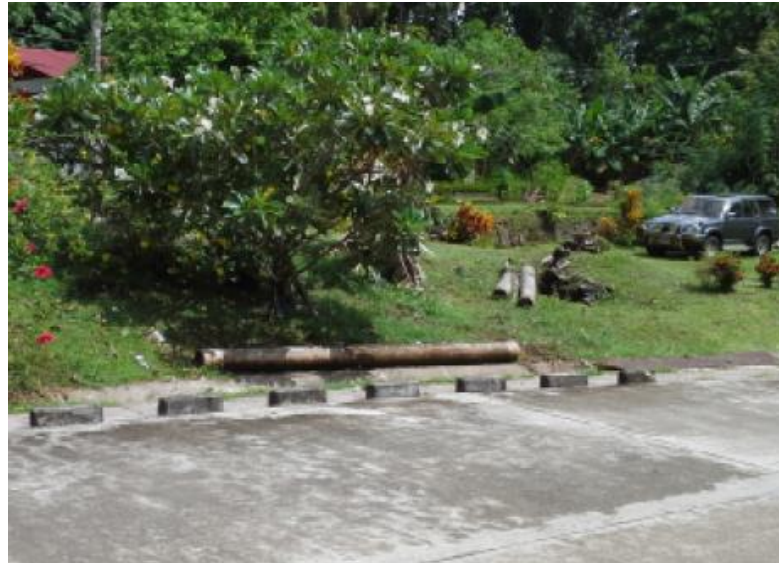
**Photo 5 – Asbestos-cement Pipe on Roadside at Imetang Village**

- 4. Roadside in Imetang Village** – Photo 5 below shows an asbestos-cement pipe (chrysotile 12%) on the side of the road in Imetang Village. There may be other similar pipes in residential areas.

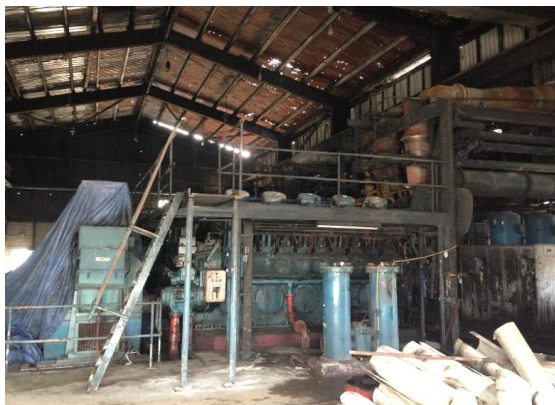
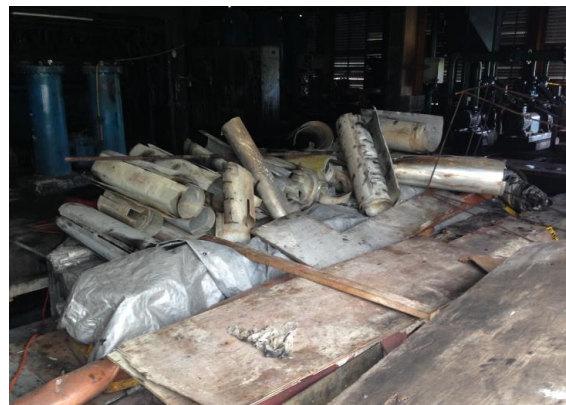
**Photo 6 – Ameliik Old Burnt-out Power Plant    Photo 7 – Insulating Material in old Power Plant**

It was reassuring to discover that the old burnt-out Power Station at Ameliik was substantially asbestos-free, based on bulk and air samples that were taken. Asbestos was, however, discovered in gasket material and so care still needs to be taken with the demolition process.

5. **Ameliik Power Plant:** The old Ameliik Power Plant burnt down in 2011 and a new power plant has now been constructed next to the old plant. There was a concern that the old burnt-out power plant contained asbestos which would have been a significant problem as fire distributes the asbestos and neighbouring workers, as well as the workers demolishing the old plant, would have been at risk of exposure to asbestos fibres. Two samples of dust residues were taken as well as one sample of the old lagging and one sample of gasket material. In addition air monitoring was carried out in the middle and the back of the burnt out area. All these results were negative except for the gasket sample. Photo 6 below shows the old burnt-out power plant and Photo 7 below shows the insulating material near the entrance.

- e. The gaskets that tested positive at the old burnt-out power plant at Ameliik indicate that all gaskets should be treated carefully during the demolition process, especially where flanged pipe joints are unbolted.

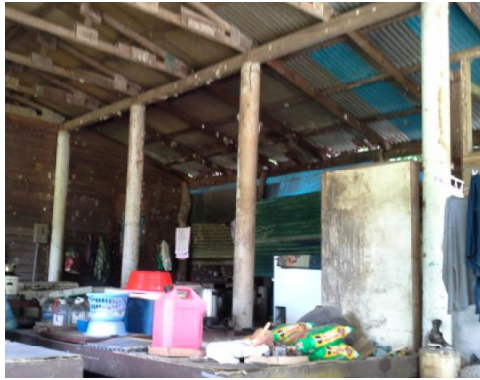
**Photo 8 – Roof Supports**

6. **Residential Property in Malekeok:** At a residential property in Malekeok two examples were discovered of asbestos-cement piping (12% Chrysotile) being used for “non-piping” uses. Photo 8 shows concrete-filled asbestos-cement pipes used as roof supports and Photo 9 shows a temporary fence that includes an asbestos-cement pipe.

One house was noted to have concrete-filled asbestos-cement pipes as roof supports, as noted in Section 4.2 above and this residence also had an asbestos pipe as part of a temporary fence. It is possible that there are other houses with asbestos-cement pipes acting as roof supports.

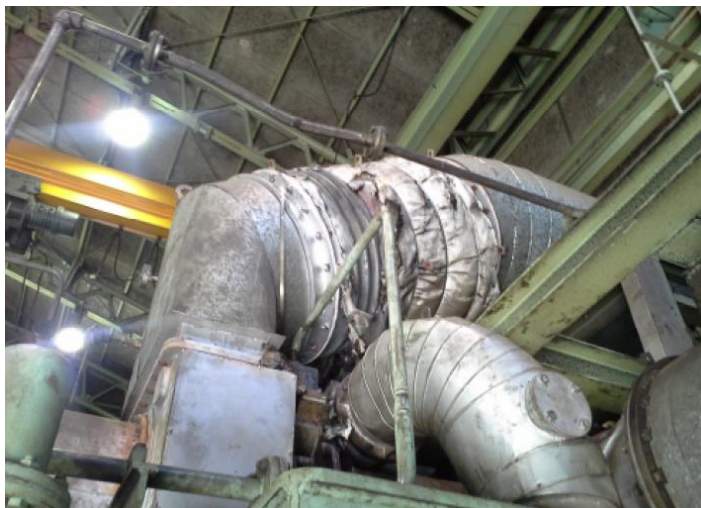
**Photo 12 – Malakal Power Station Roof Underside**

The amount of asbestos to remediate in Palau is quite small but there is potentially a large project to be done, namely the remediation of 2000 m<sup>2</sup> of roofing and cladding at the Malakal Power Station. This building does not have a ceiling (see Photo 12) so encapsulation would provide a cost advantage. Based on the above, the rate of \$US46/m<sup>2</sup> could be used plus a small contingency for some imported supervision to ensure that asbestos protocols are followed and the work is done safely. A figure of \$US50/m<sup>2</sup> could therefore be used for a budget cost. One additional advantage of encapsulation is that there is no issue with disposal and also the disposal costs do not need to be factored in. The cost would therefore be 2000 x \$US50 = \$US100,000. The rough figure of 100,000 m<sup>2</sup> would need to be checked.

Local contractors could not provide day rates for labour or plant. However, formal quotes for work on the Malakal Power Plant (options to paint the existing cladding or to replace the cladding with steel) were obtained. The costs of materials were obtained by contacting the local hardware store.
