# **Survey of the Regional Distribution and Status of Asbestos-Contaminated Construction Material and Best Practice Options for its Management in Pacific Island Countries**

## **Report for the Kingdom of Tonga**

**Prepared for the Secretariat of the Pacific Regional  
Environment Programme (SPREP)**

**May 2015**

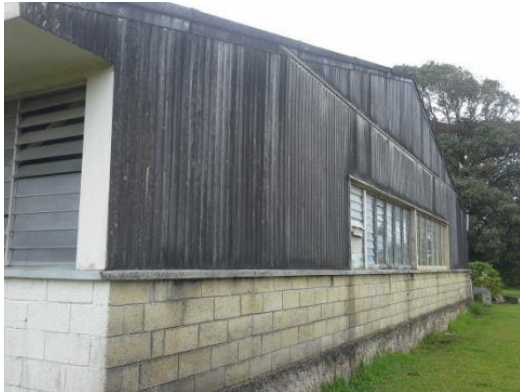
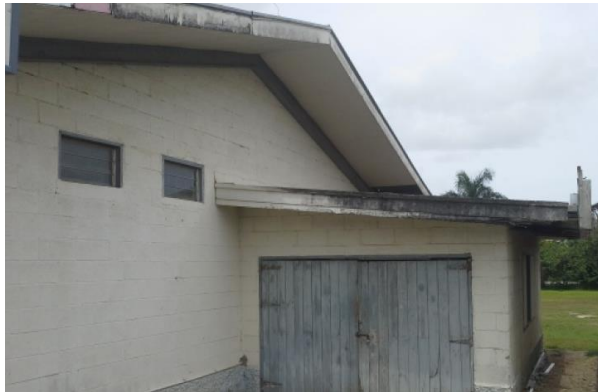
**Photos 3 and 4 – Tonga Post**

Photos 3 and 4 below are of the Tonga Post complex. There are several commercial buildings with asbestos and some loose asbestos.

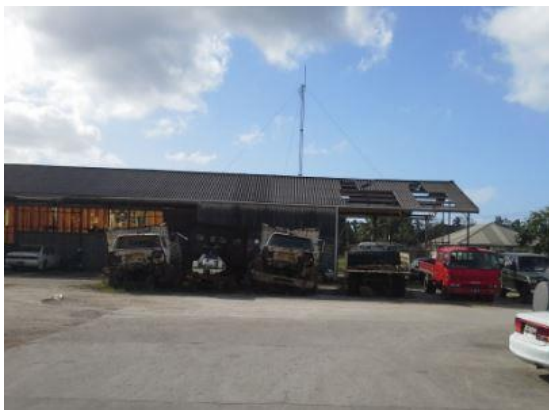
**Photo 5 – MOI WOF Centre**

Photo 5 below shows the MOI WOF Centre with an asbestos roof and Photo 6 below shows the MOI Workshop.

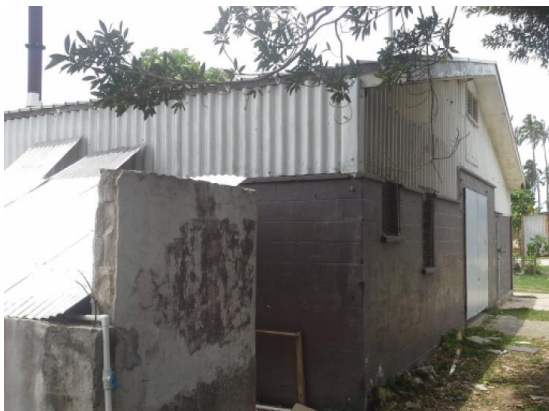
**Photo 7 – Industrial 01 Building**

Photo 7 below shows the Industrial 01 Building cladding and Photo 8 shows cladding on the Small Business Centre Office. Both sets of cladding are damaged.

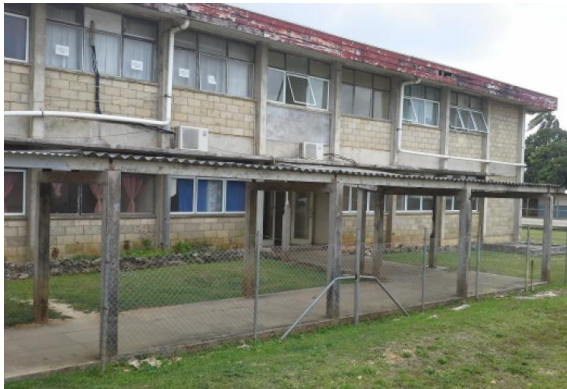
**Photo 11 – Vaiola Hospital**

Photo 9 shows the Vaiola Hospital Walkway Roof in Tongatapu and Photo 10 shows one of the Prince Ngu Hospital Roof in Vava'u. This hospital has four asbestos roofs as well as some loose asbestos. The total roof area is about 3100 m<sup>2</sup>.

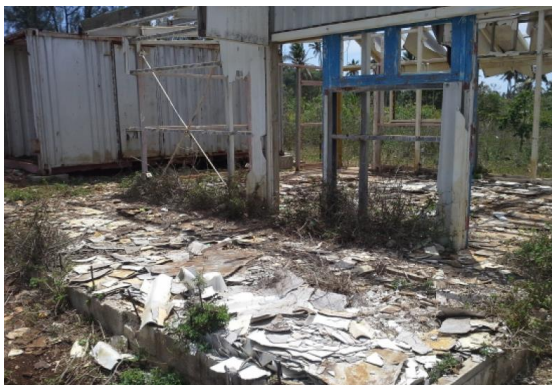
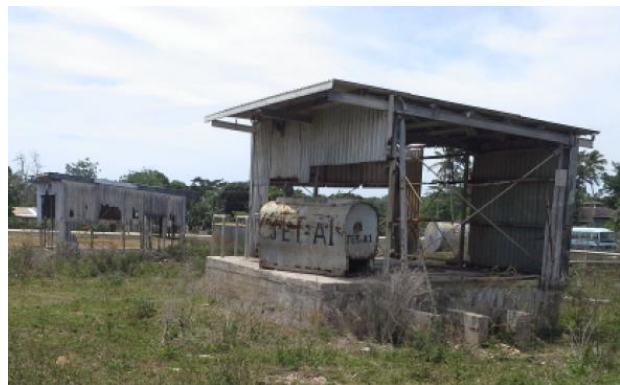
**Photos 13 and 14 – Vava'u Former Bulk Fuel Terminal**

Photo 13 and 14 show the Vava'u Former Bulk Fuel Depot. There is significant damage and signs of vandalism, stock grazing in areas with ACM. There is loose ACM over most of site and off-site towards school and on playing fields. The site has been derelict for at least 15 years and is not fenced. It is relatively exposed topographically, i.e. top of hill, receives wind flows directly. There is a school approximately 100m away to east. Residential areas are on two sides within 50m. Discussions with MOI indicated that there is a tender to purchase the land and they were unsure who owns land now. Pacific Energy has a sign near the site but this relates to an active fuel terminal nearby.

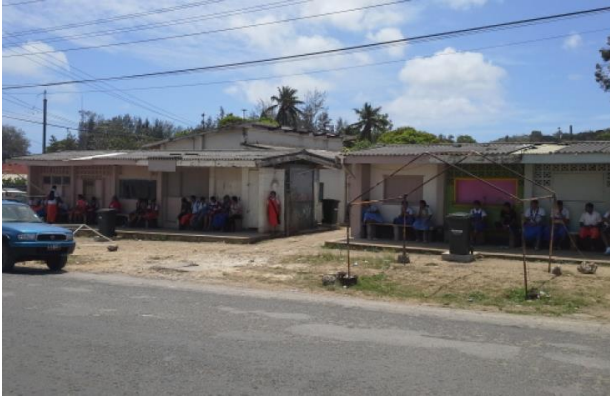
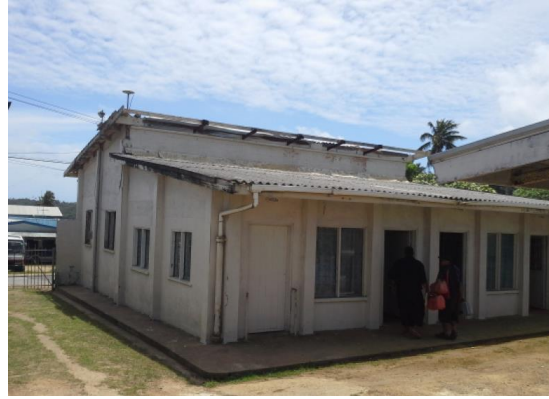
**Photos 15 and 16 – Former Neiafu Market.**

Photos 15 and 16 show the Neiafu former market. There are damaged ACM roofs on several buildings and ACM fragments observed on ground across the road from the southern building. This former market is still widely used.
