Survey of the Regional Distribution and Status of Asbestos-Contaminated Construction Material and Waste - Best Practice Options for its Management in Pacific Island Countries

Report for Tuvalu

**Prepared for the Secretariat of the Pacific Regional
Environment Programme (SPREP)**

May 2015

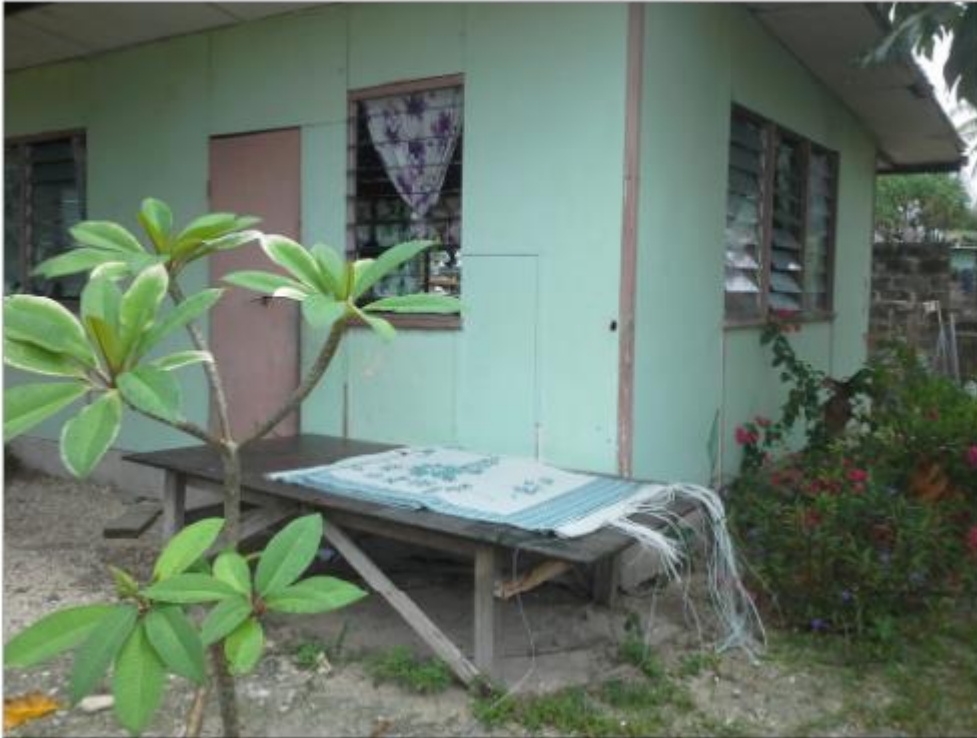
Photo 1: typical structure in Funafuti showing fibre board cladding

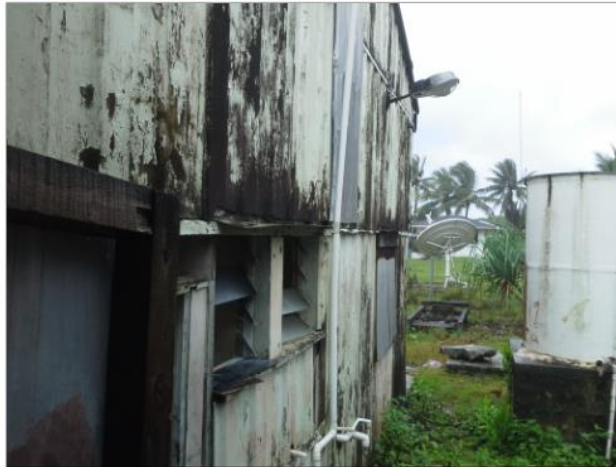
The risk ranking scores presented in Table 8 indicate that the survey has identified five sites that are considered to currently present a moderate risk of asbestos exposure to the occupants. Photos 2 and 3 show the old power station and Photo 4 shows the decaying asbestos roof on the meteorological station. Two further sites present a low risk. One of these is the Princess Margaret Hospital which would normally be considered a higher risk, but the only positive asbestos material there is loose fibreboard. Two further sites are considered to present a very low risk. This risk assessment is based on current conditions, ACM condition and site use observed at the time of the survey. Should these change over time, reassessment of the risk presented would be required.

Photo 2: Wall cladding on the former power station

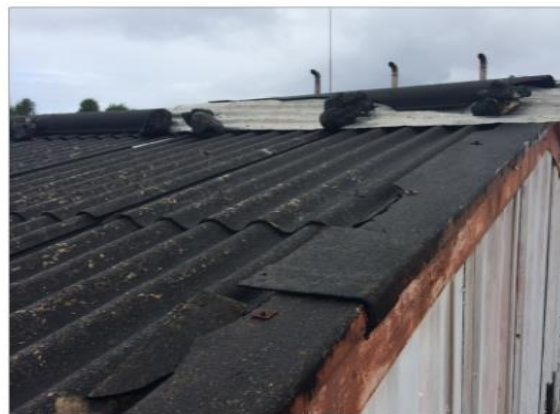
Photo 3: Asbestos roofing material on the former power station

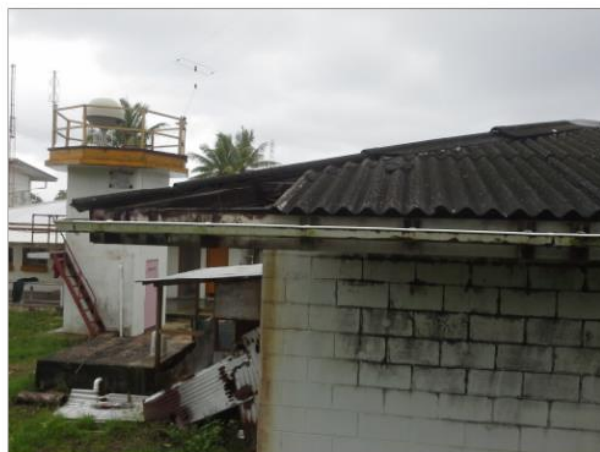
Photo 4: Asbestos roof at the meteorological centre
