Survey of the Regional Distribution and Status of Asbestos-Contaminated Construction Material and Best Practice Options for its Management in Pacific Island Countries

**Report for the
Republic of Nauru**

**Prepared for the Australian Department of Foreign Affairs and
Trade (DFAT)**

June 2015

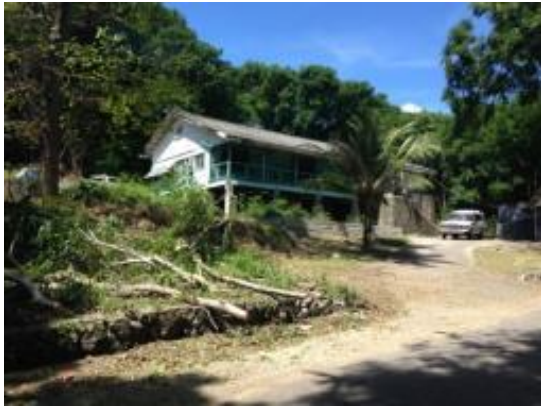
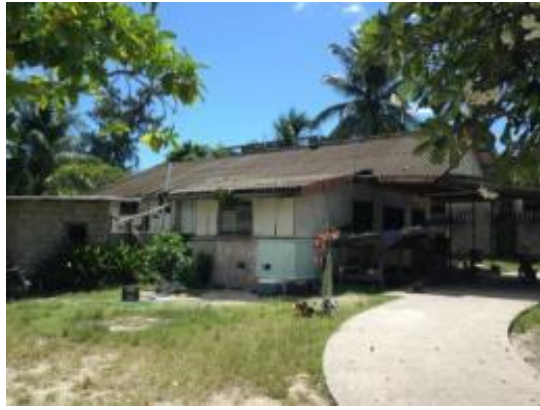
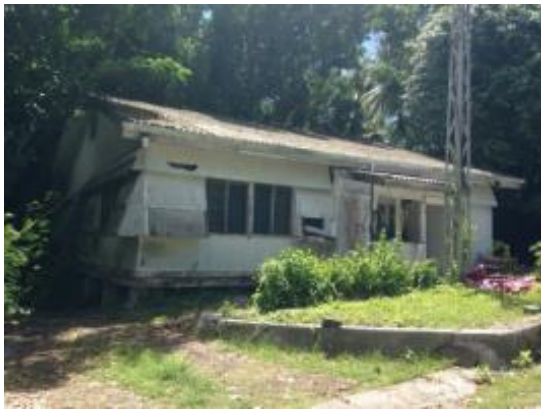
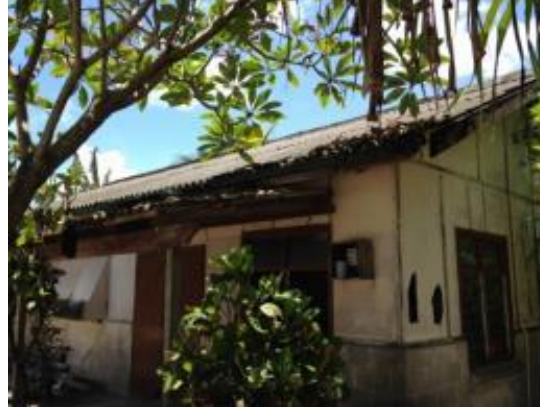
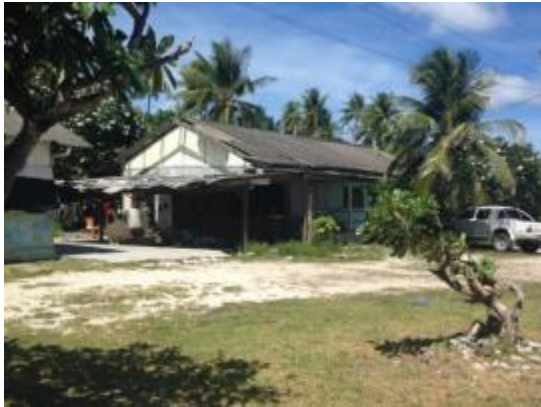
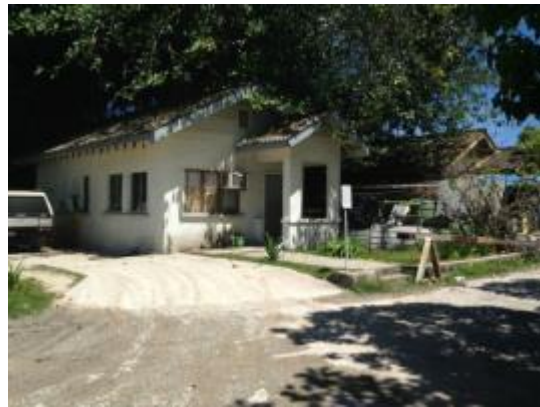
Photos 5-10 – Six Typical Houses with Asbestos Roofs and Possibly Asbestos Cladding

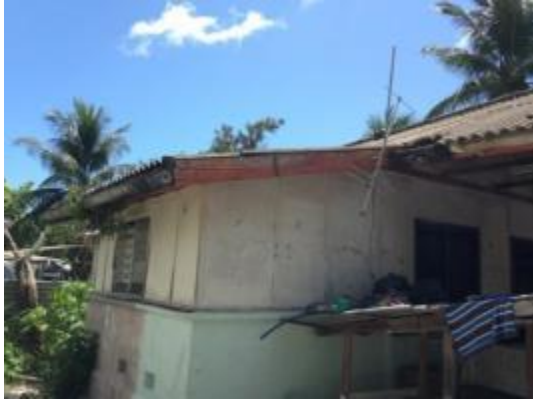
Photo 11 shows a close-up of possible cladding and Photo 12 shows an abandoned house littered with asbestos debris. This abandoned house was close to other houses and children were noted playing in the asbestos debris.

Photo 11 – Possible Asbestos Cladding

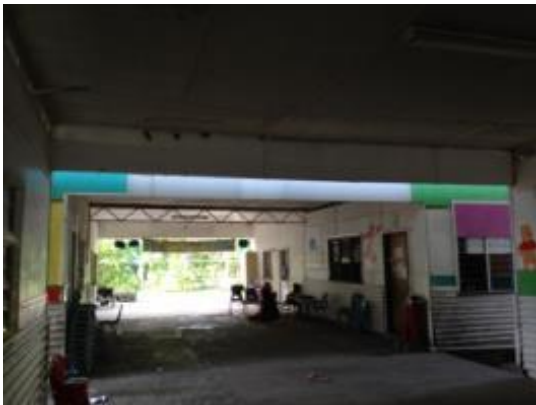
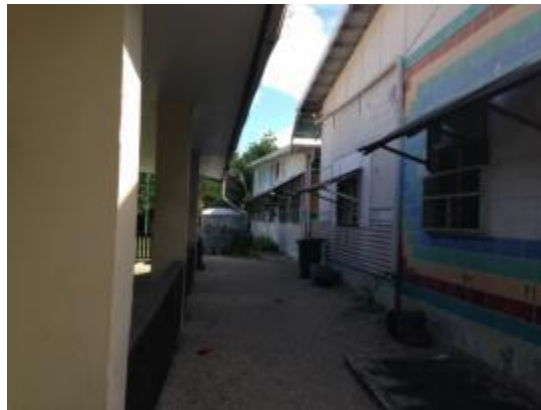
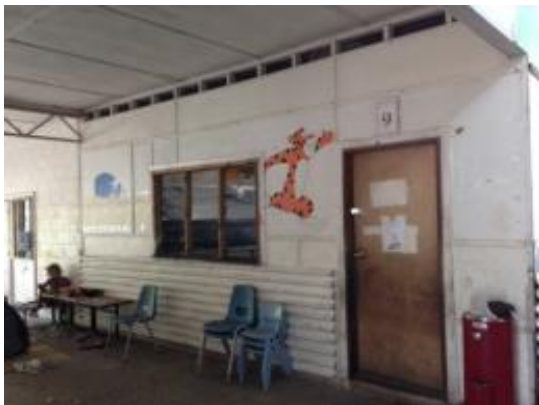
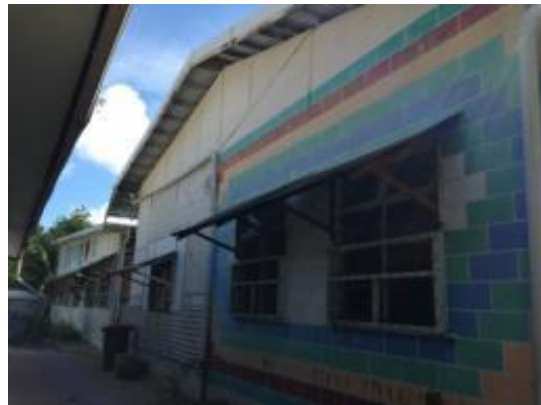
In the cases of the three infant schools shown below, only the cladding (and not all the cladding) has been confirmed as asbestos). The vinyl floors were checked at the Anetan and Nibok Schools and found to be negative for asbestos.

Photos 18-22 - Boe Infant School Asbestos Cladding

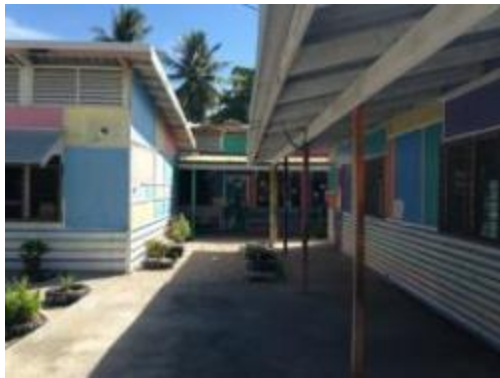
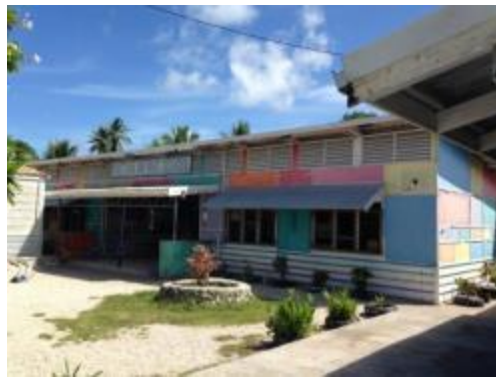
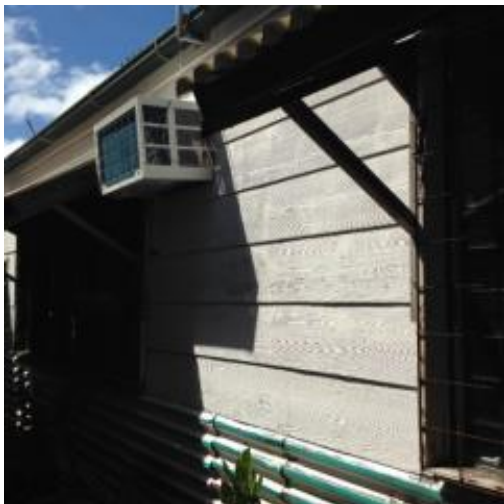
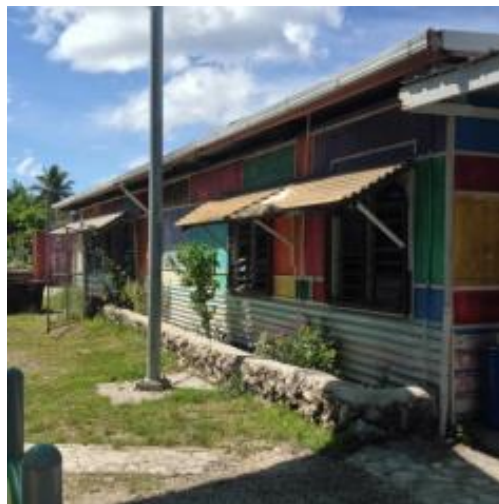
Photos 27-30 – Anetan Infant School Asbestos Cladding

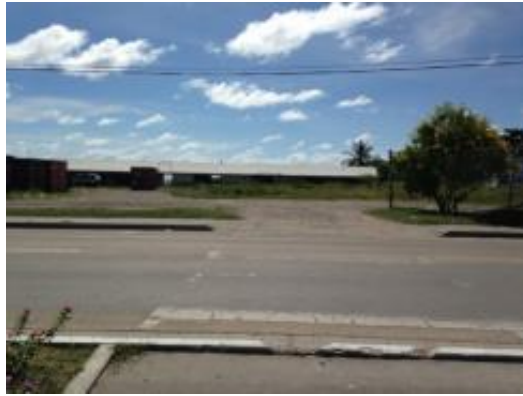
The original site of the Nauru Primary School was in Aiwo and the school was burnt down in 2007. This resulted in the relocation of the school to Menen. The old school reportedly had an asbestos roof and cladding and so the site in Aiwo would probably have been contaminated with asbestos debris and fibres when the fire occurred. This site is now a vacant site opposite the Civic Centre in Aiwo – see Photo 31 below.

Photo 31 – Site of Old Aiwo School

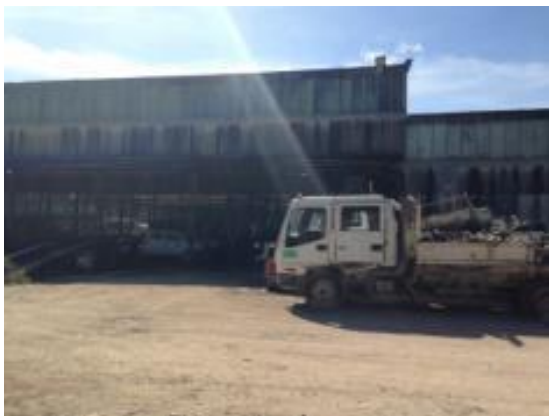
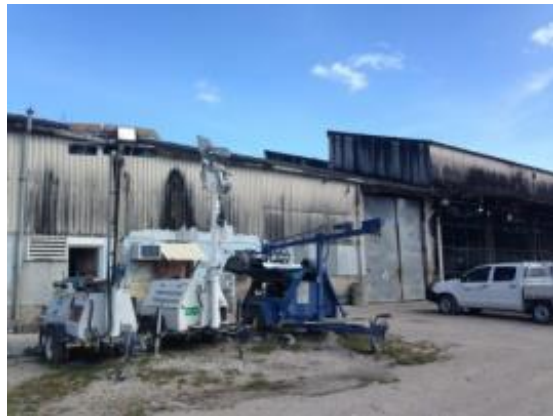
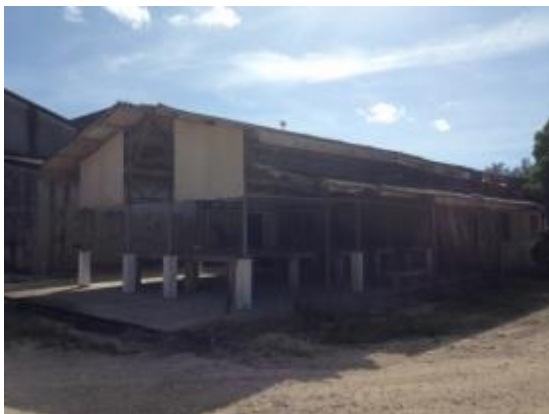
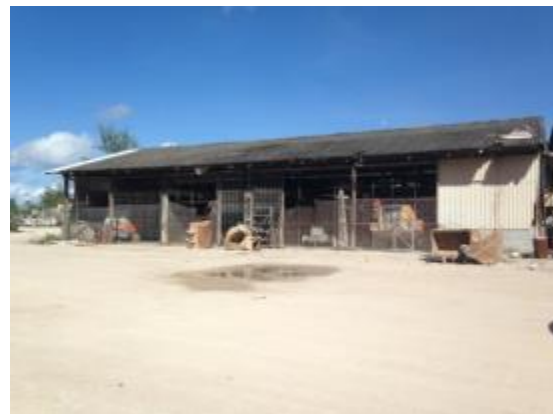
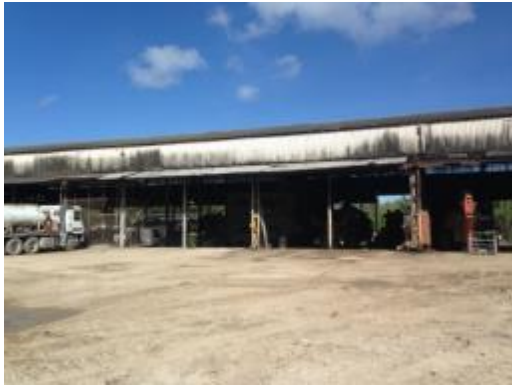
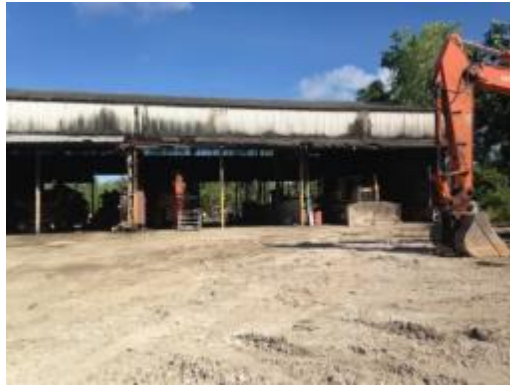
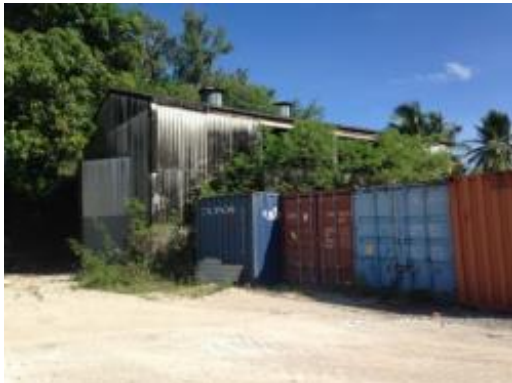
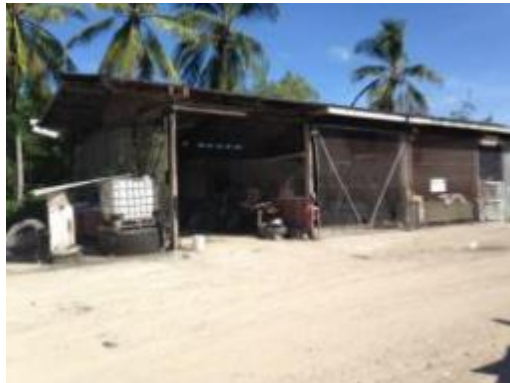
The NRC workshops and maintenance area is up on Topside and all the buildings are clustered together in one area. Most of them have asbestos cladding, much of which is deteriorating. Photos 32-39 below show the main buildings:

Photos 32-39 – Various Buildings in NRC Workshop Area with Asbestos Roofing and Cladding

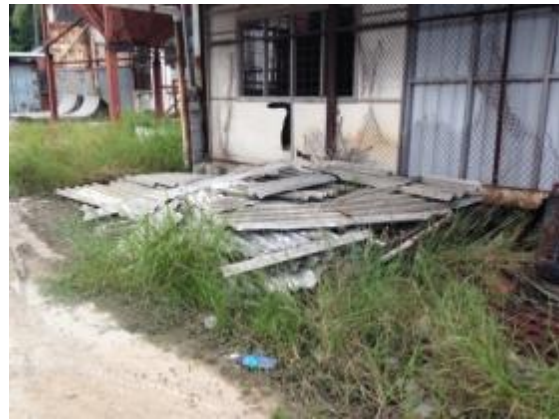
Photo 50 - Broken Asbestos Sheets

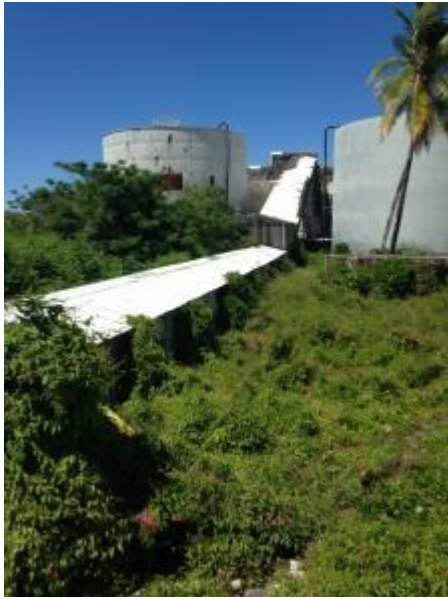
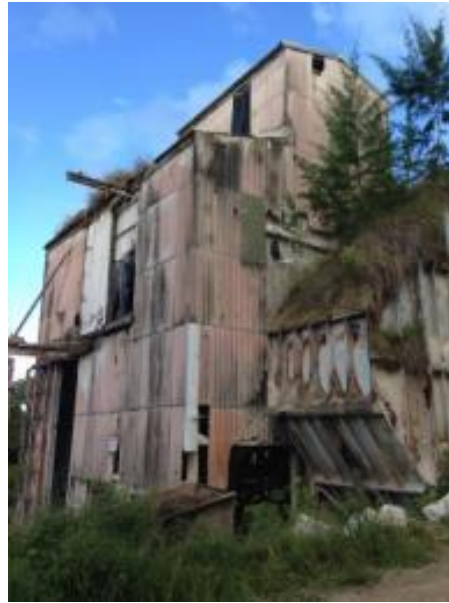
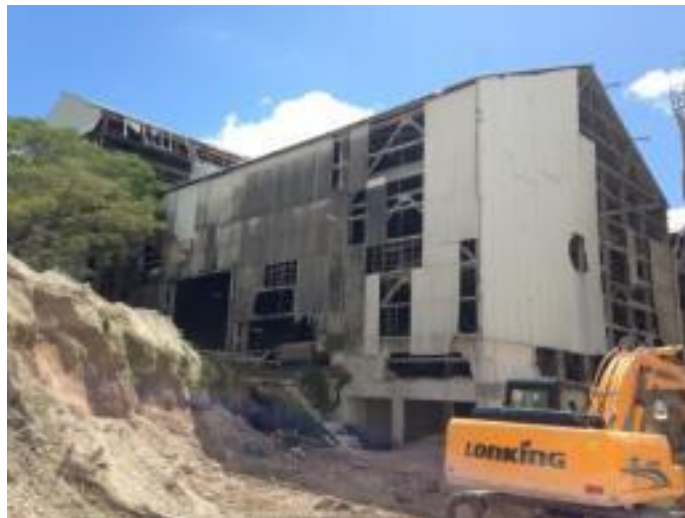
Photos 51-56 show some of the various components of the phosphate processing plant, which is still partly operational although some sections are not used now and are falling into disrepair. The first photo shows the conveyor from the processing area to the storage area.

Photos 51-56 – The Old RonPHOS Processing Area

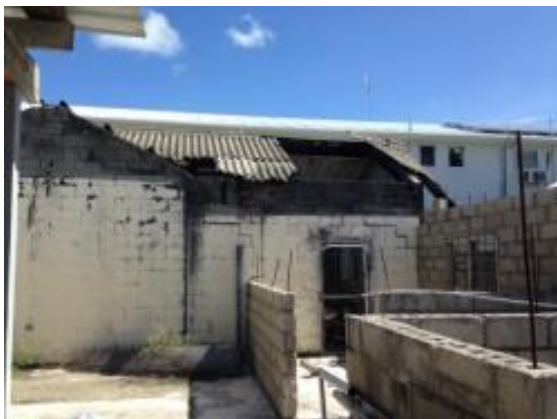
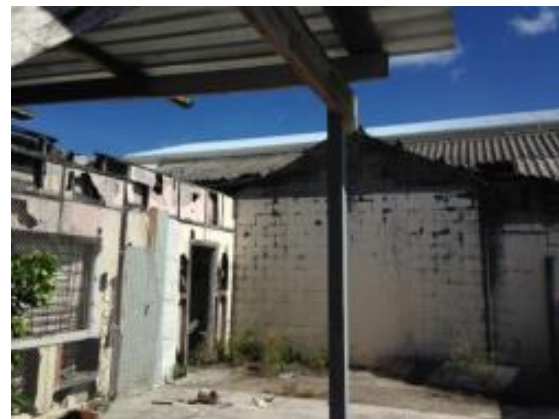
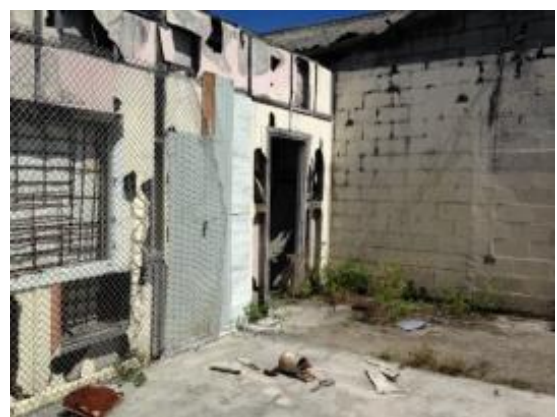
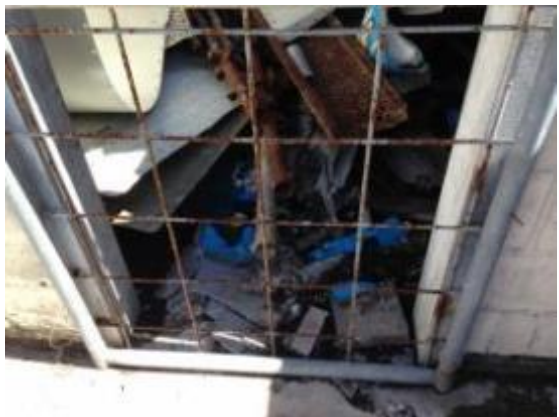
There was a fire in the combined Prison and Police Station in 2007. The Police Station was relocated but the prison remained on the same location. Some of the burnt-out buildings are still in place together with some of the old debris. They have damaged asbestos roofing and cladding – see Photos 75-78 below.

Photos 75-78 – Prison Asbestos in Burnt Area including Asbestos Debris

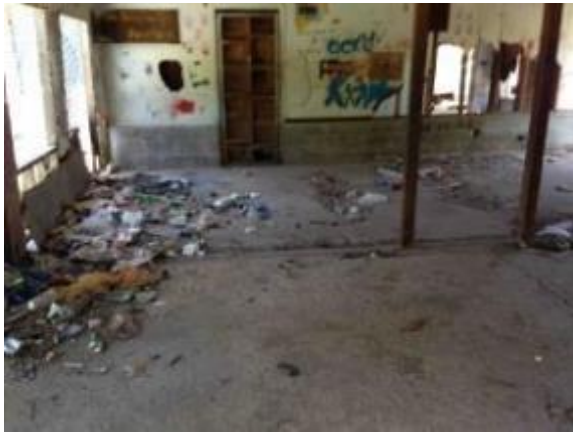
Photo 5 – Old House with Broken Asbestos

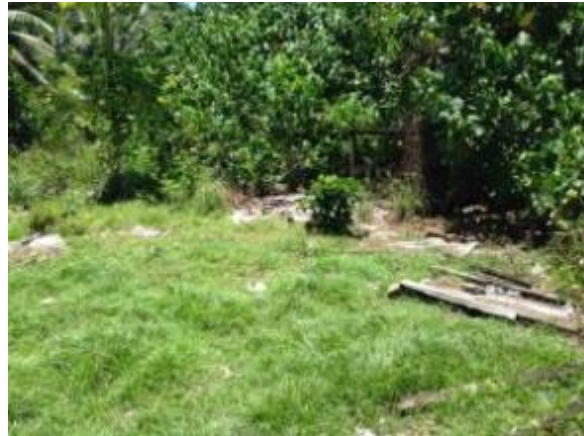
Photo 6 – Asbestos on Ground Behind House

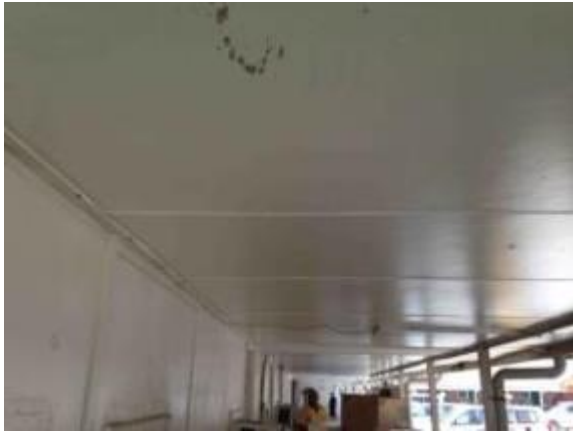
Photo 8 – Asbestos Hospital Parapet Ceiling

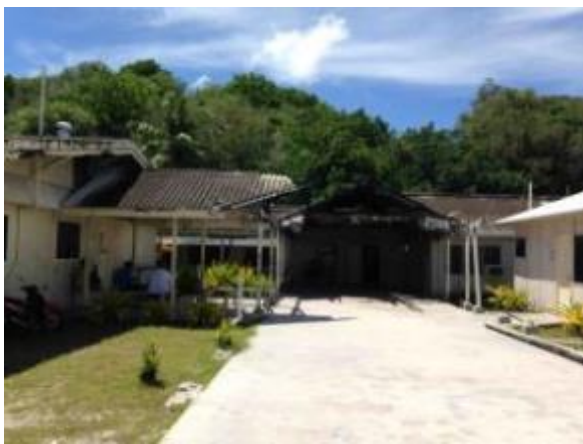
Photo 10 – Burnt Part of Hospital

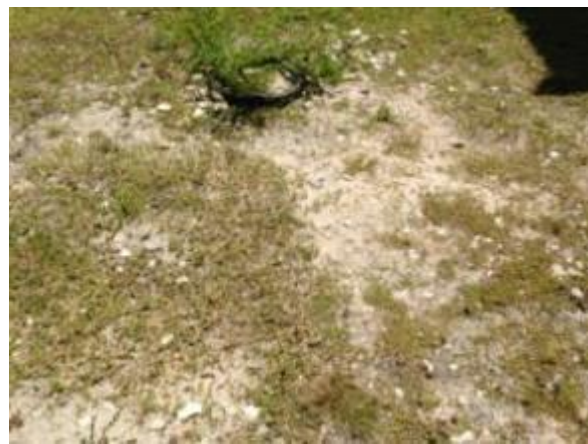
Photo 11 - Debris from Fire on Hospital Grounds

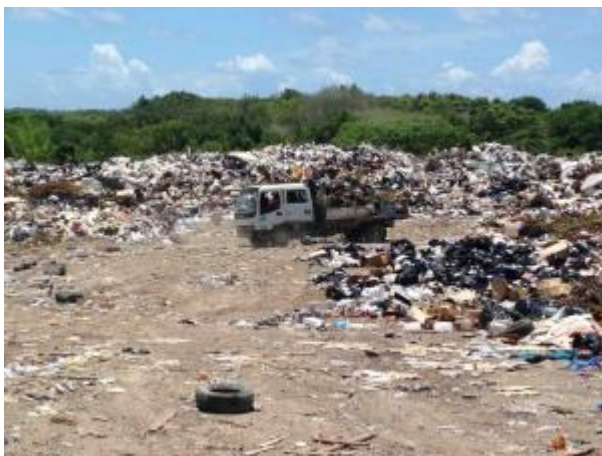
We visited the only landfill on Nauru, where open dumping was conducted. No attempt was being made to manage the dumping, control what was dumped, or cover refuse – see Photo 12.

Photo 12 – Nauru Landfill

Waste asbestos was observed being dumped in several locations at the landfill. It was also noted that wastes were being dumped at several other locations adjacent to roads around Topside, including asbestos wastes.

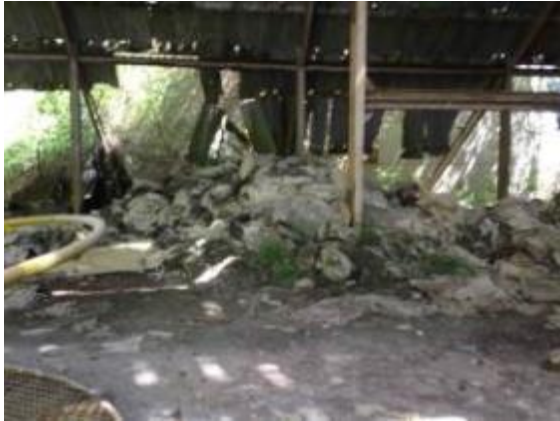
A sample was not taken of the material as that would have been too dangerous without proper protection. RONPhos advised, however, that before the bags deteriorated, the labels were clearly visible saying that the material in the bags was powdered asbestos and that it was chrysotile (white asbestos).

Photo 13 – Bags of Reported Asbestos Powder

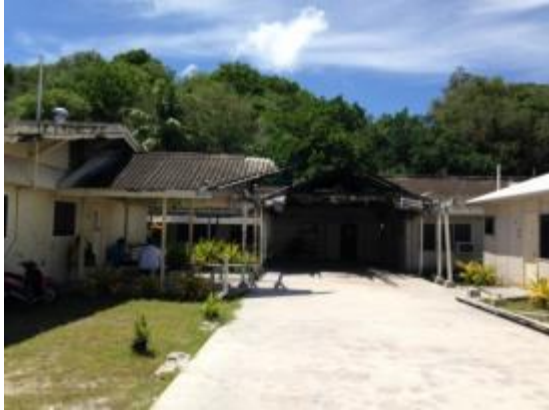
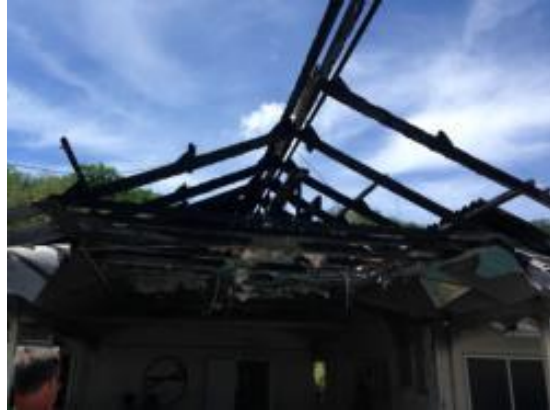
The fire at the hospital occurred in August 2013. Several buildings burnt down before the fire was put out and some buildings were partially burnt – see photos below:

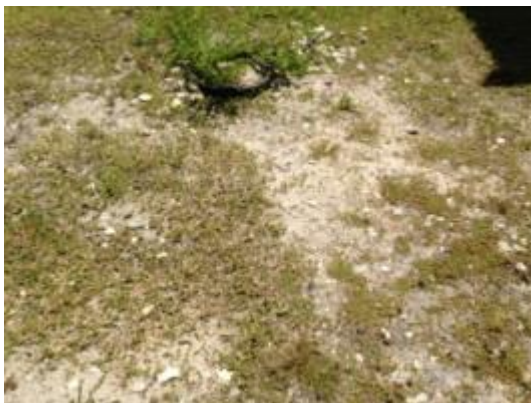
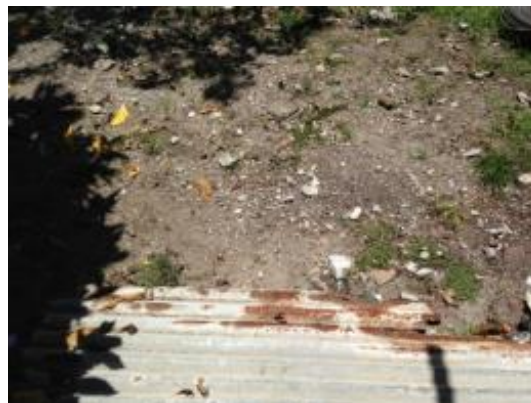
In addition asbestos debris was spread over the hospital grounds by the fire which would have generated loose asbestos fibres and small pieces of asbestos. This debris was evident on the ground even a year after the fire – see photo below:

It was decided to spend part of the DFAT grant towards the Nauru Asbestos Assessment on removing the remaining part of the burnt structure and cleaning up the ground. The local company Central Meridian was commissioned to undertake the removal and clean-up work, and this work was supervised by John O’Grady from Contract Environmental Ltd.

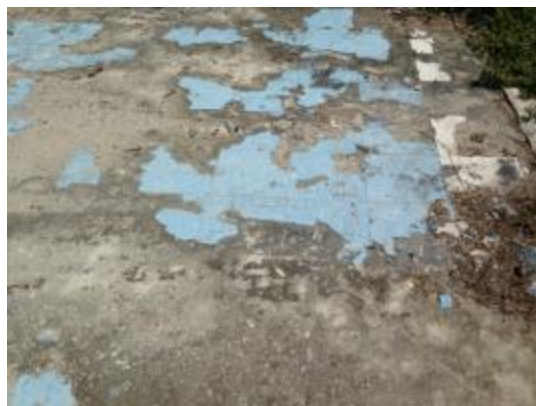
Finally the remaining floor slabs had some remnants of vinyl flooring – see photo below. A sample of this vinyl flooring was sent away for analysis and found to be free of asbestos.
