# **Survey of the Regional Distribution and Status of Asbestos-Contaminated Construction Material and Best Practice Options for its Management in Pacific Island Countries**

## **Report for the Republic of Fiji**

**Prepared for the Secretariat of the Pacific Regional  
Environment Programme (SPREP)**

**May 2015**

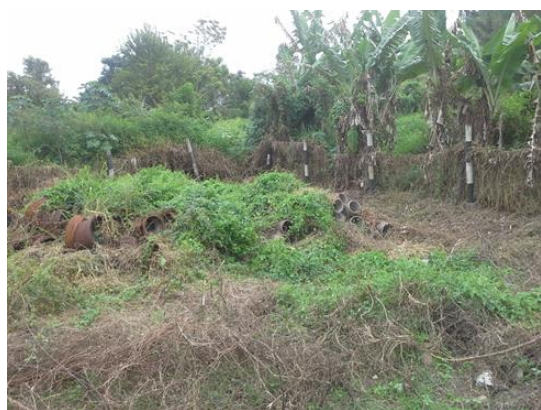
**Photo 1 – WAF Sigatoka**

Photos 1 and 2 are of Water Authority of Fiji (WAF) stockpiles. Photo 1 was taken at Sigatoka and Photo 2 was taken at Labasa.

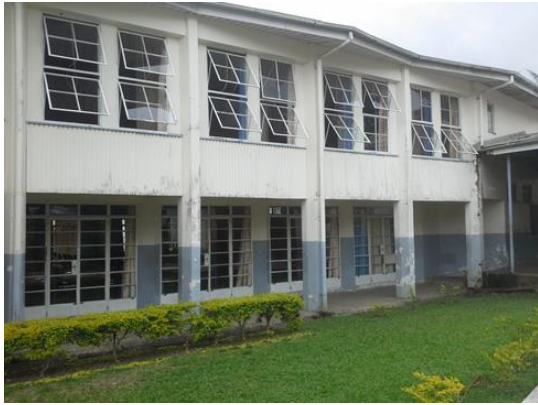
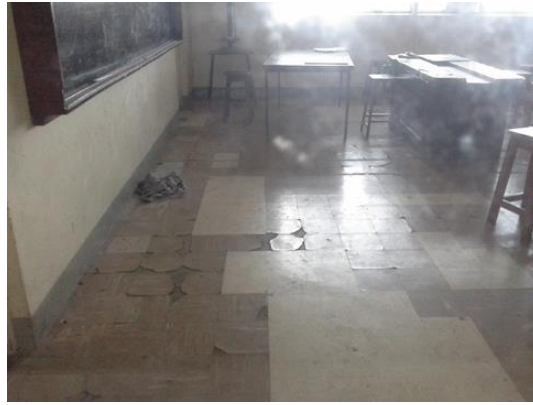
**Photos 3 and 4 – Suva Grammar School**

The photos below are of the Suva Grammar School. In Photo 3 the panels below the windows are asbestos sheeting. At the time of the visit there were about 200 of them but there was a plan to have them all removed. Photo 4 shows the broken vinyl flooring in the classrooms. This vinyl flooring contains 5% asbestos.

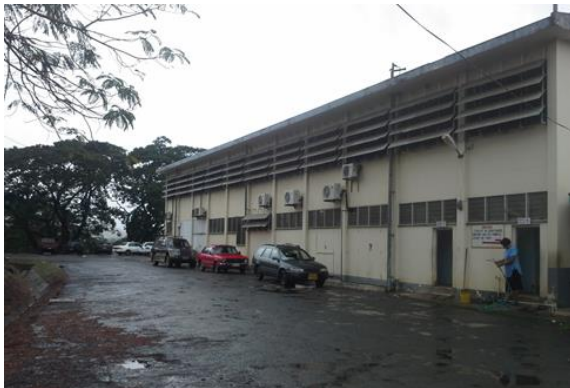
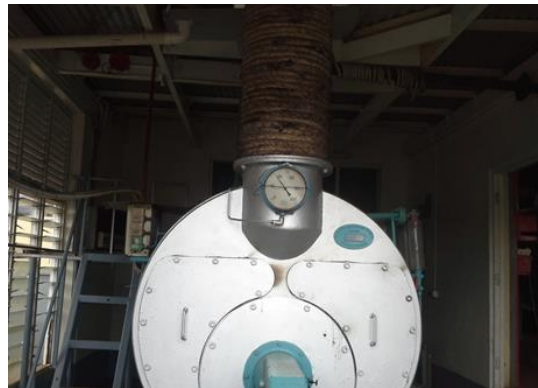
**Photos 5 and 6 – Labasa Hospital**

The photos below are of the Labasa Hospital. Photo 5 shows the sunshades. There are many such sunshades at the hospital. Photo 6 shows old fibreglass boiler pipe lagging. This lagging is 95% chrysotile asbestos.

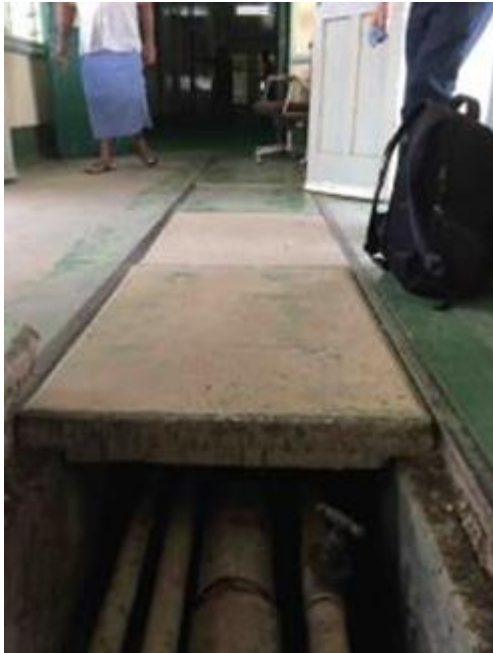
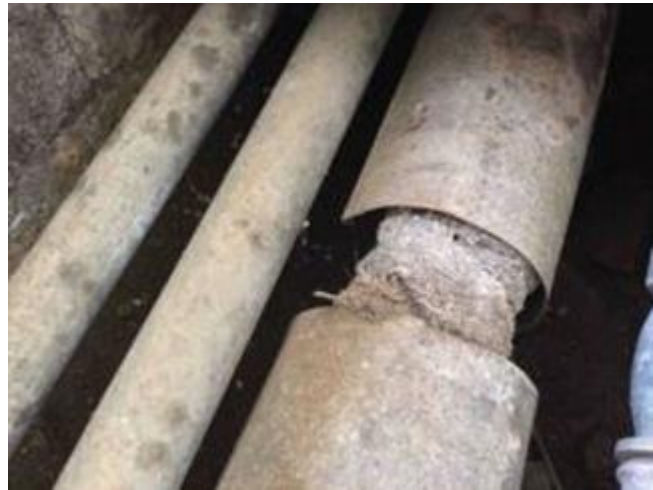
**Photos 7 and 8 – Pipe lagging in Tamavua-Twomey Hospital**

There is also extensive old asbestos remaining at the Tamavua-Twomey Hospital Complex in Suva. Photos 7 and 8 show the asbestos-lined pipe ducting that runs along ward corridors for a long distance. Photo 9 shows the old Ward 5 complex which has asbestos cladding on the outside and asbestos lining and ceilings on the inside. Friable asbestos was removed from two boiler rooms at the Tamavua-Twomey Hospital Complex as part of emergency work carried out under this project. Appendix 7 contains a report written prior to the work being undertaken, as well as the Asbestos Management Plan for the emergency work and the results of the air clearance analyses.

- It is recommended that the above higher priority asbestos work is carried out in Fiji and that consideration be given to removing other asbestos as per the table above. In particular the work at the Tamavua-Twomey Hospital should be completed.
- No residential houses were identified as having asbestos in Fiji but it is still possible that houses may contain asbestos, so vigilance should still be maintained.
- The Naboro Landfill is ideal for receiving asbestos wastes and should be used for all asbestos disposal.
- Before asbestos remediation takes place (and after if all the asbestos is not removed) it would be appropriate to set in place suitable asbestos management practices and procedures to deal with the ongoing risk posed to human health by asbestos exposure. This should be accompanied by an appropriate education and training programme.

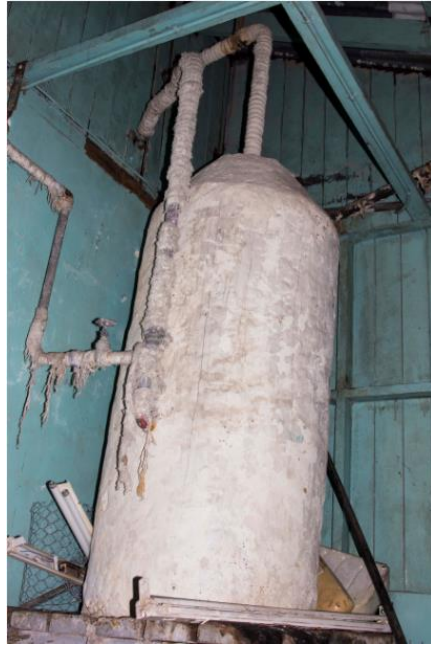
**Photo 10 – Hospital Boiler**

Photo 10 below shows a boiler and associated piping at the Tamavua-Twomey Hospital with friable asbestos lagging. There are also six hot water header tanks and associated piping in the roof space with friable asbestos cladding.

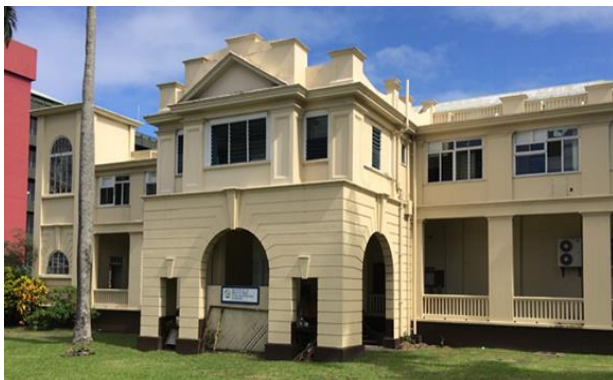
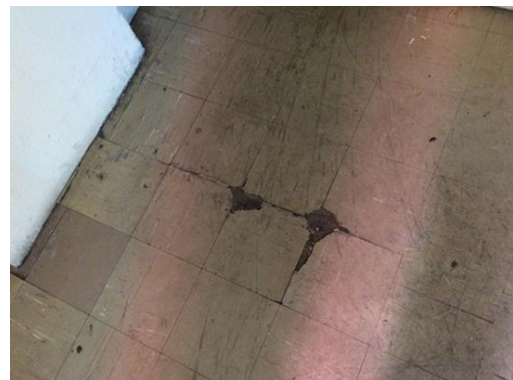
**Photos 11 and 12 – Stephens Building, Suva**

Photos 11 and 12 show the Stephens Building in the Suva CBD and the vinyl flooring in this building. These pictures were taken before the building was demolished. The results that established that the vinyl floor contained asbestos were available at an early stage of the demolition but the demolition still proceeded with no precautions taken to protect workers or the public. An investigation was carried out and the resulting report is contained in Appendix 8. There was no additional clean-up work undertaken but air monitoring for asbestos was carried out and no air-borne fibres were detected.

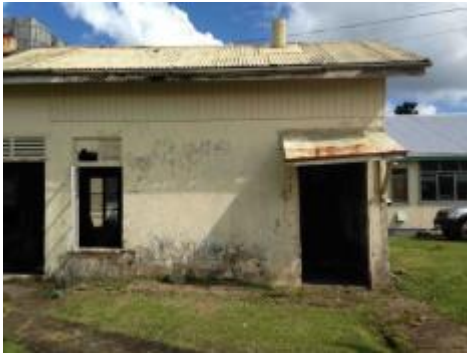
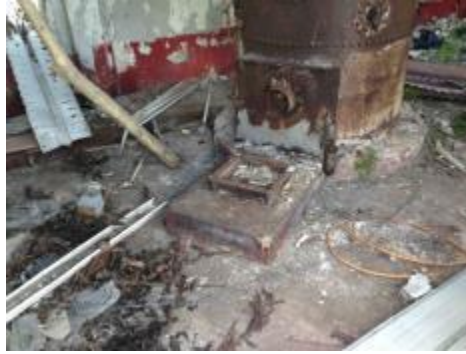
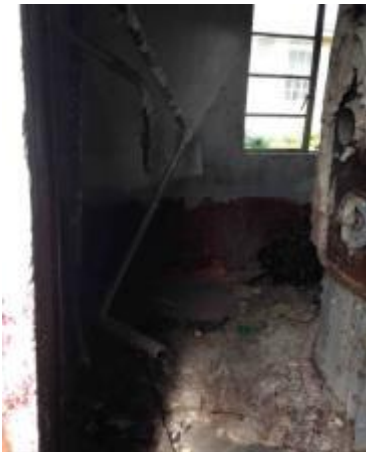
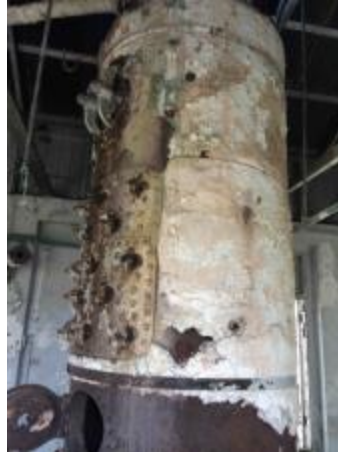
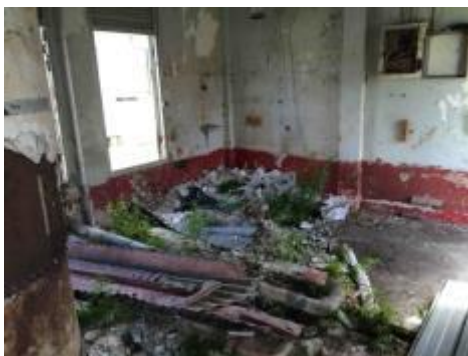
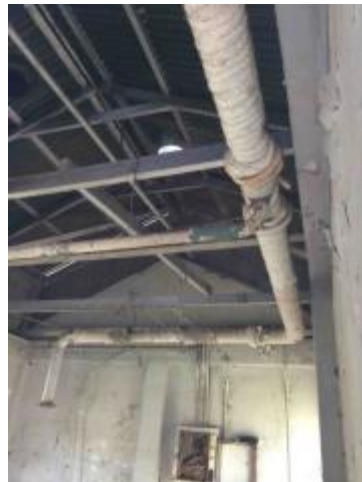
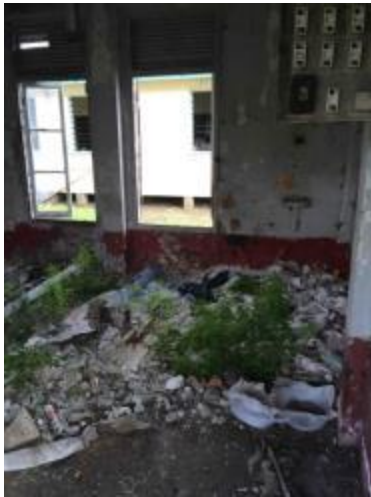
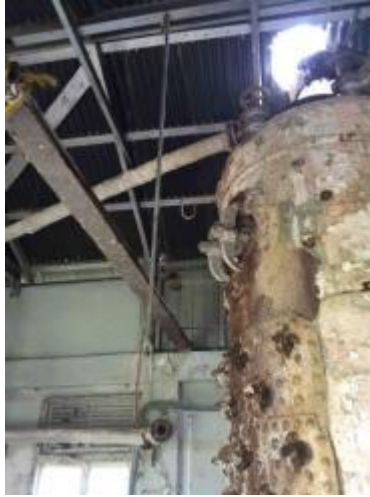
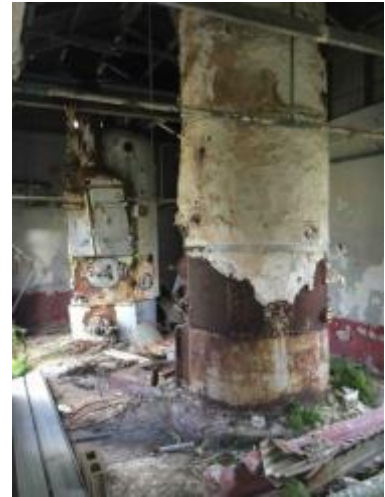
##### **2.1 Derelict Room**

This room is shown in the following nine photos. The room is open with windows facing towards the hospital. Broken down lagging is on two vessels and strewn over the floor. Rope lagging is coating some pipes. If this lagging is confirmed as asbestos, especially blue asbestos, then this is a serious situation that needs to be addressed urgently.

The situation is a serious one that needs to be addressed urgently. If some or all of the material described above proves to be asbestos, which seems likely, based on previous information and the experience of the SPREP consultants, then urgent action is needed. Much of the hospital and its grounds may be contaminated with asbestos.

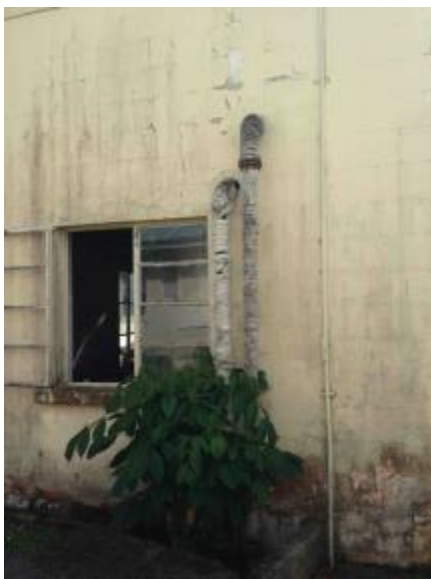
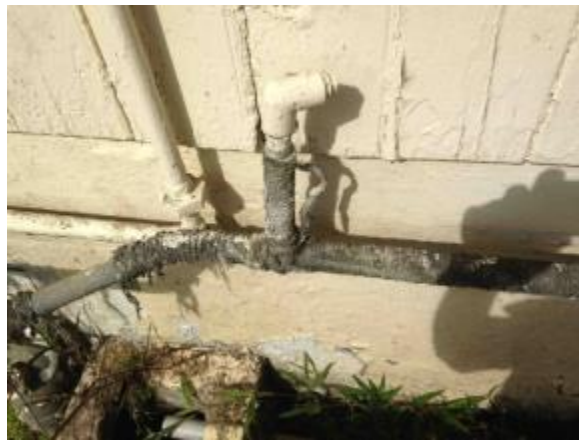
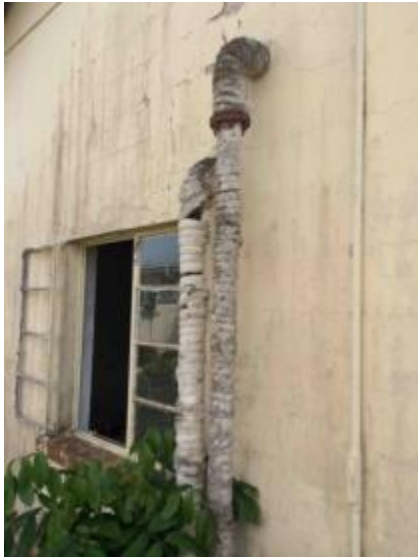
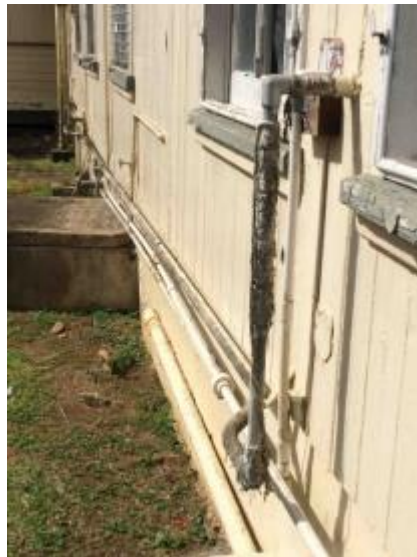
## 2.2 Exterior Rope Lagging

Rope lagging in a deteriorating condition covers pipes that are attached to walls in numerous locations as shown in the following four photos. Rope lagging of this type has commonly been made from asbestos.

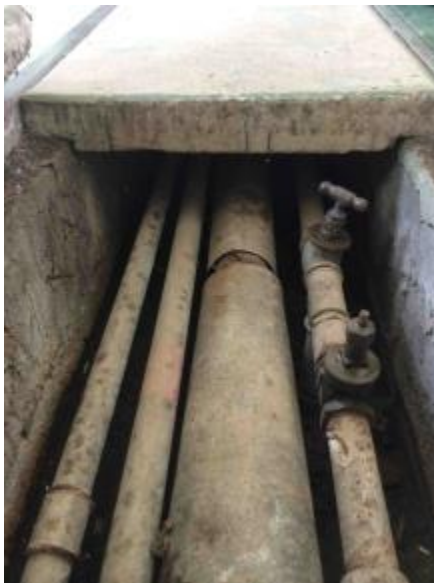
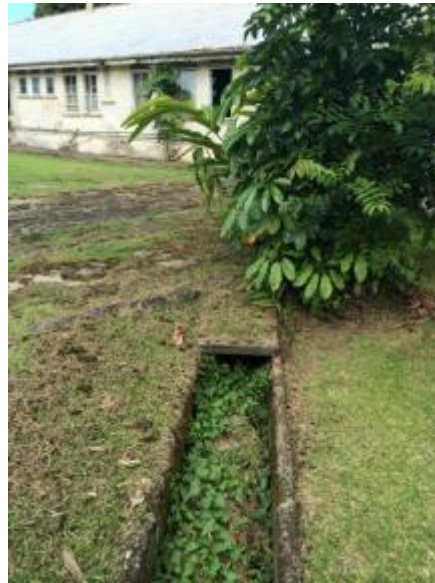
### 2.3 Exterior Ducting

Pipes encased in lagging runs through a large network of ducting through the grounds of the hospital. This is shown in the following two photos.

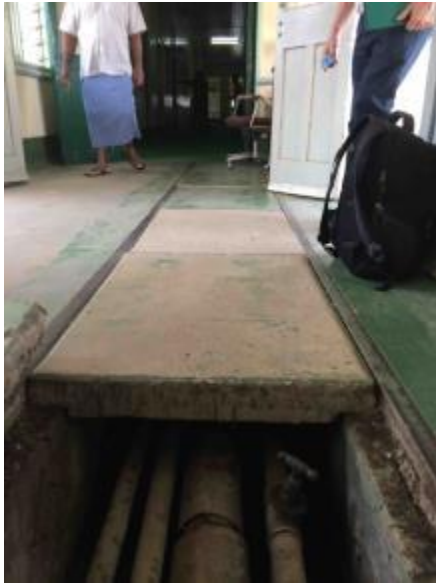
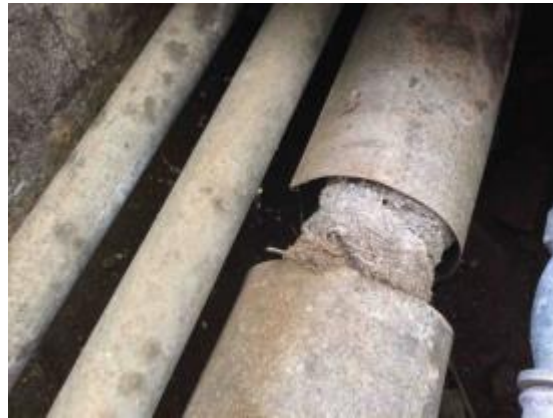
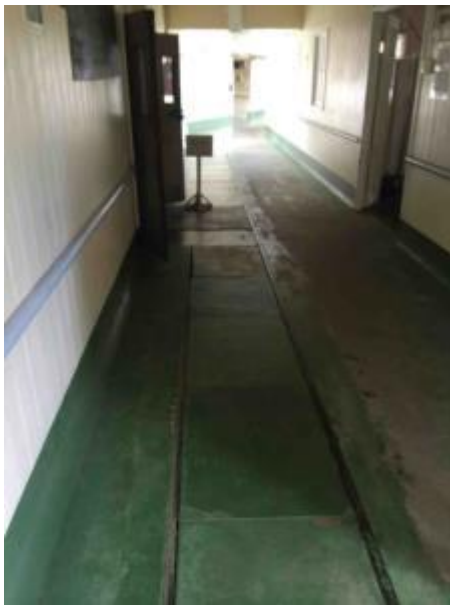
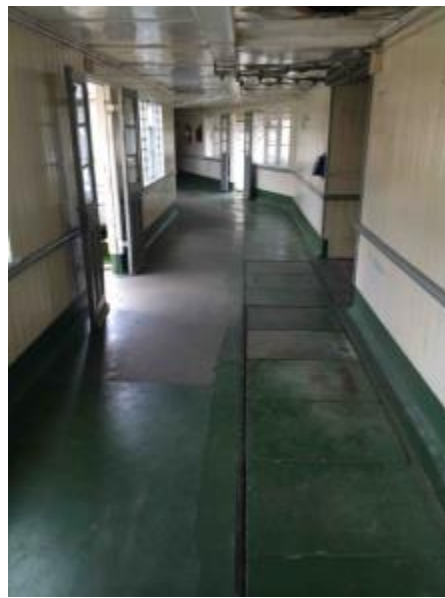
### 2.4 Internal Ducting

Pipes encased in lagging run through ducts in a network of corridors inside the hospital as shown in the following four photos. Lagging on the largest pipe is the rope lagging that has commonly been made from asbestos.

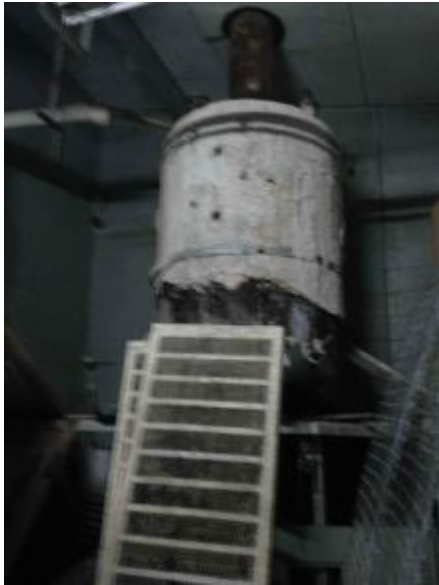
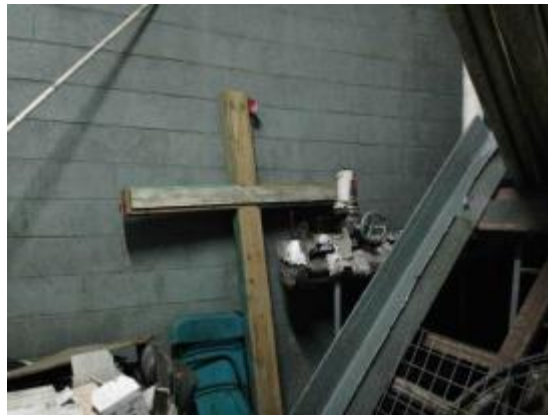
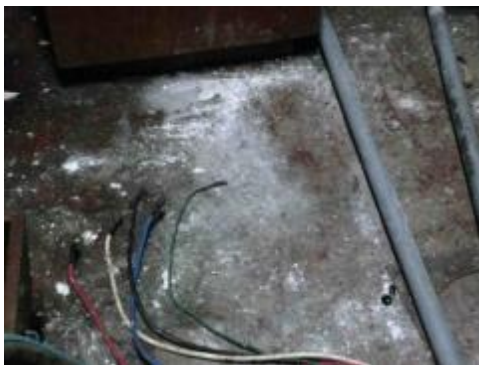
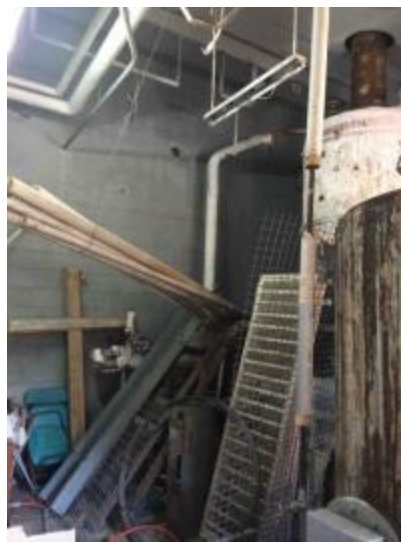
## 2.5 Old Boiler Storage Room

There is an old boiler room in the newer part of the hospital that is currently being regularly used as an equipment storeroom as shown in the four photos below. If the lagging on these old vessels is asbestos (especially blue asbestos) then this is another serious matter that needs to be addressed urgently. Lagging debris is spread on the floor of this room and the equipment stored in the room may be taken all round the hospital.

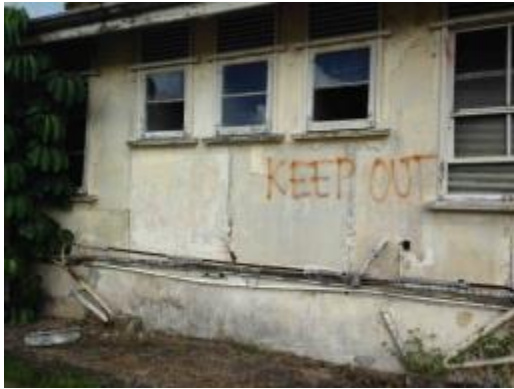
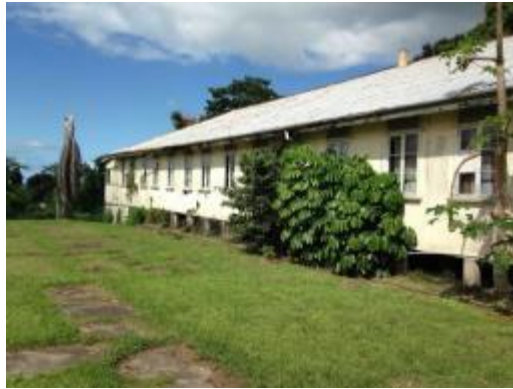
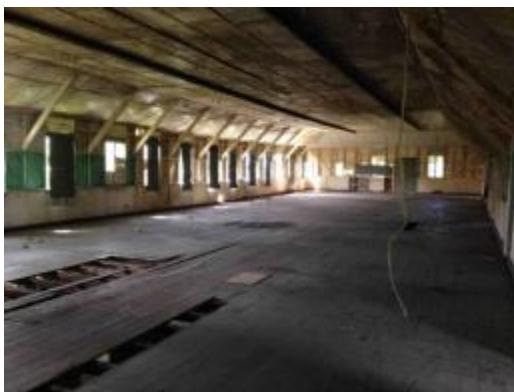
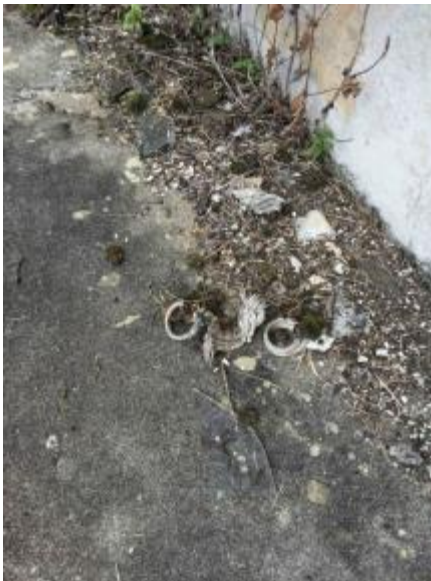
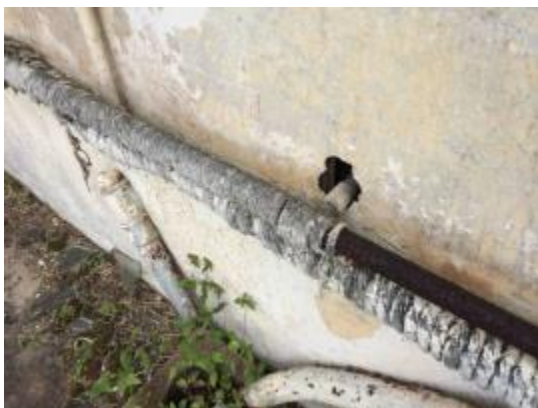
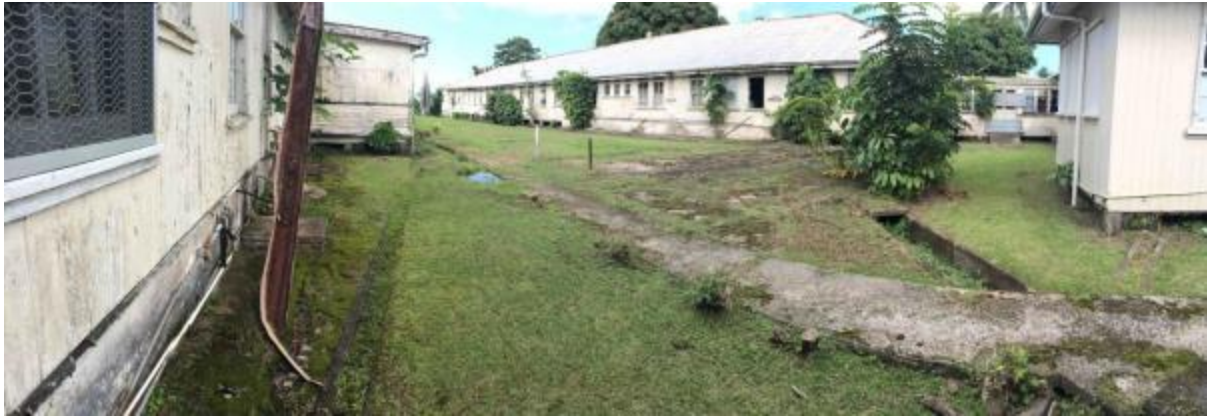
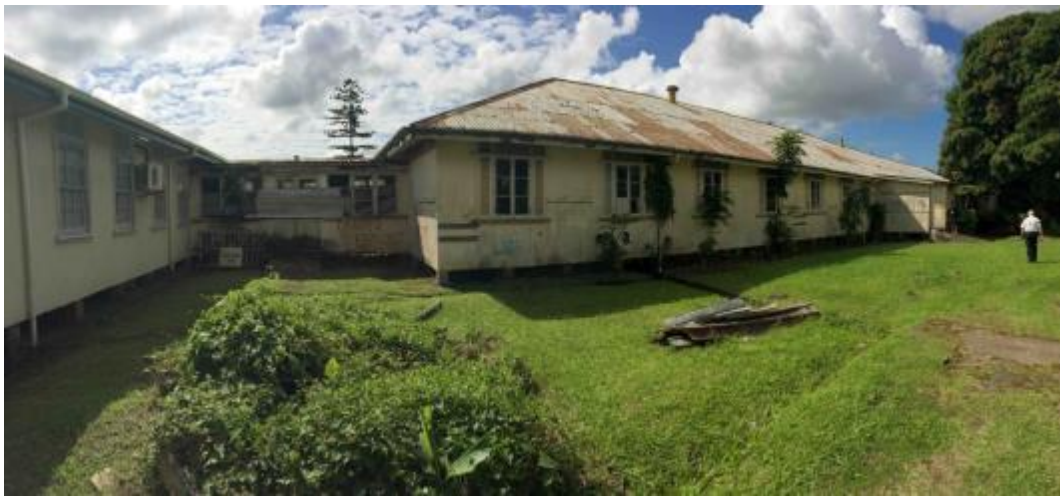
## 2.6 Old Ward 5

The old Ward 5 is known to be an asbestos building and “Keep Out” warnings have been painted on the building. It is a large old building as shown in the seven photos below. There is asbestos cladding on the outside and the internal walls are also understood to be asbestos. A network of pipes hang off the side of the building that are covered in very deteriorated rope lagging, some of which has fallen to the ground.

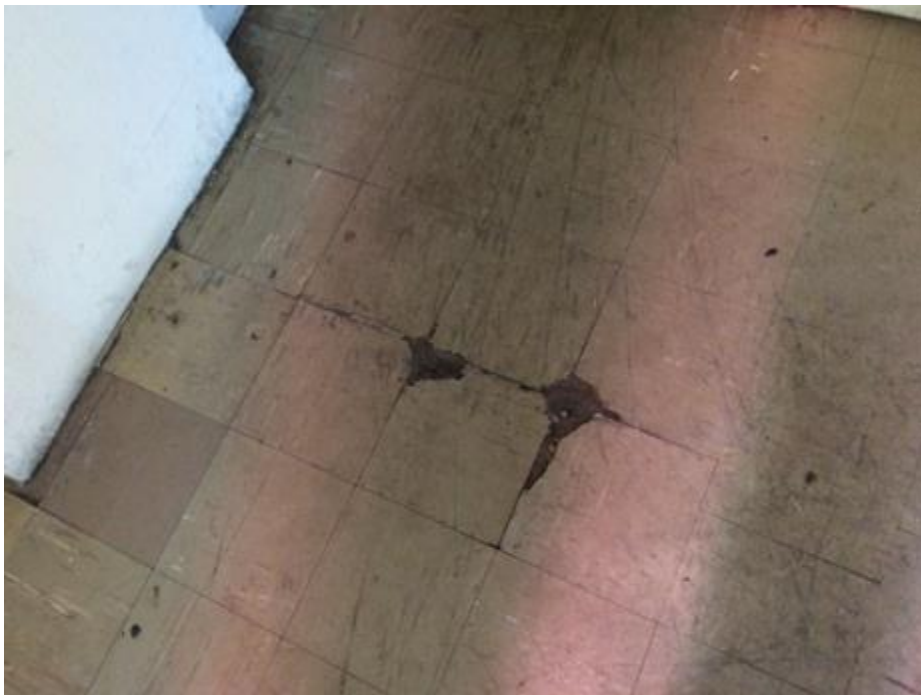
Photograph 2: Damaged ground floor vinyl floor tiles sampled 16 July 2014.

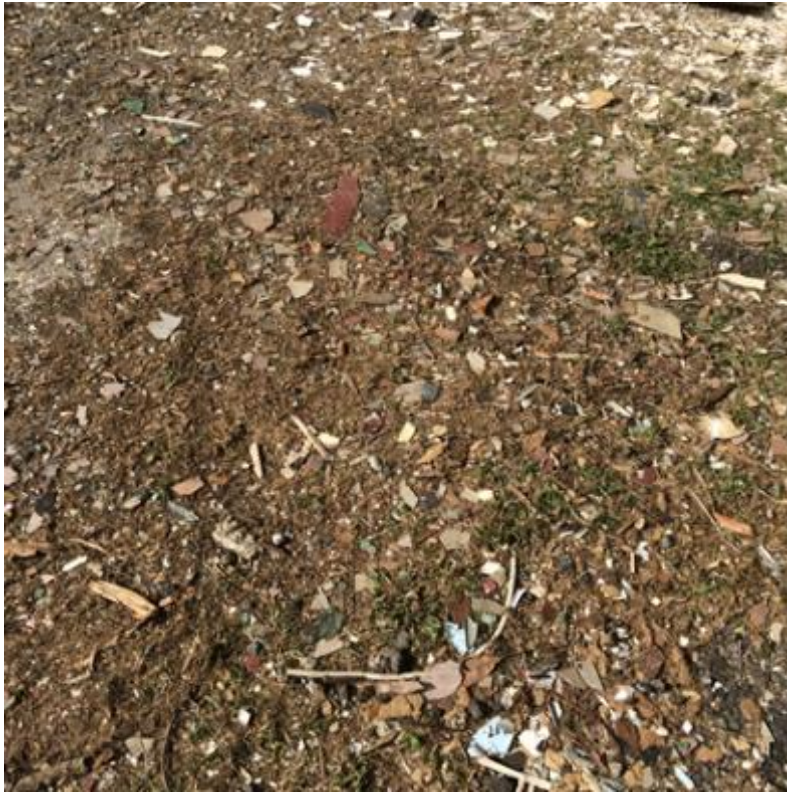
Pieces of floor tiles varying in size from approximately 5 - 150 mm were observed on the ground (see photograph 4) on all four sides of the building covering an area of approximately 100m<sup>2</sup>. A small downstairs room was observed to still contain vinyl floor tiles. No renovation staff were observed to be wearing suitable PPE for a site containing damaged asbestos materials.

Photograph 4; vinyl floor and other misc. building material on ground to north of building.

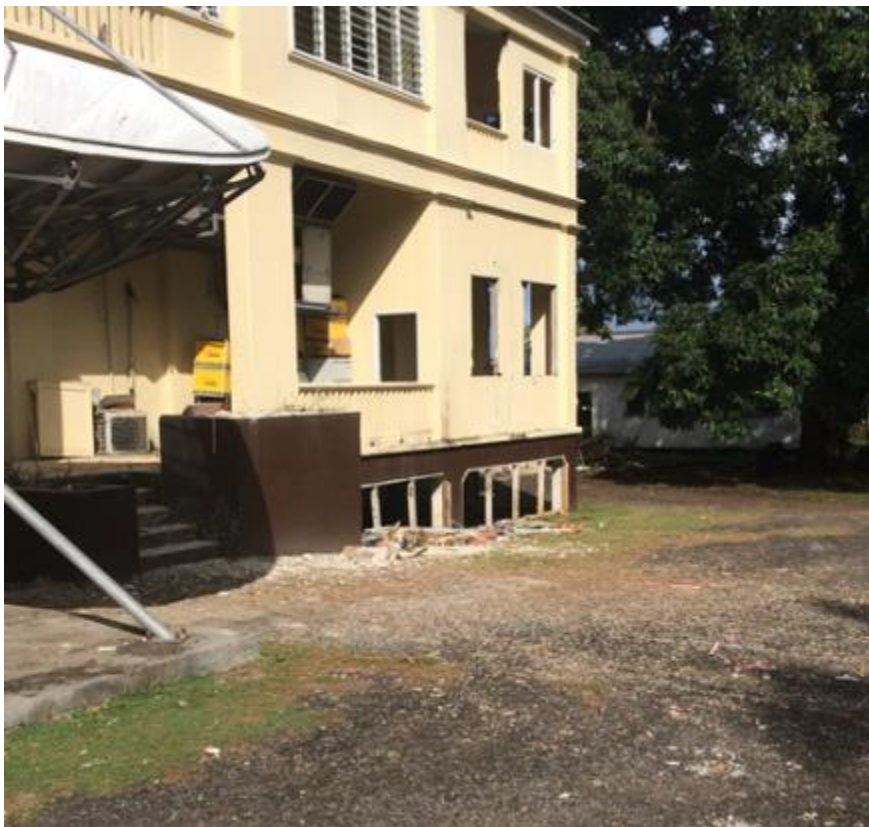
Photograph 6; acm vinyl floor tiles on ground adjacent to north facing façade
