# **Survey of the Regional Distribution and Status of Asbestos-Contaminated Construction Material and Best Practice Options for its Management in Pacific Island Countries**

## **Report for the Sovereign Republic of Kiribati**

**Prepared for the Secretariat of the Pacific Regional  
Environment Programme (SPREP)**

**May 2015**

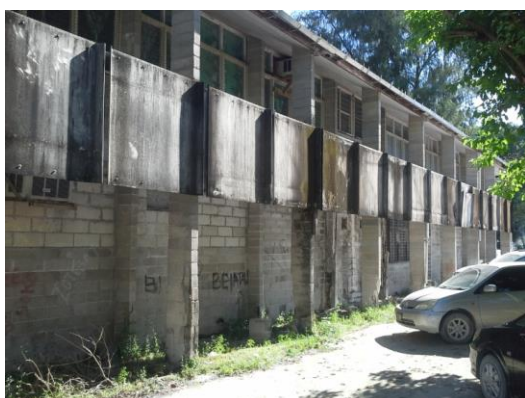
**Photo 1 – Ministry of Fisheries**

Photo 1 shows sunshades at the Ministry of Fisheries and Photo 2 shows loose – Old Powerhouse – loose fibreboard at the rear of the old Powerhouse.

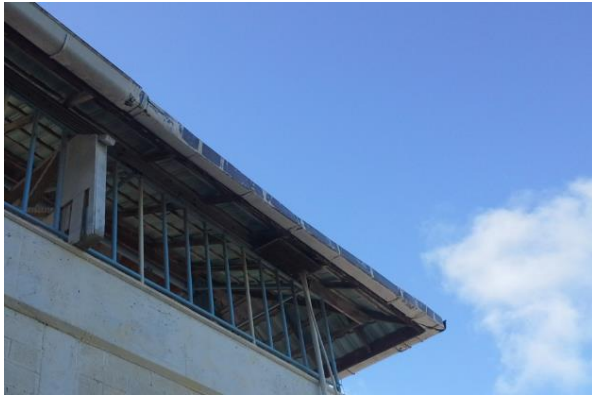
**Photo 3 – Kiribati Community Club**

Photo 3 below shows the AC guttering at the Kiribati Community Club. Photo 4 below shows AC cladding at Bobotin Kiribati Ltd.

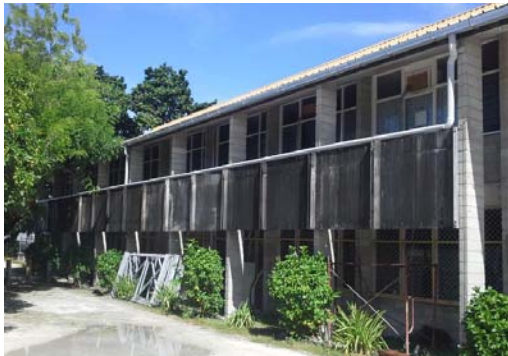
**Photo 5 – Ministry of Finance**

Photo 5 below shows the sunshade panels at the Ministry of Finance and Photo 6 shows the AC guttering at Bonriki International Airport.

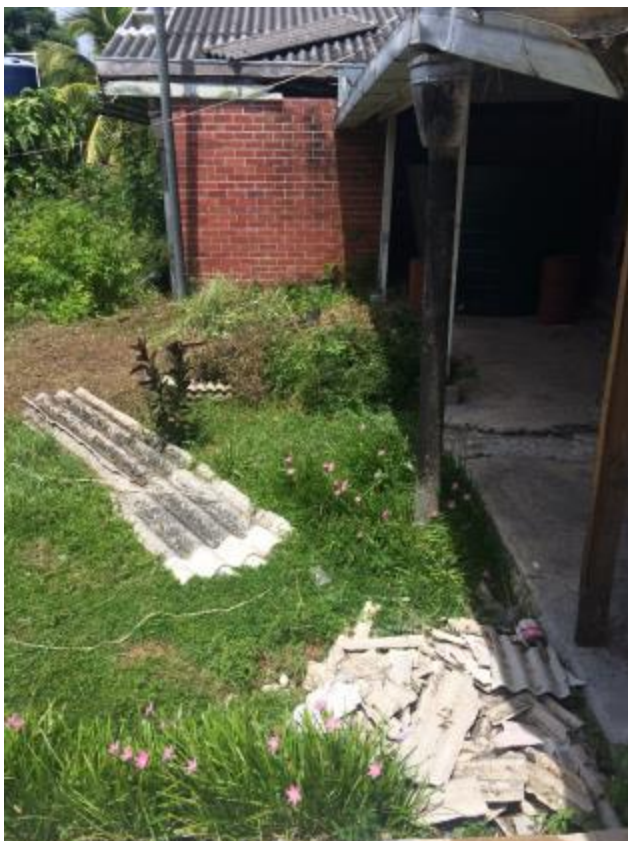
**Photo 7: Banaba Hospital; Damaged ACM roof sheets and loose ACM**

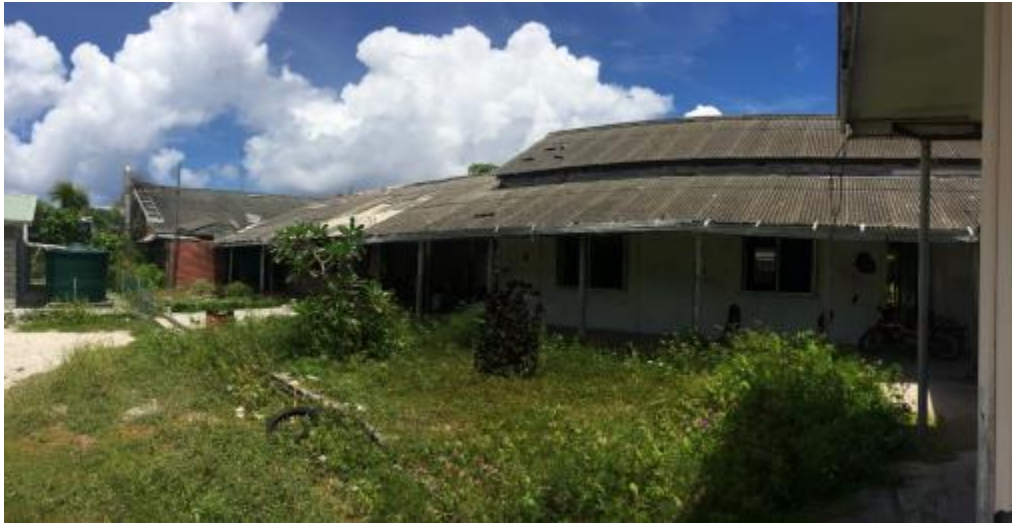
**Photo 8: Banaba Hospital – ACM Roof**

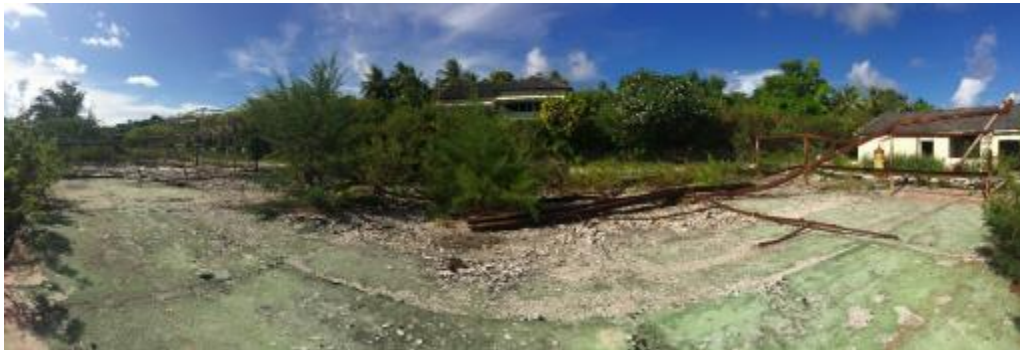
**Photo 9: Warehouse 4; fire damaged structure previously containing PACM. Site covered in ACM fragments. Public roadway in background.**

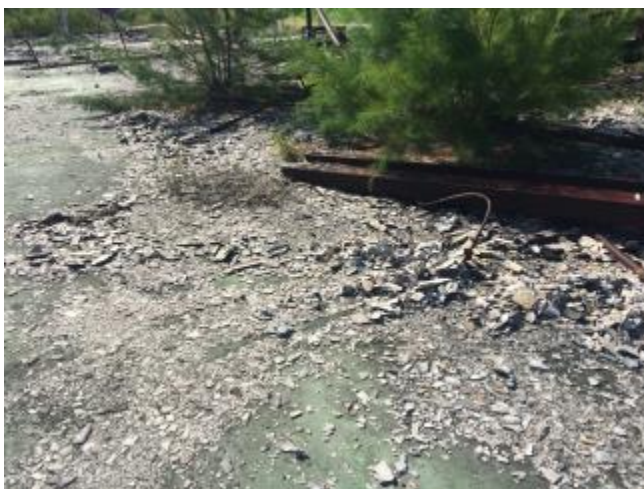
**Photo 10: Warehouse 4; view of ACM debris**

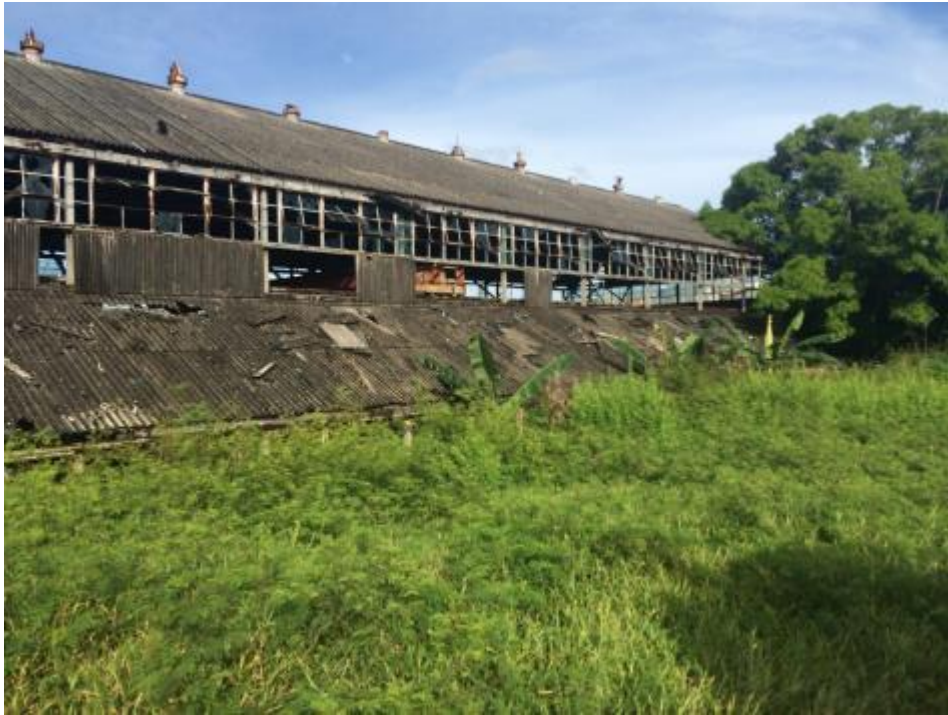
**Photo 11: Banaba former power house. ACM Roof**

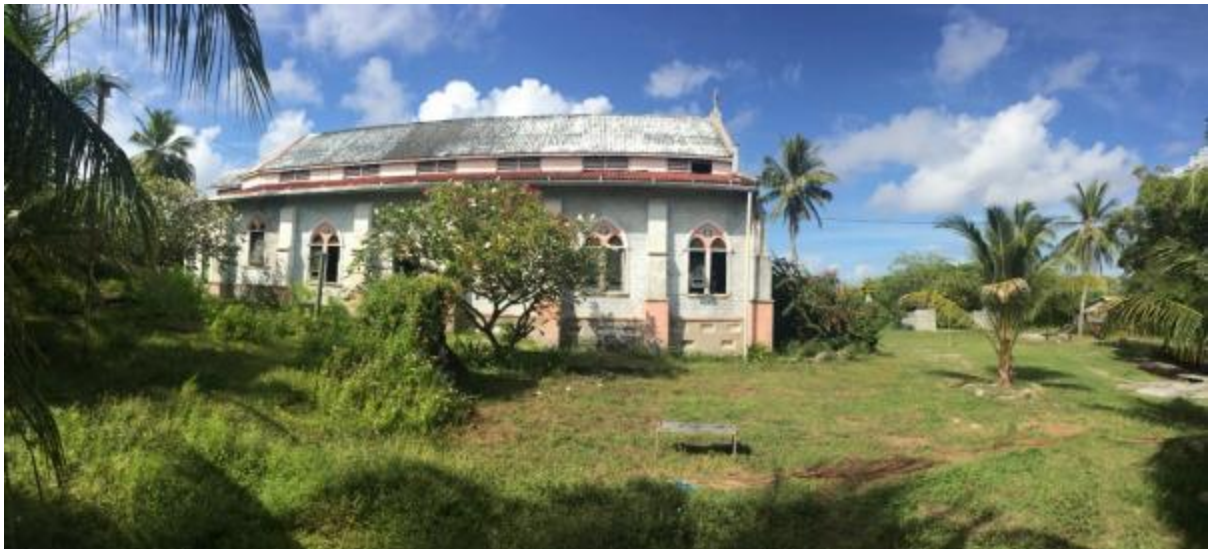
**Photo 12: Catholic Church in Fatima village with ACM Roof**

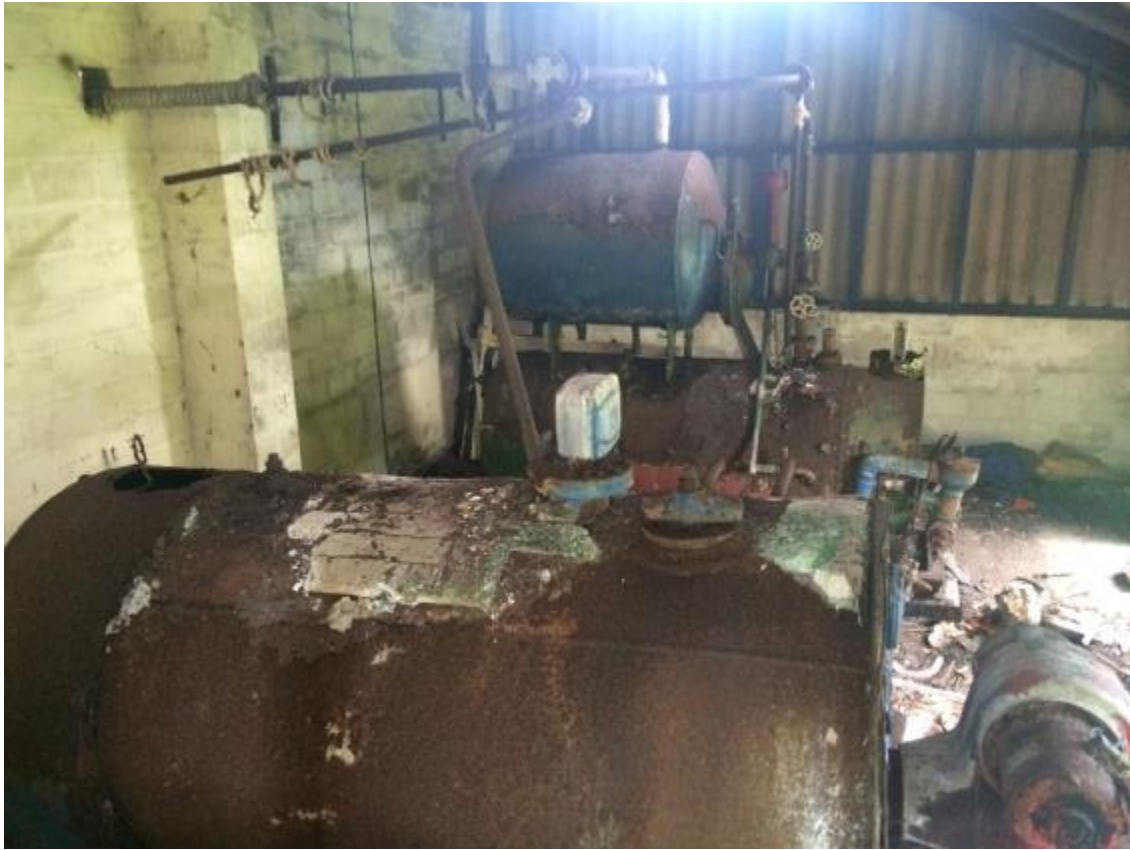
**Photo 13: Residential property 18, boilers with ACM lagging**

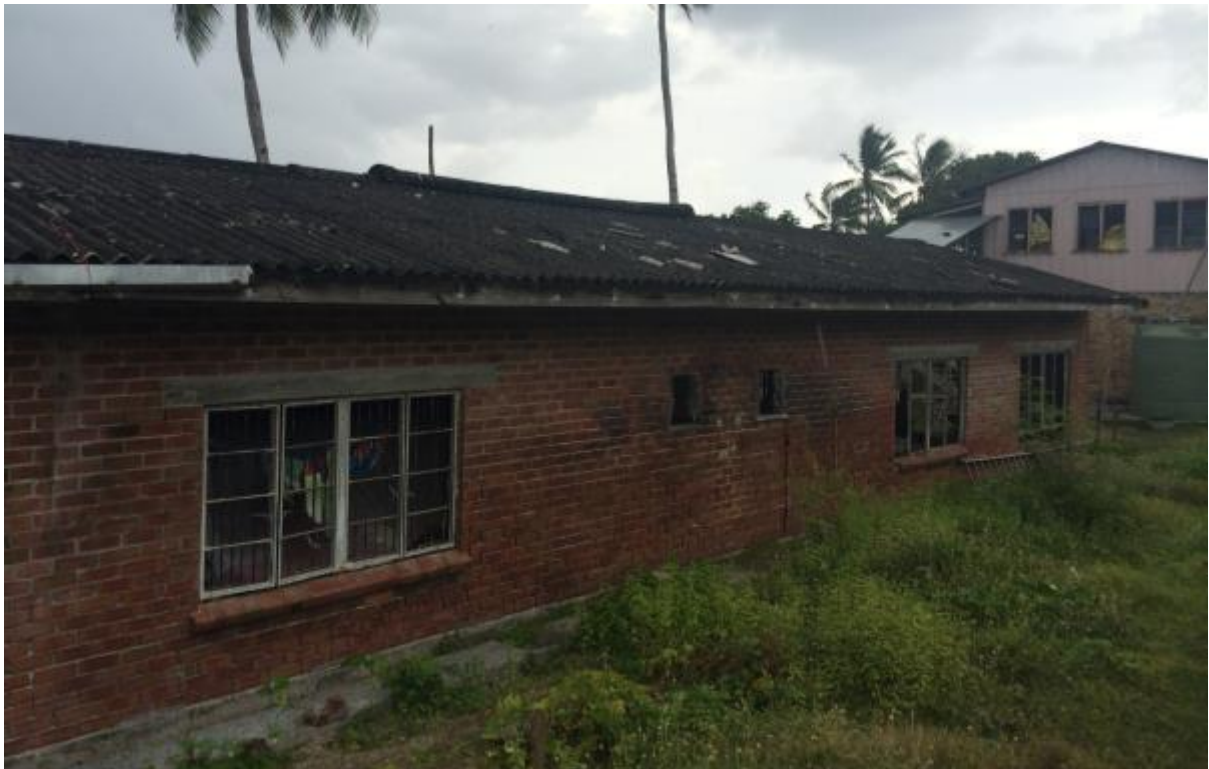
**Photo 14: Banaba school, ACM roof and cladding on brick building.**

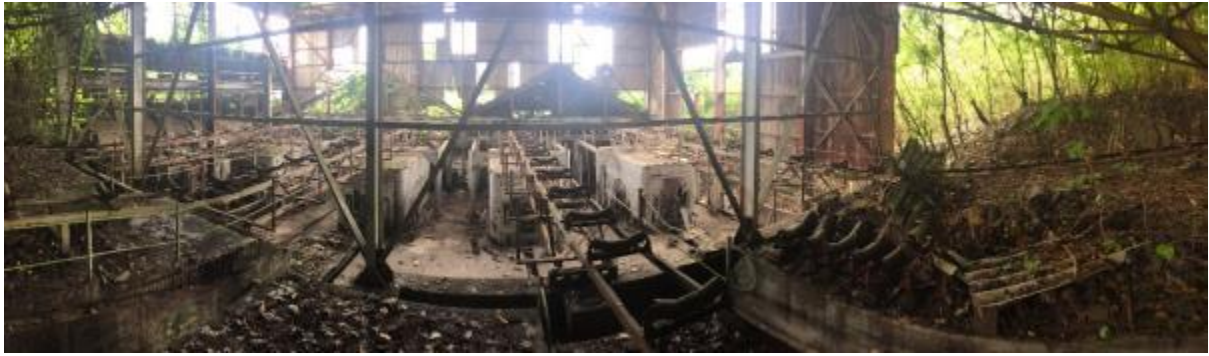
**Photo 15: Former phosphate processing plant. In dis-repair with significant ACM scattered across entire site.**

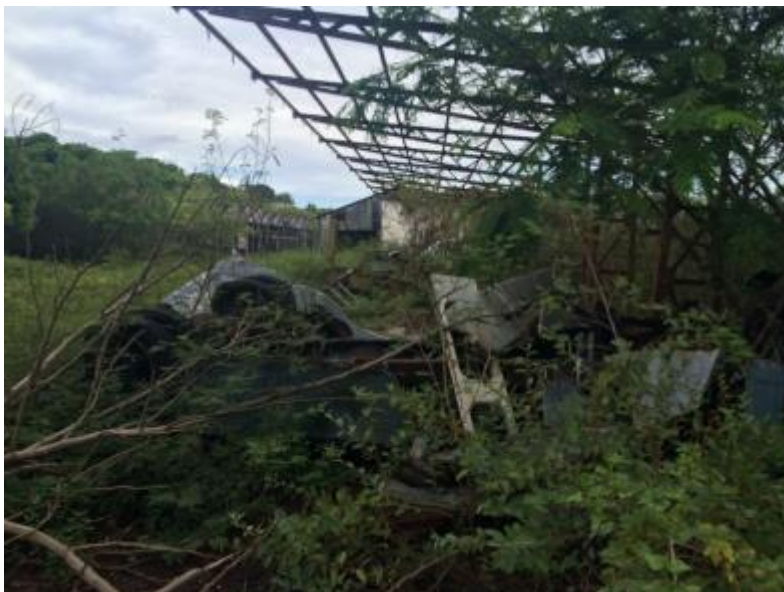
**Photo 17: Former mechanical repair workshop building with no cladding or roof**

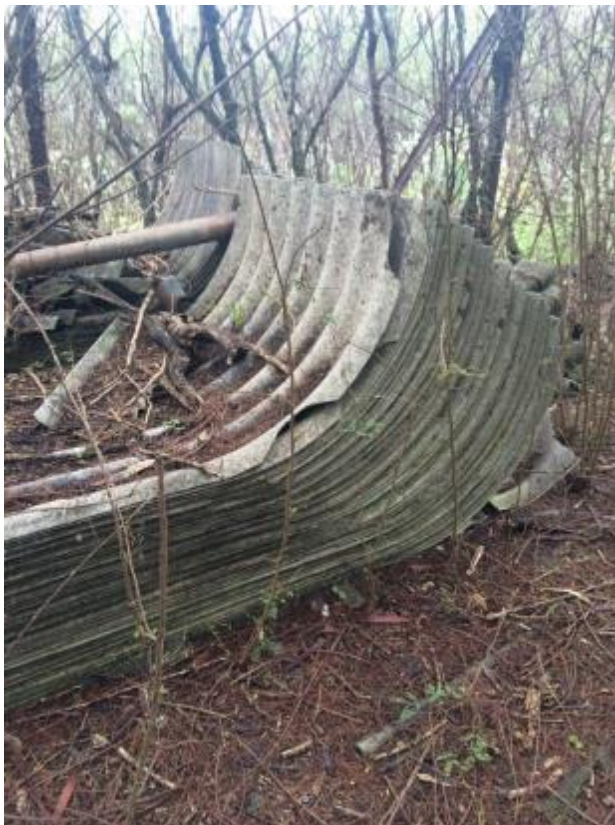
**Photo 19: ACM stockpile behind mechanics to south**

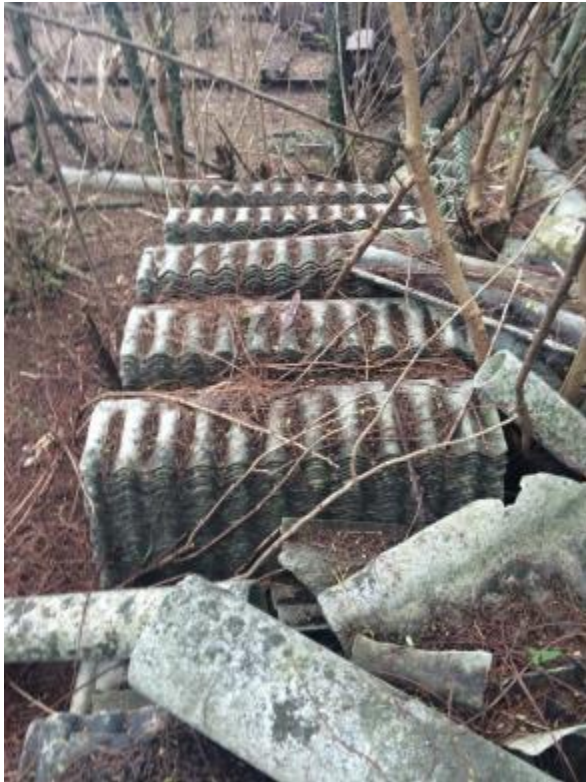
**Photo 20: ACM stockpile behind mechanics to south**

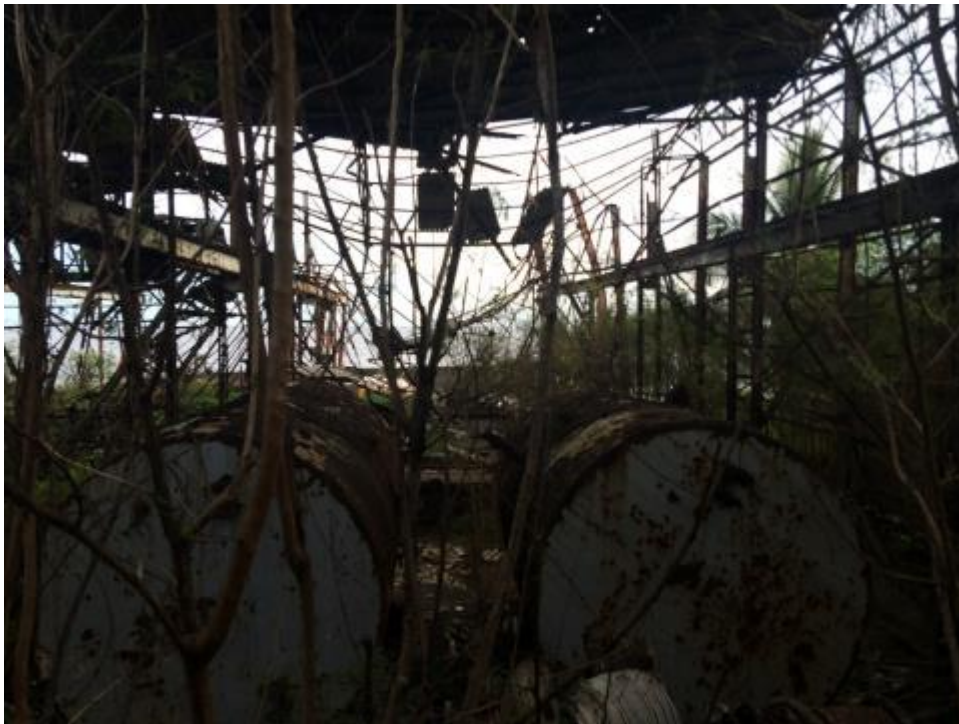
**Photograph 21: Warehouse 7 by wharf – another badly damaged building with ACM scattered across site.**

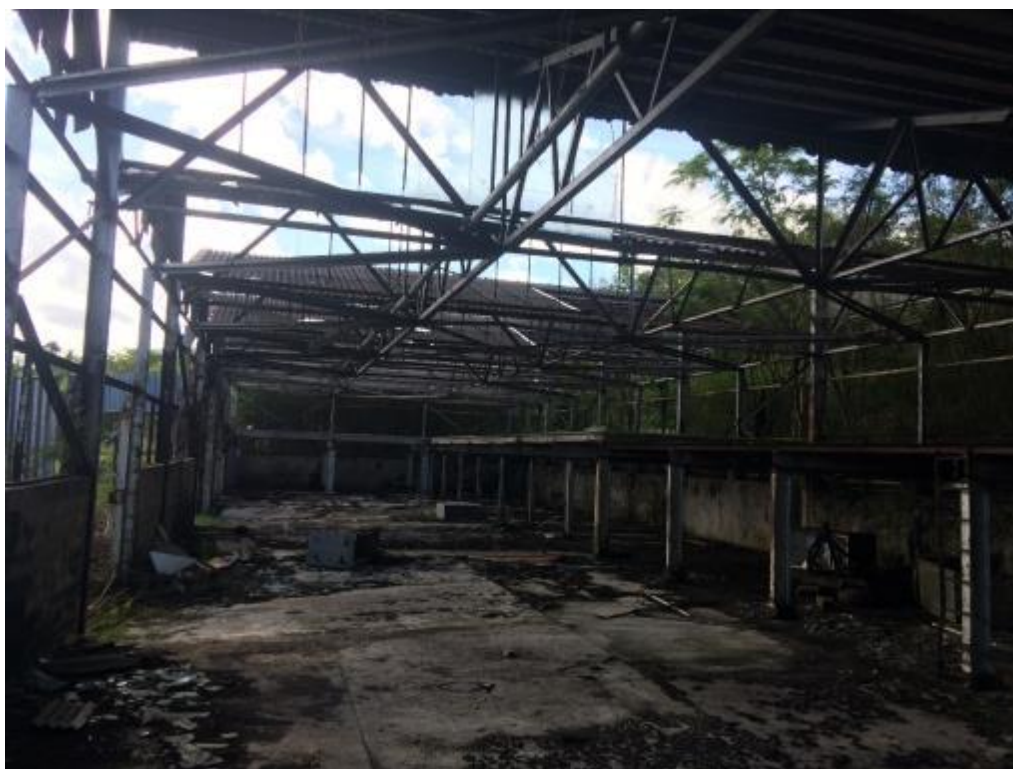
**Photo 22: Warehouse 3 – badly damaged ACM roof and walls.**

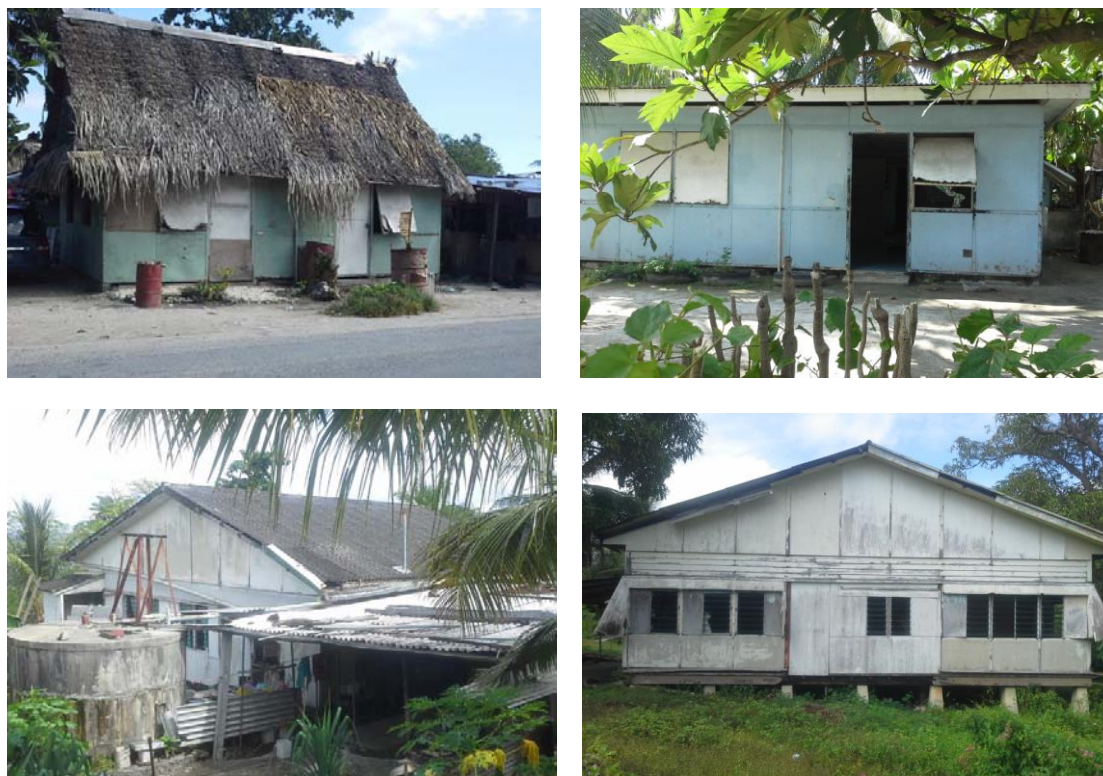
**Photos 23-26: Typical South Tarawa Houses**

fibre cement board. Photos 23-26 below show typical houses in South Tarawa with fibre cement cladding.

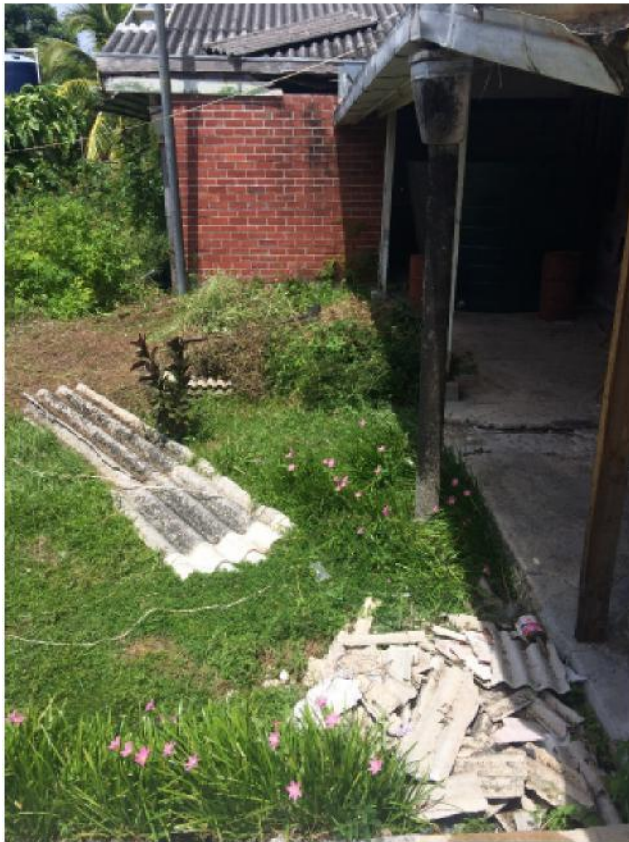
Photograph 1: Banaba Hospital; Damaged acm roof sheets and loose acm

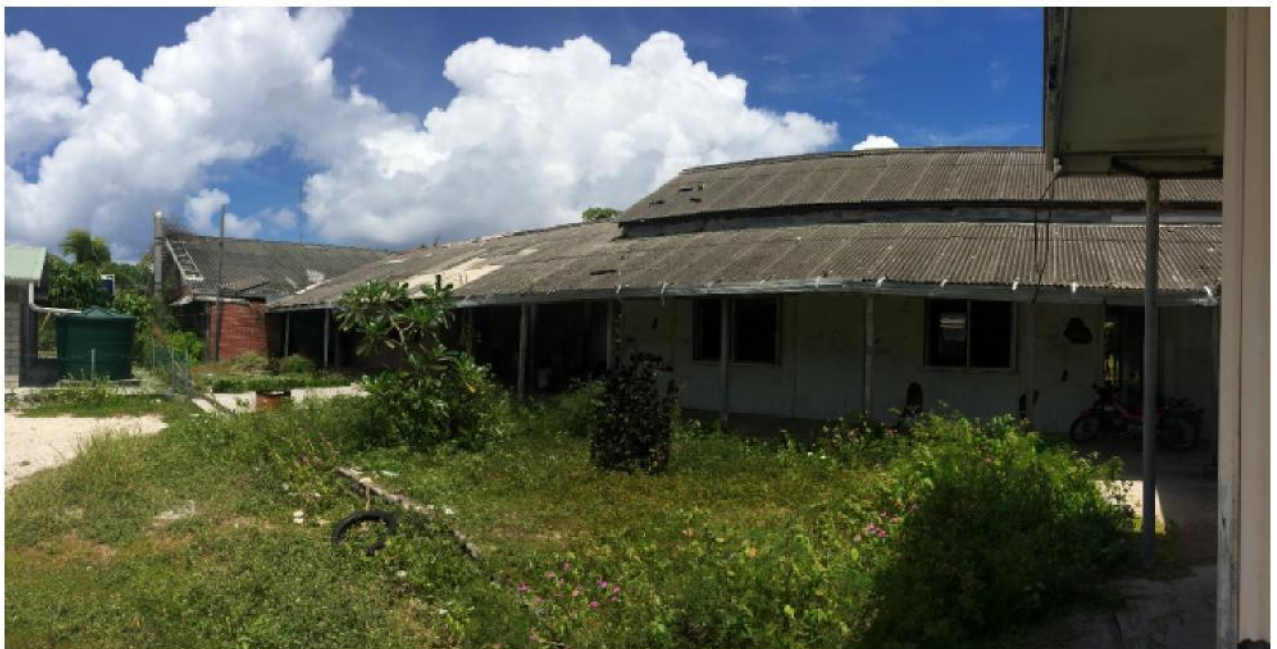
Photograph 2: Banaba Hospital – acm roof.

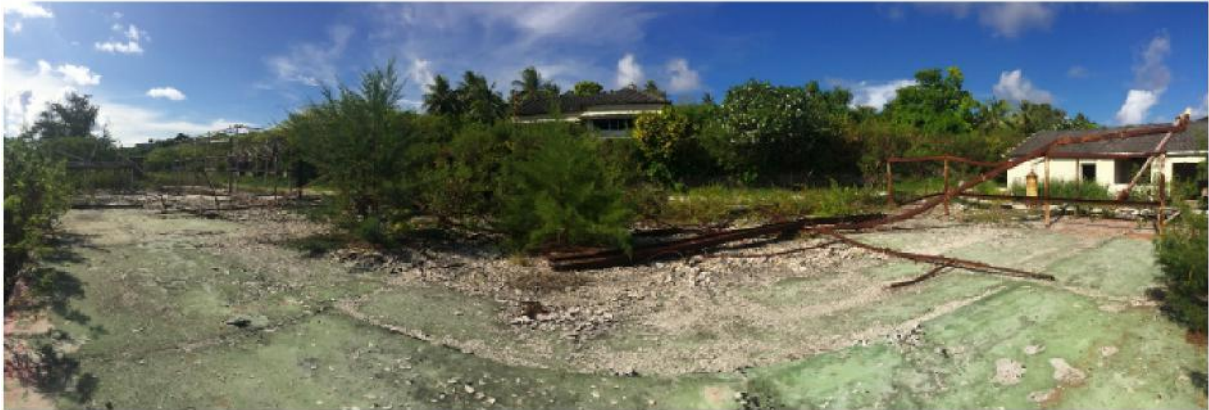
Photograph 3: Warehouse 4; fire damaged structure previously containing pacm. Site covered in acm fragments. Public roadway in background.

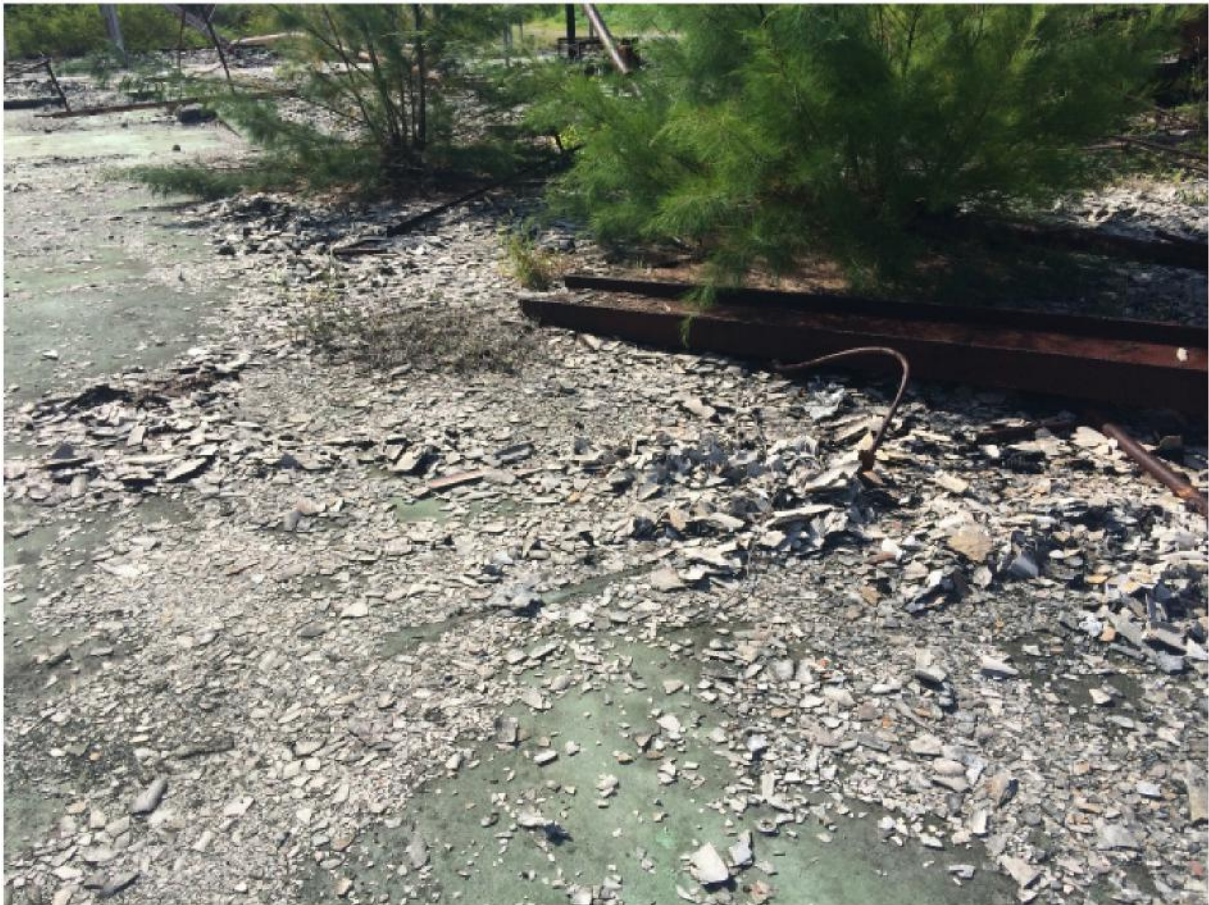
Photograph 4: Warehouse 4; view of pacm debris.

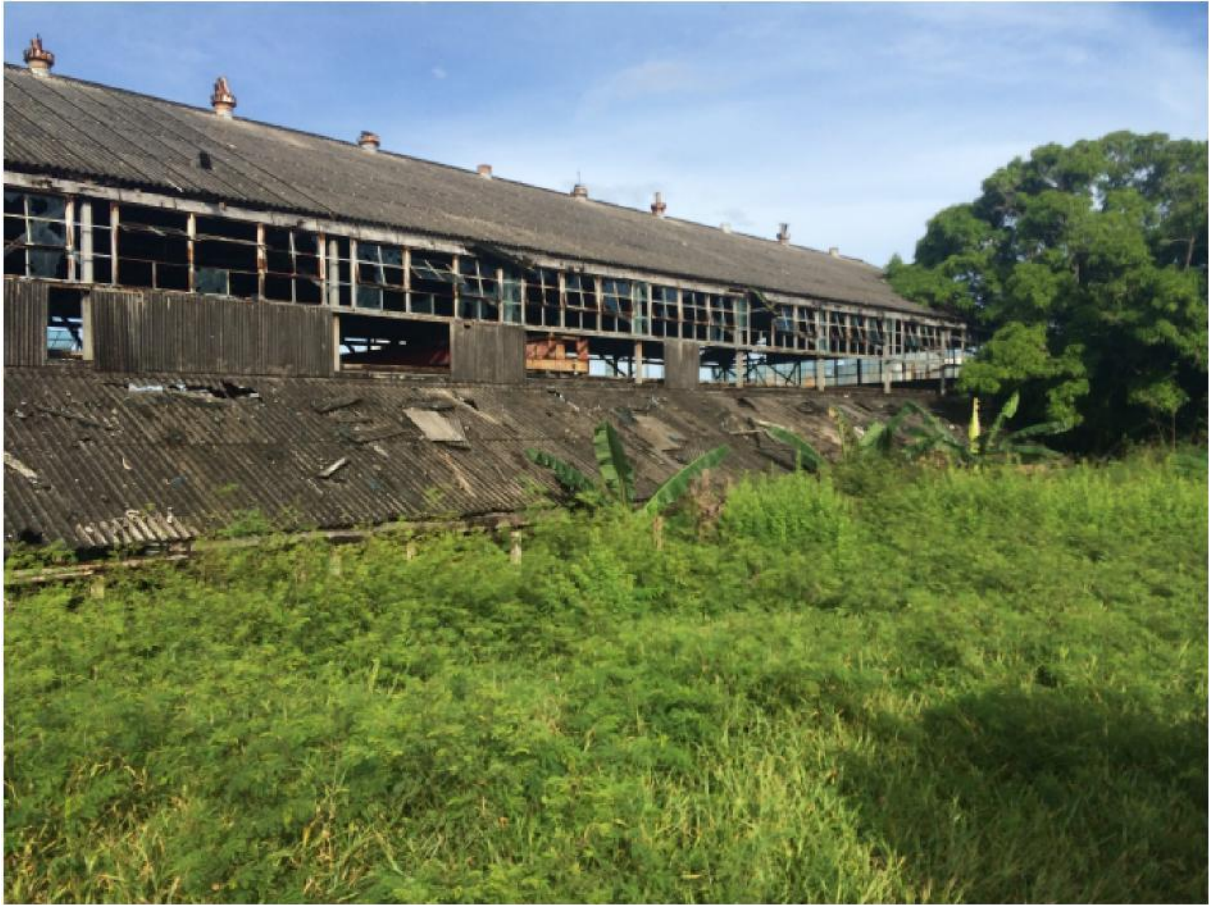
Photograph 5: Banaba former power house. pacm roof.

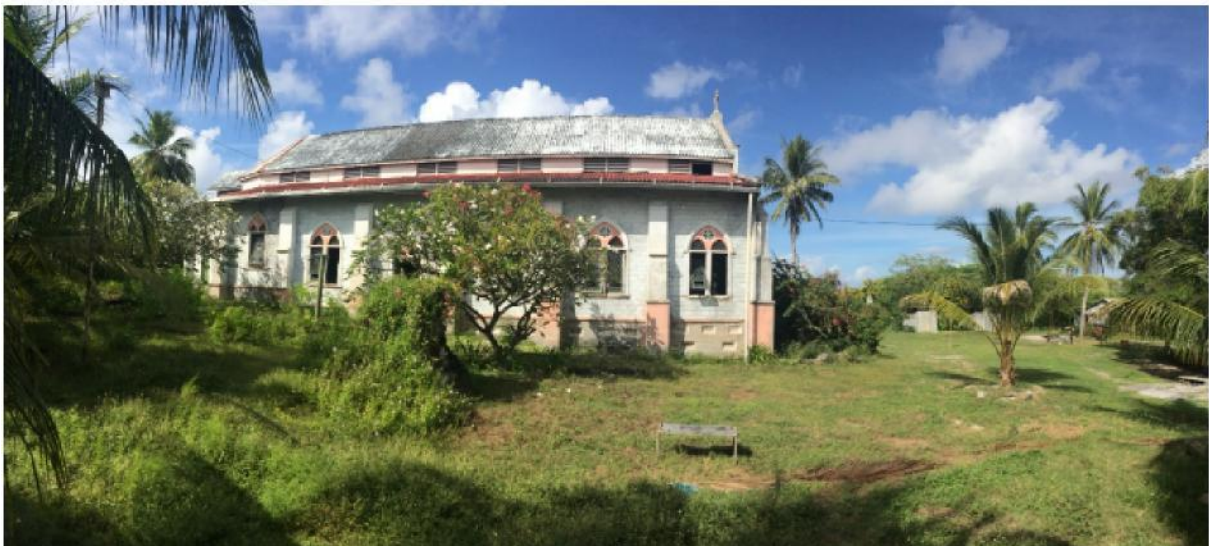
Photograph 6: Catholic Church in Fatima village with pacm roof.

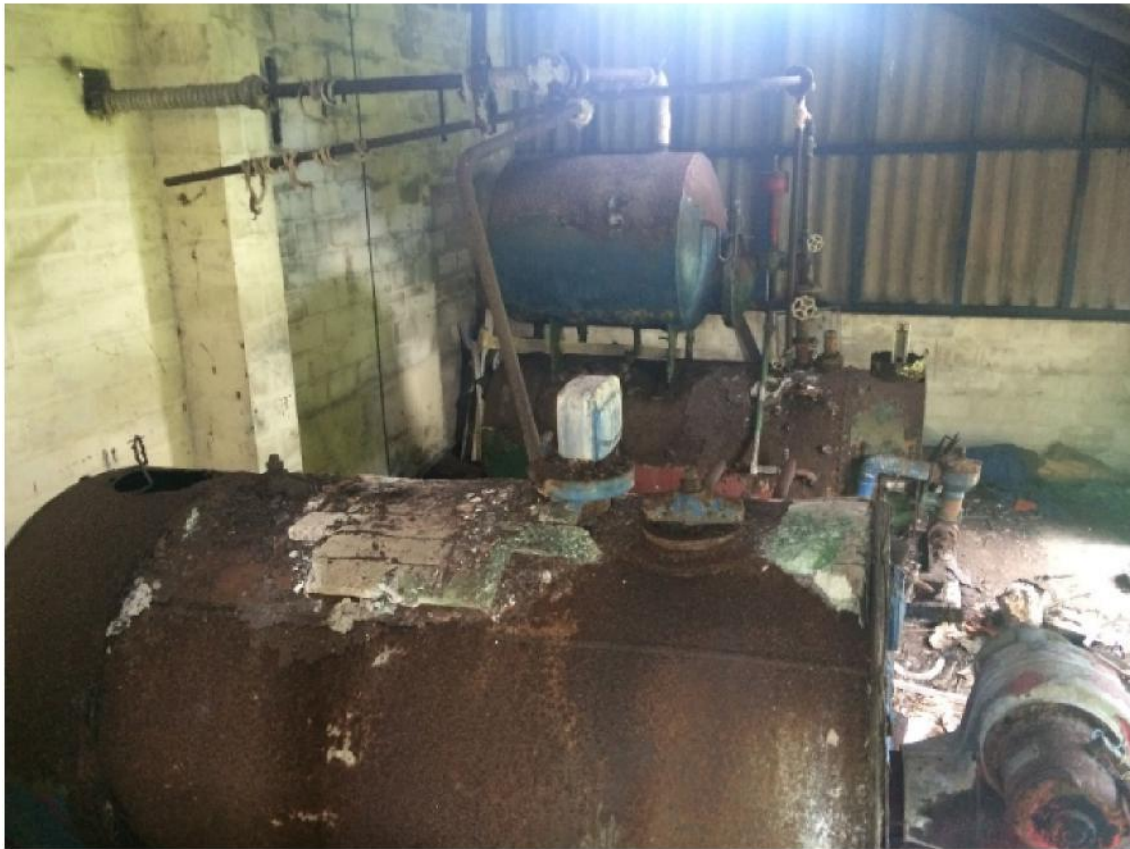
Photograph 7: Residential property 18, boilers with pacm lagging.

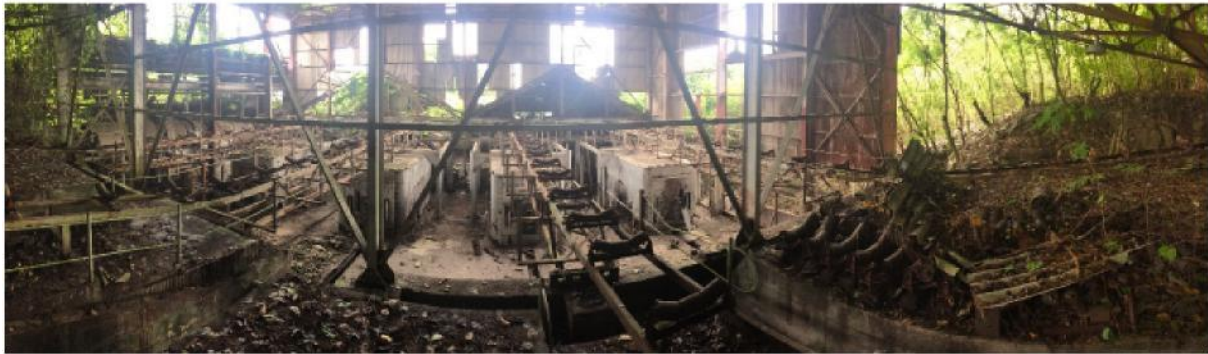
Photograph 9: Former phosphate processing plant. In disrepair with significant pacm scattered across entire site.

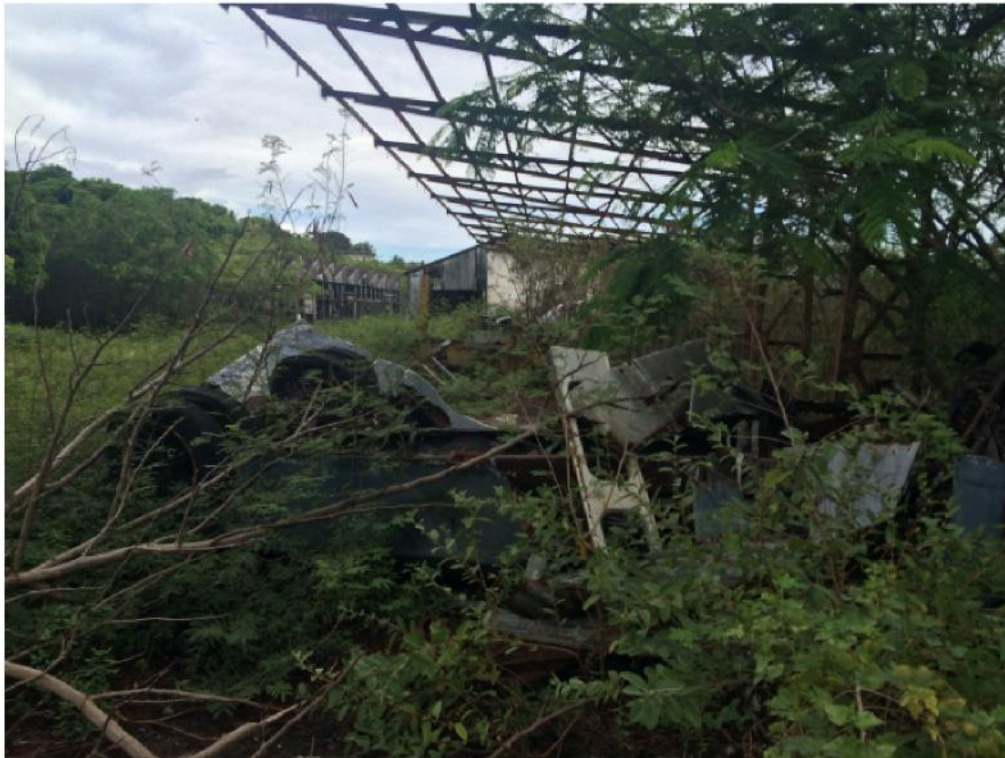
Photograph 11: Former mechanical repair workshop building with no cladding or roof.

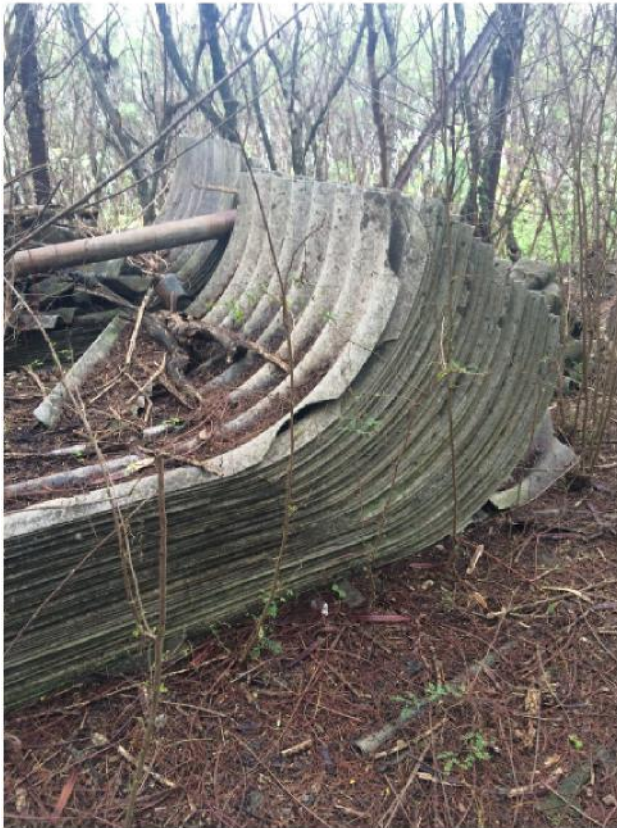
Photograph 13: pacm stockpile behind mechanics to south.

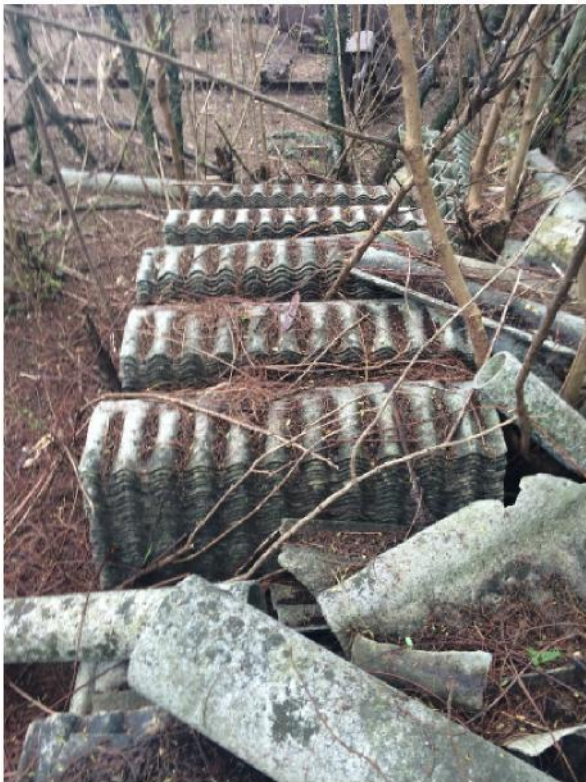
Photograph 14: pacm stockpile behind mechanics to south.

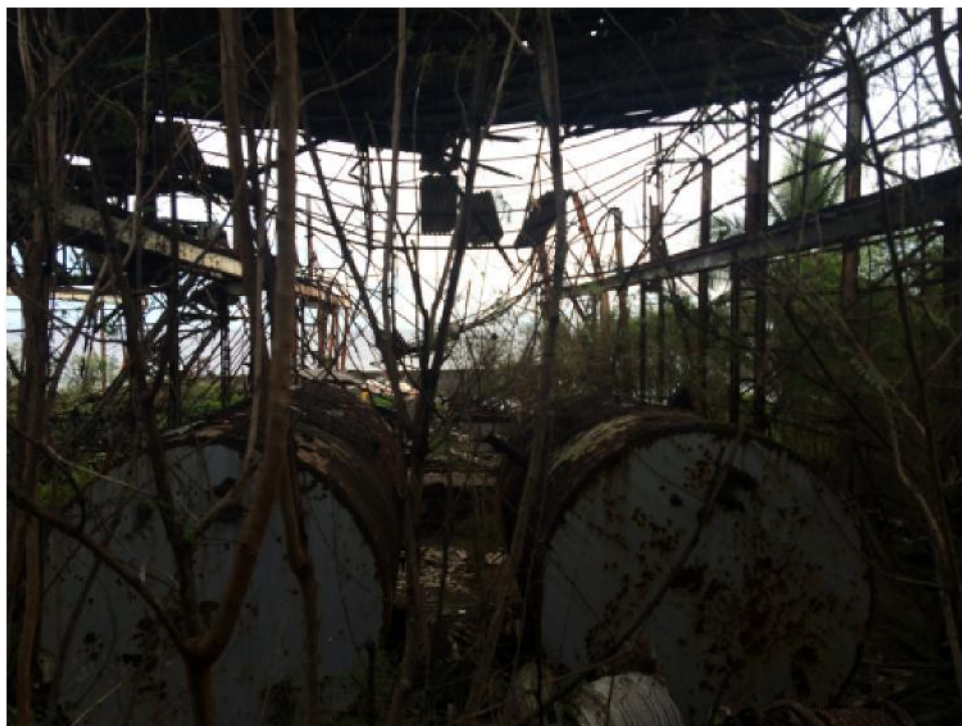
Photograph 15: Warehouse 7 by wharf – another badly damaged building with acm scattered across site.

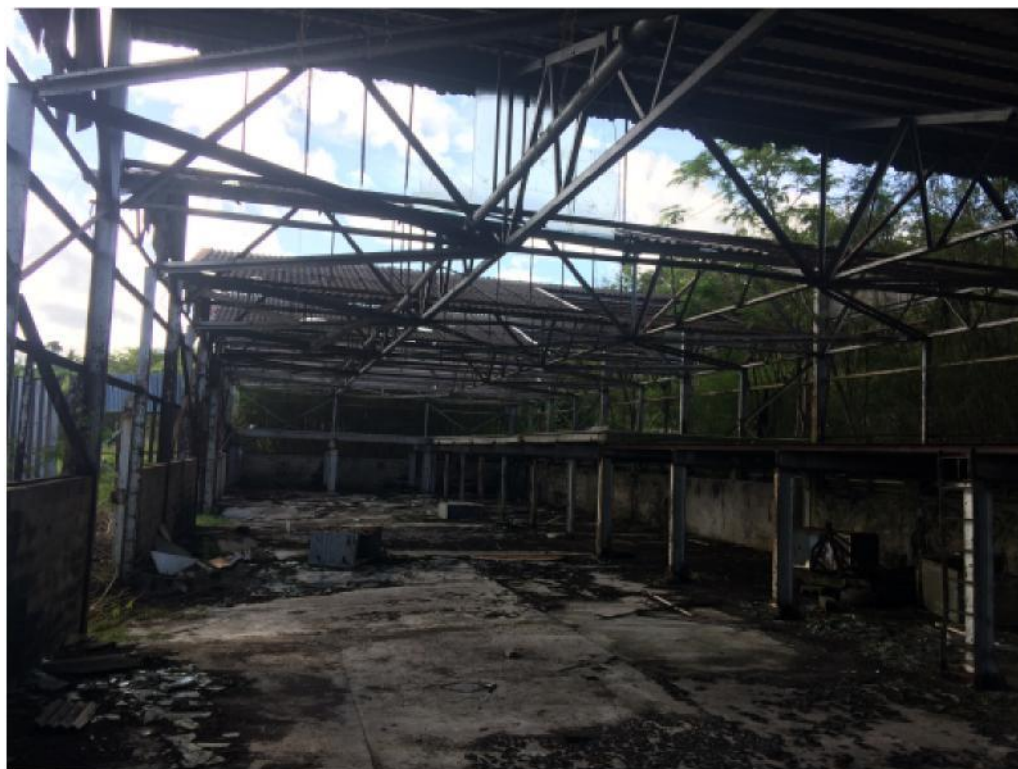
Photograph 16: Warehouse 3 – badly damaged pacm roof and walls.

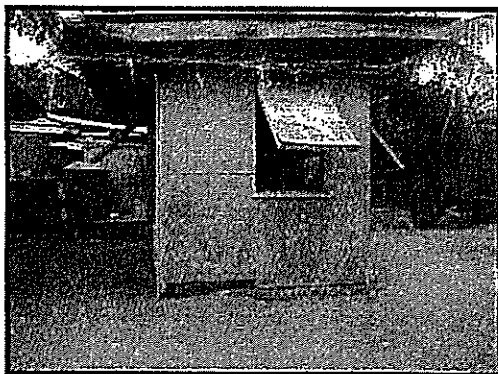
A Grade E House in Betio at St Betero, Temakin that has asbestos contained materials in its exterior wall claddings is shown in Figure 2. The house condition is deteriorating with holes and paintings worn out hence need immediate renovation to avoid asbestos fibres from being exposed to air which then could easily inhaled by occupants. In Figure 3, pieces of exterior wall claddings are depicted to show how asbestos fibres could be easily blown away and inhaled by occupants.

**Figure 2. Grade E – Kitchen with asbestos used in exterior walls as heat and fire retardant**

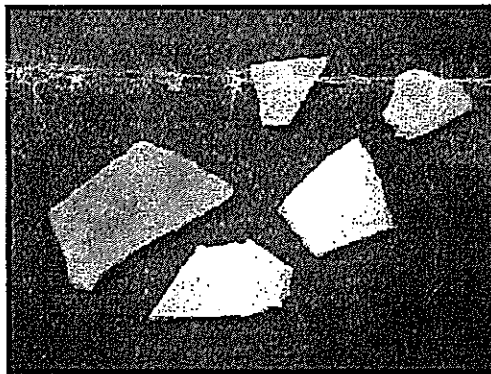
**Figure 3. Fragments of wall claddings contained with asbestos fibres**
