Survey of the Regional Distribution and Status of Asbestos-Contaminated Construction and Waste Material and Best Practice Options for its Management in Pacific Island Countries

Report for the Republic of Vanuatu

**Prepared for the Secretariat of the Pacific Regional
Environment Programme (SPREP)**

May 2015

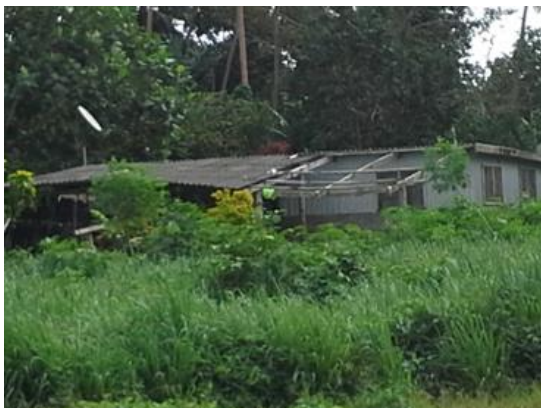
Photo 1 - Pang Pang Residential

Photo 1 below is of a residence in Pang Pang with an asbestos roof. The dwelling owner reported that the roofing material had been resourced from the nearby Forari Mine, which returned a positive sample.

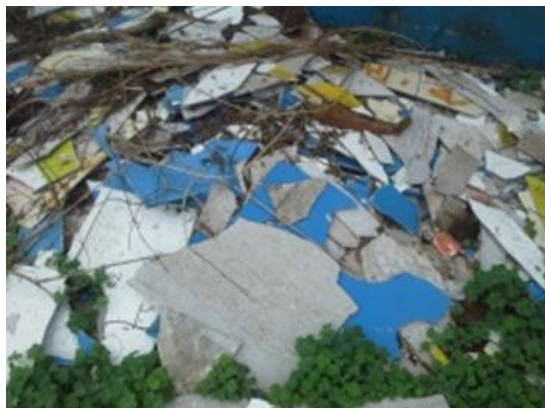
Photo 2 – Residential Demo Site Rue de Wales

Photo 2 below shows a residential demolition site in Rue de Wales where asbestos cement (AC) cladding was lying spread out on the ground. It was located in a residential area with a playground adjacent to the north and Port Vila's main hospital to the east.

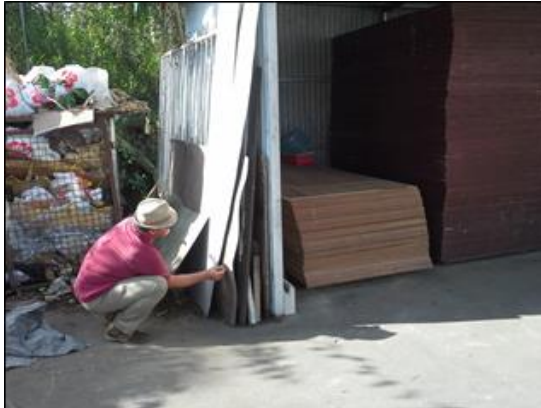
Photo 3 – Hardware Store New Sheeting

Photo 3 below shows an AC sheet at the entrance to a Chinese Hardware Store (MOK 3) in Elluk Rd. The shop manager had previously reported that he sometimes sells asbestos cement sheeting but that he did not have any in stock at the moment. The above panel was then found and sampled.

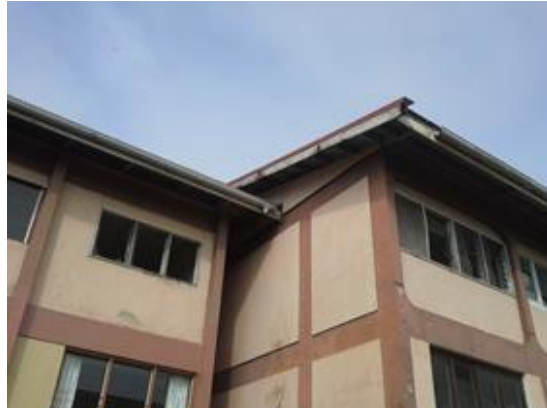
Photo 4 – Ministry of Lands and Nat Resources

Photo 4 shows AC cladding on the Ministry of Land and Natural Resources building at Port Vila. The AC sheeting was confined mostly to the outside gable and soffits, although limited quantities were also used as wall cladding.

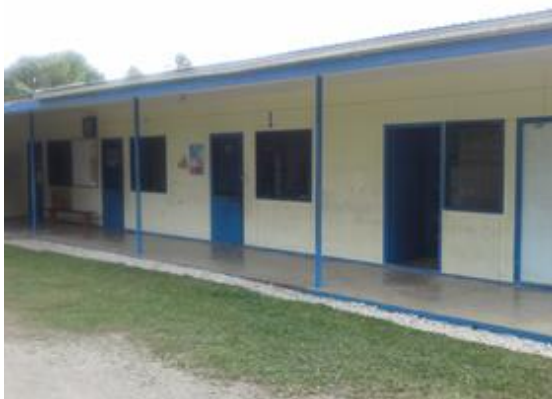
Photo 5 – Paonangisu Health Centre

Photo 5 below shows AC cladding on the Paonangisu Health Centre. The sample was collected at the reception area but ACM has presumably been used on all the five structures present at the site.

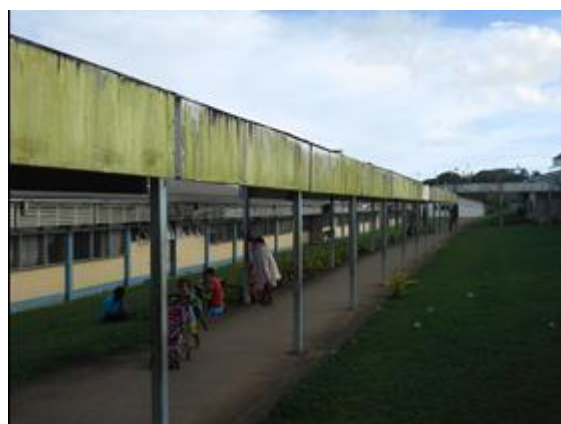
Photo 6 – Port Vila Central Hospital

Photos 6, 7 and 8 were all taken at the Port Vila Central Hospital. Photo 6 shows the covered walkways connecting the building. Photo 7 shows an example of the vinyl floor. Only one of the three sampled floors returned a positive result and this sample was collected from the theatre corridor. Photo 8 shows the services and heating pipes running the length of the covered walkways connecting the buildings. Some of these pipes are lagged with asbestos lagging, as confirmed by visual inspection.

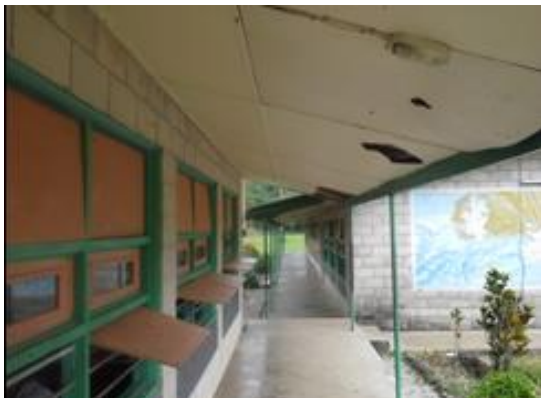
Photo 9 – Presbyterian College

Photo 9 shows the soffit material surrounding most of the classrooms at the Presbyterian College. Photos 10 and 11 are from the Malapoa College. Photo 10 shows AC cladding material which is applied to walls throughout the whole college. Photo 11 shows the roof with bitumen coating, which has been applied to roofs on all four buildings. Photo 12 has been taken at the abandoned manganese mine in Forari, and there is AC cladding and roofing on four remaining structures. The site is abandoned and in a rural area.

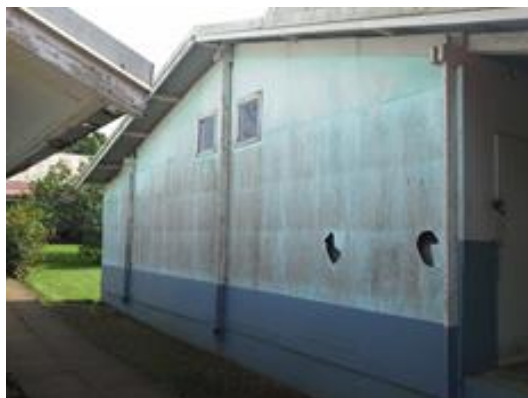
Photo 10 - Malapoa College

S6	Malapoa College	Cladding	Mixed - some badly damaged	500	10% Chrysotile and 10% Amosite
S7	Malapoa College	Cladding	Mixed - some badly damaged	500	15% Chrysotile and 5% Amosite
S8	Malapoa College	Bitumen Roof	Damaged	600	60% Chrysotile

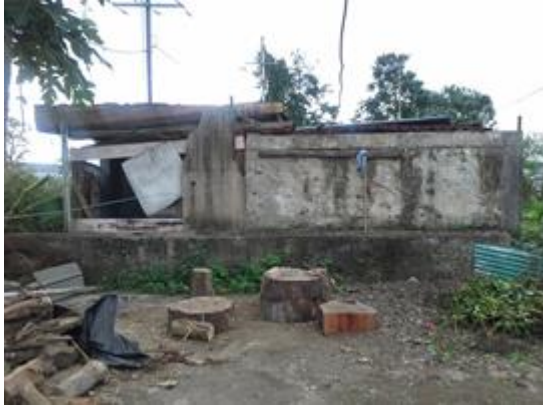
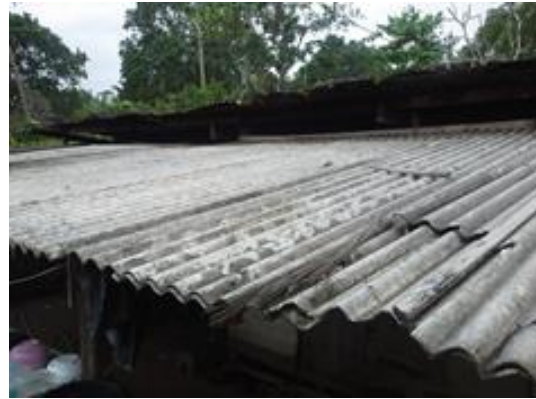
Photos 13 and 14 – Residence in Luganville

Photos 13 -16 were all taken in Luganville. Photo 13 shows AC cladding on a residence and Photo 14 shows the asbestos roofing on the same dwelling. The house was made of concrete, except for the

roof and several sheets. The owner reported that he sourced these asbestos materials from other WWII structures in the neighbourhood. He stated that he had also built a shelter out of these materials. It was unclear where this shelter was located. A family member pointed out that most of the houses in the surrounding area (approximately 100 dwellings) originally had similar roofing but that most of them had been replaced over the years. He was not sure where the asbestos had been deposited. Approximately 25 structures in the immediate surrounding area were inspected but no other PACMs were encountered.
