Regional Distribution and Status of Asbestos-Contaminated Construction Materials and Best Practice Options for its Management in Pacific Island Countries

Status Report

**Prepared for the Secretariat of the Pacific Regional
Environment Programme (SPREP)**

June 2018

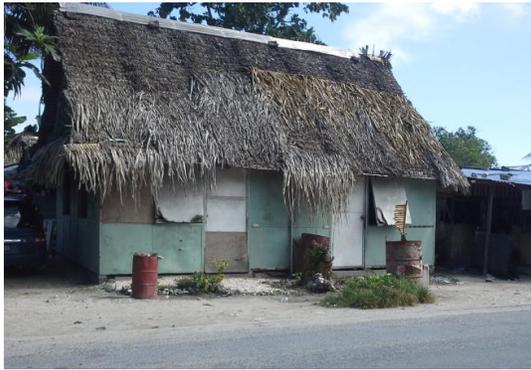
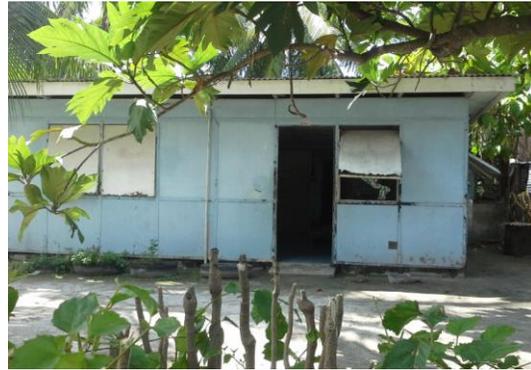
Kiribati Houses with Asbestos Cladding

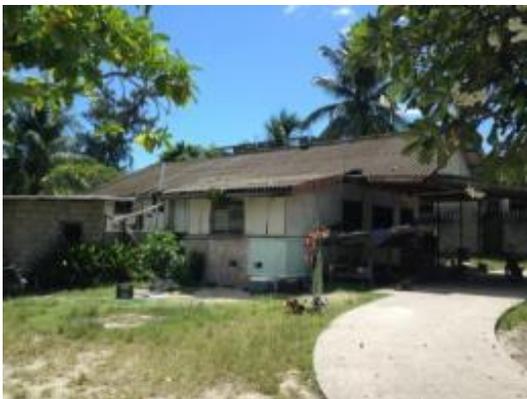
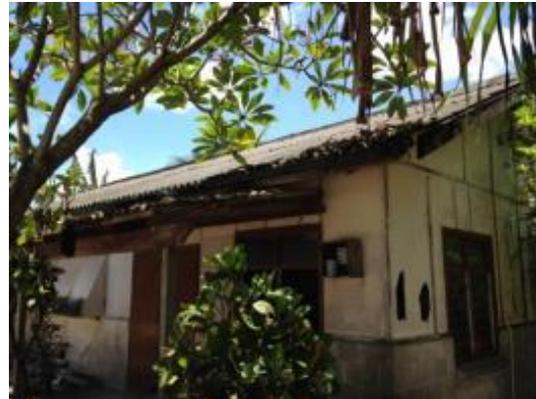
Nauru Houses with Asbestos

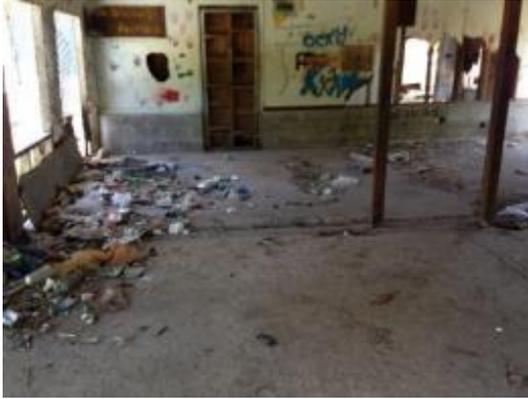
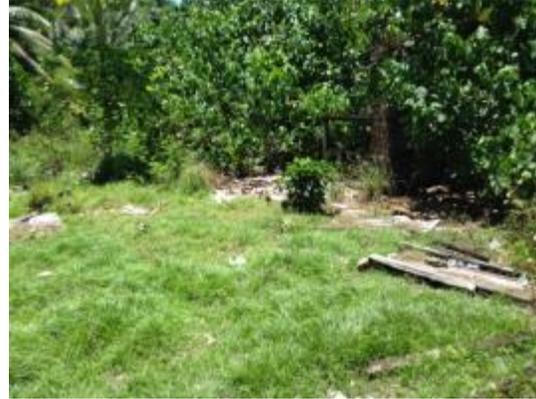
The photos below show an abandoned house littered with asbestos debris and a grassed area with asbestos debris. This abandoned house and grassed area was close to other houses and children were noted playing in the asbestos debris. Such asbestos litter and debris is quite common around houses on Nauru.

Nauru Houses with Asbestos Debris

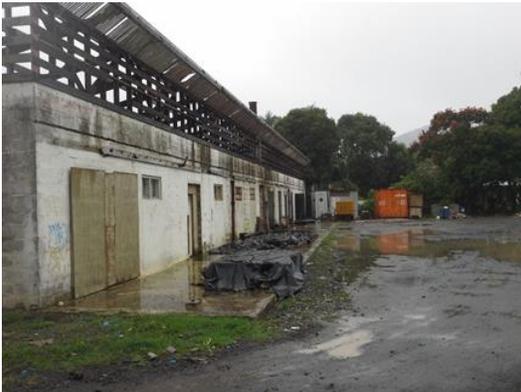
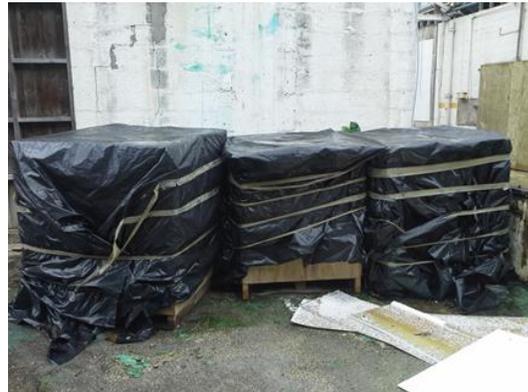
Disposal is an issue in the Cook Islands as the current landfill on Rarotonga is unsuitable for receiving asbestos. Asbestos waste materials are currently being stored awaiting export see two photos below.

Rarotonga Government Collection Point for ACM

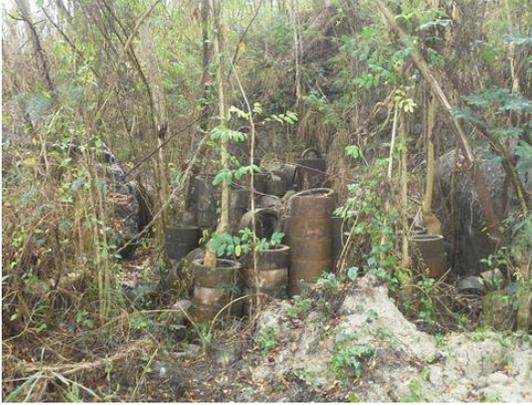
Pipes – WAF Labasa

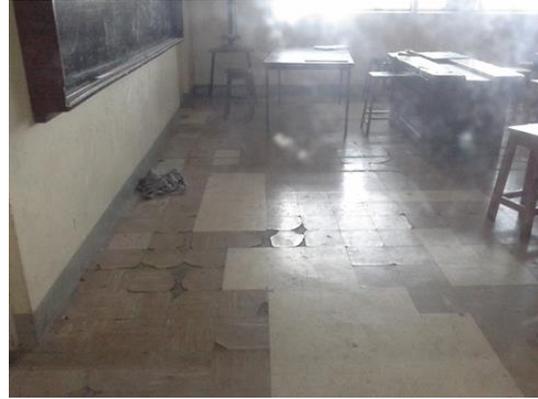
Suva Grammar School Vinyl Floor

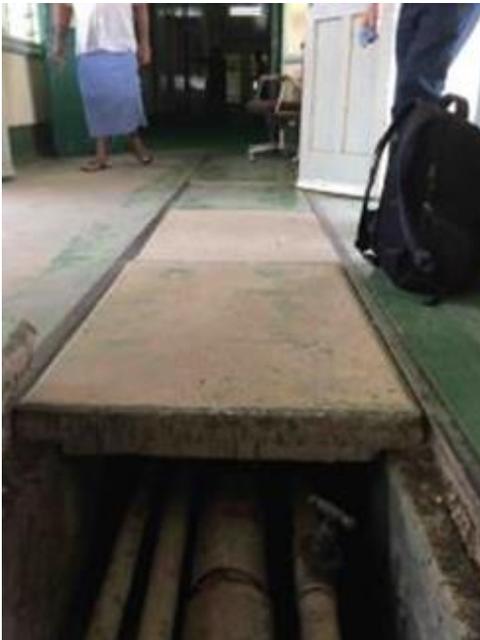
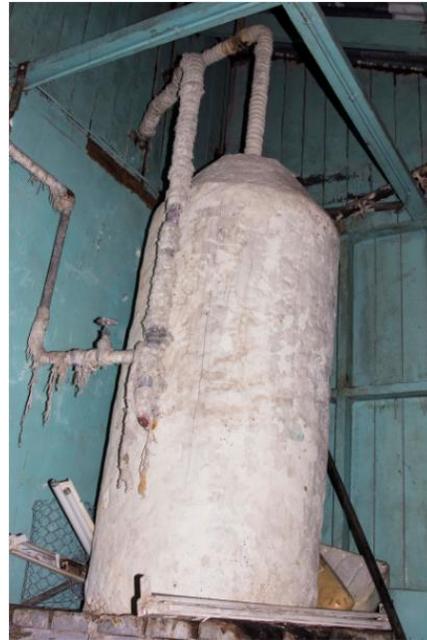
Tamavua-Twomey Hospital Lagging on Pipes and Hospital Boiler

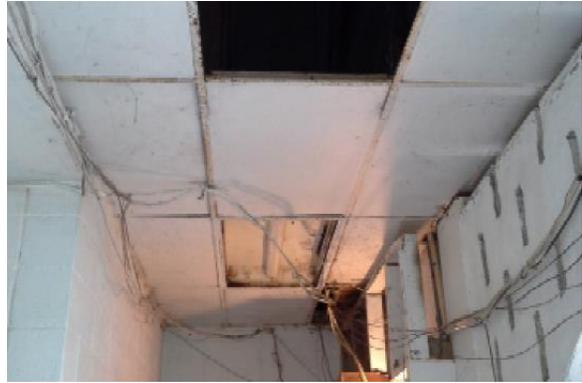
Chuuk – State Court Ceiling

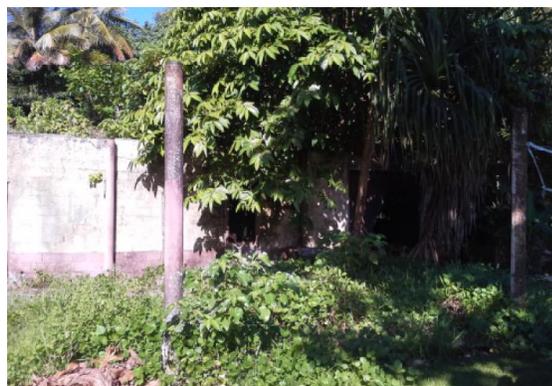
Kosrae – Old Hospital Columns

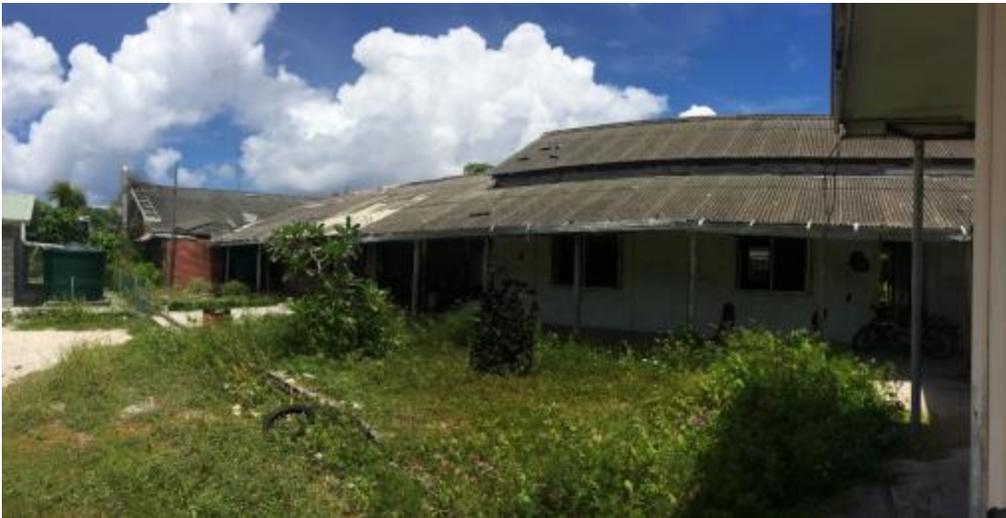
Banaba Hospital – ACM Roof

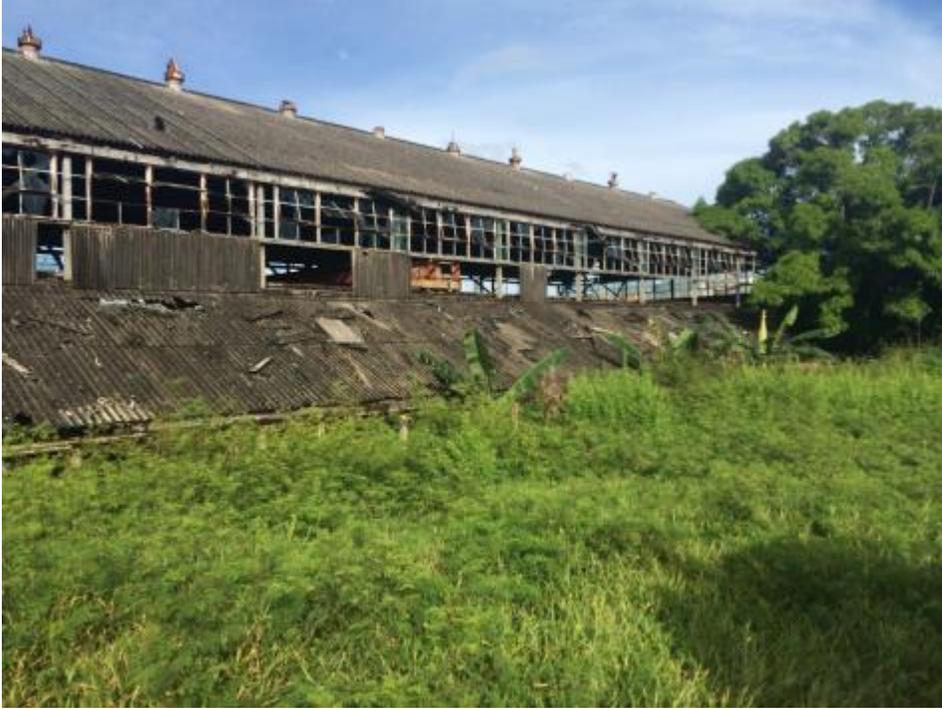
Banaba former power house

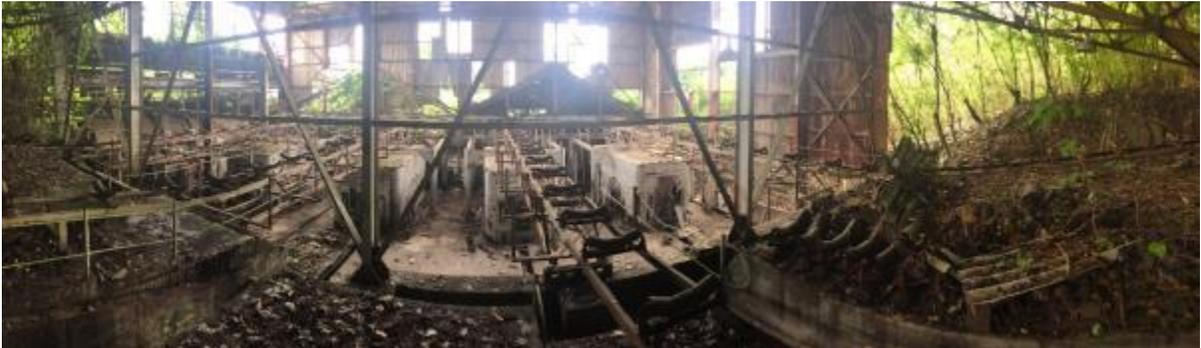
Banaba former phosphate processing plant. In disrepair with significant ACM scattered across entire site.

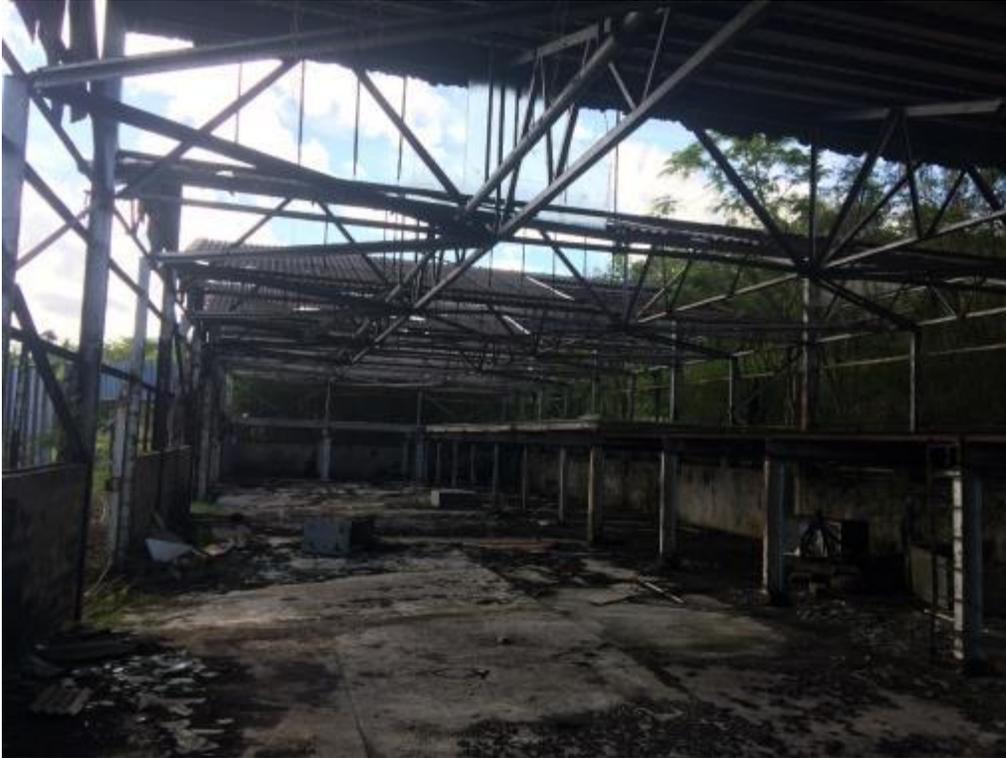
Banaba Warehouse 3 – badly damaged ACM roof and walls.

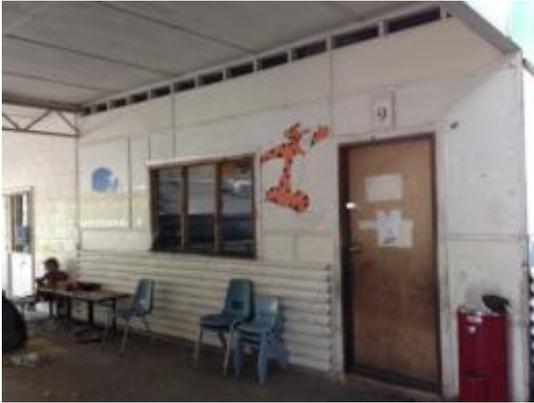
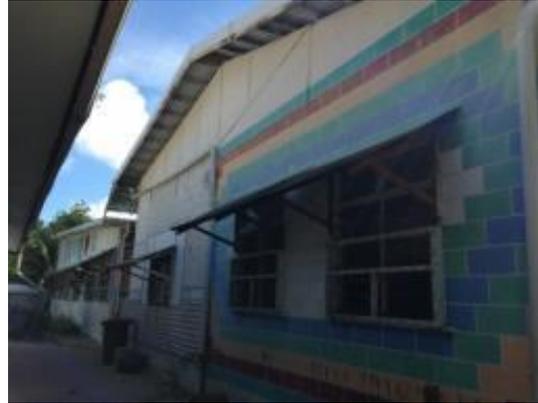
In the cases of the three infant schools shown below, only the cladding (and not all the cladding) has been confirmed as asbestos). The vinyl floors were checked at the Anetan and Nibok Schools and found to be negative for asbestos.

Boe Infant School Asbestos Cladding

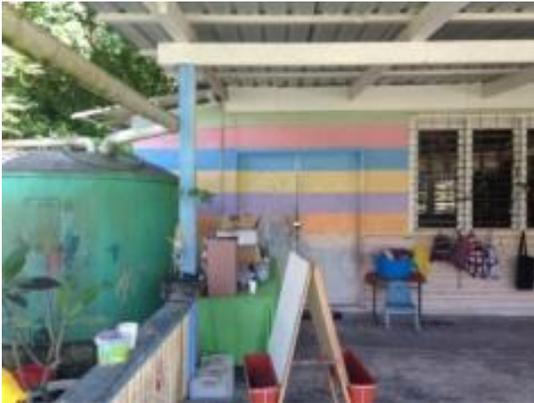
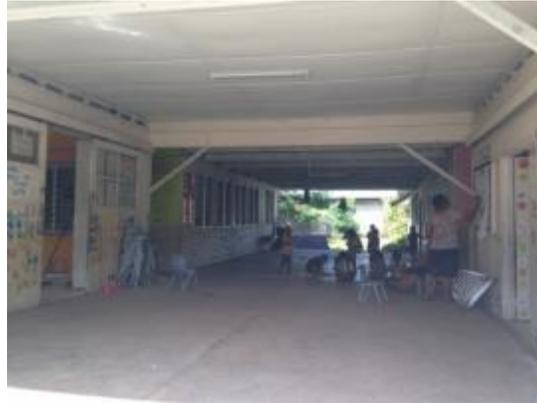
Nibok Infant School Asbestos Cladding and Suspected Ceiling

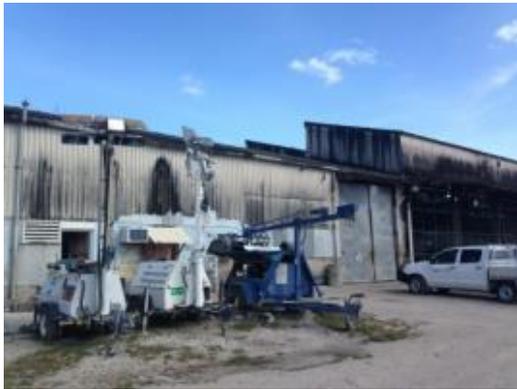
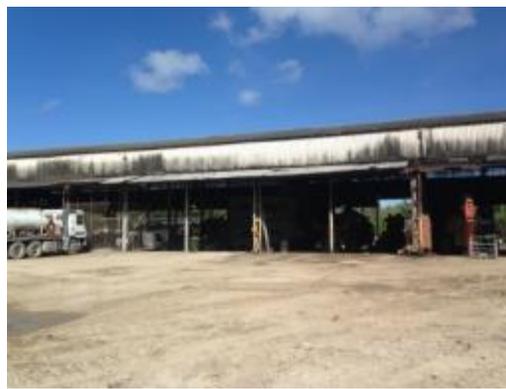
The NRC workshops and maintenance area is up on Topside and all the buildings are clustered together in one area. Most of them have asbestos cladding, much of which is deteriorating. Photos 32-39 below show the main buildings:

Buildings in NRC Workshop Area with Asbestos Roofing and Cladding

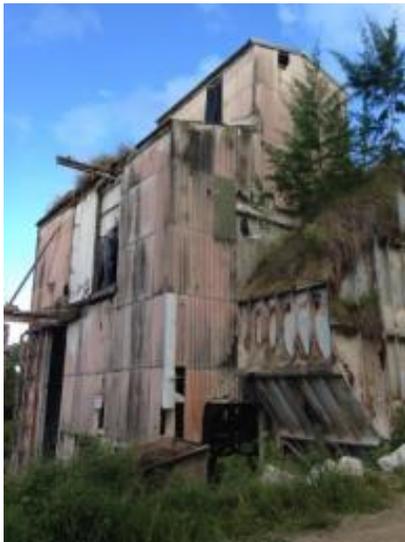
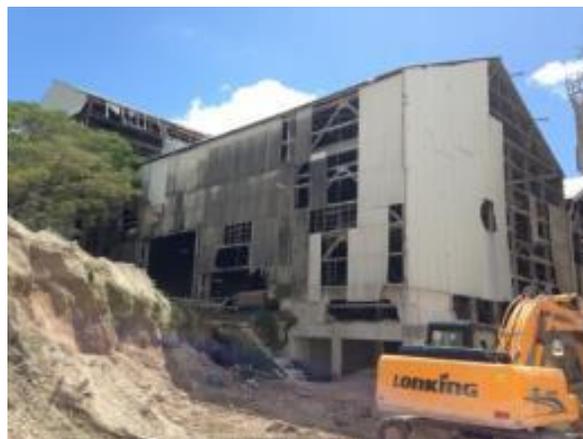
The photos below show some of the various components of the phosphate processing plant, which is still partly operational although some sections are not used now and are falling into disrepair. The first photo shows the conveyor from the processing area to the storage area.

The Old RonPHOS Processing Area

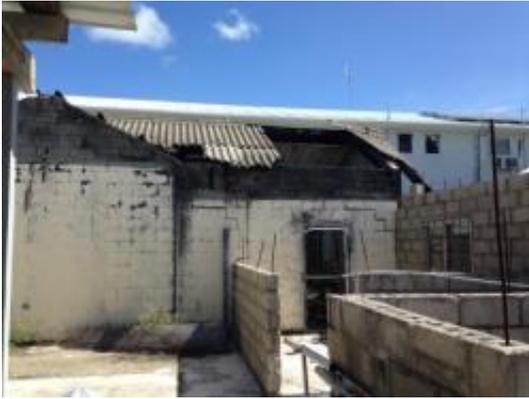
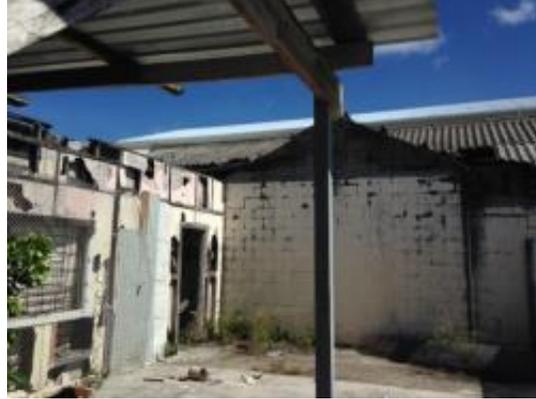
There was a fire in the combined Prison and Police Station in 2007. The Police Station was relocated but the prison remained on the same location. Some of the burnt-out buildings are still in place together with some of the old debris. They have damaged asbestos roofing and cladding – see Photos below.

Prison Asbestos in Burnt Area including Asbestos Debris

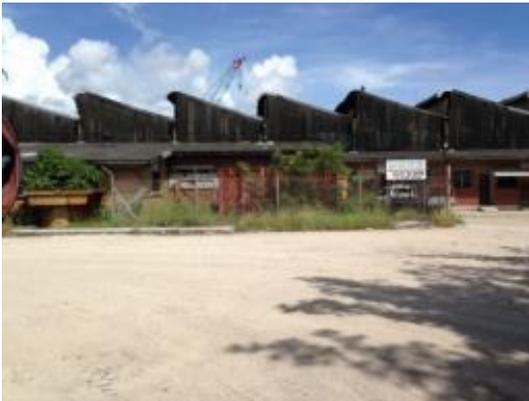
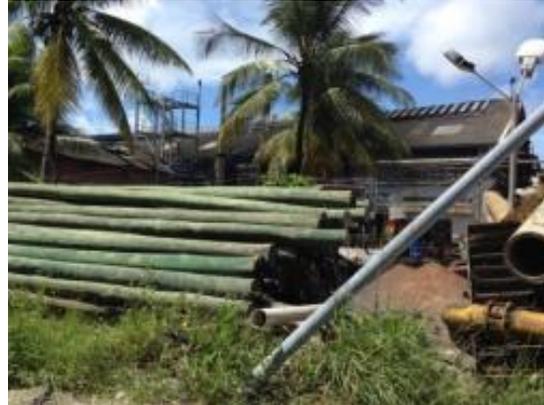
The Power Station has asbestos roofing and cladding in several locations – see Photos 79-80 below. It was the subject of a separate GHD investigation in 2007.

Power Station Asbestos Roofing and Cladding

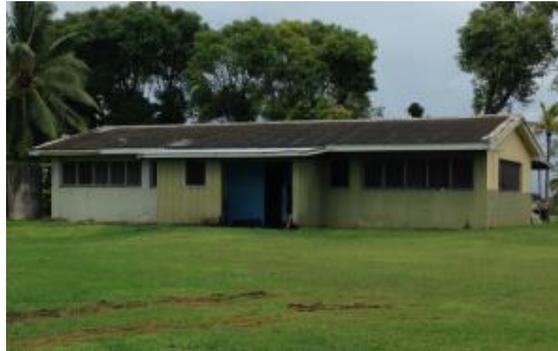
Honey Processing Building Roof

It should be noted that a wipe sample taken in the Honey Processing Building on the second visit produced a moderately high result for chrysotile of 71,000 Str/cm².

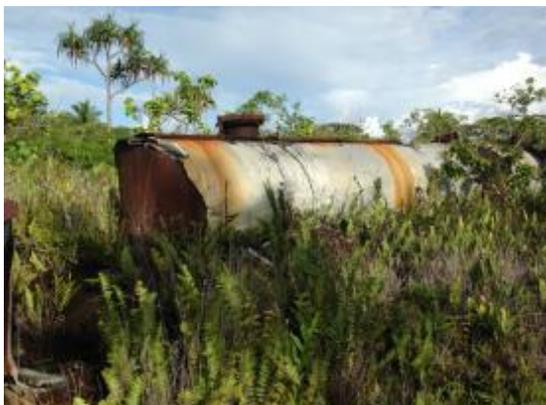
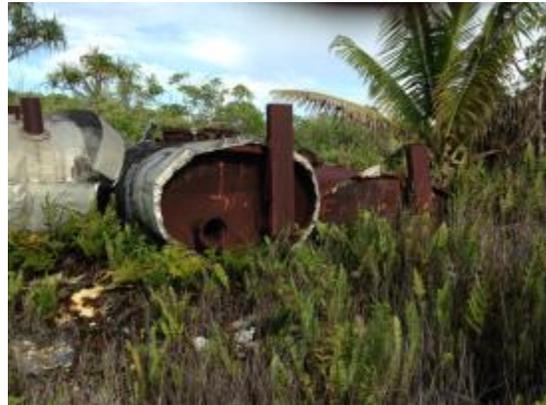
Reservoir Bitumen Tank A

Three Reservoir Bitumen Tanks

This building needs to have the asbestos removed and the structure needs to be cleaned. It is an old high building and some significant safety issues need to be addressed, regarding the removal of the asbestos.

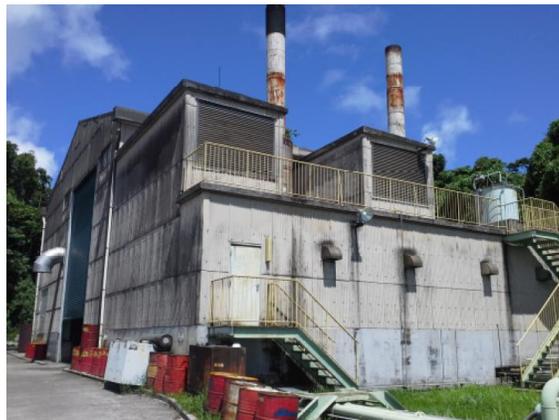
The generator building at the rear of the power station contains exterior corrugated roofing and cladding that tested positive for asbestos. This was a relatively new building and was about 15 years old. The total area of asbestos material is about 2000m². The building is shown in the Photo below and is in reasonable condition.

Malakal Power Station New Generator Building

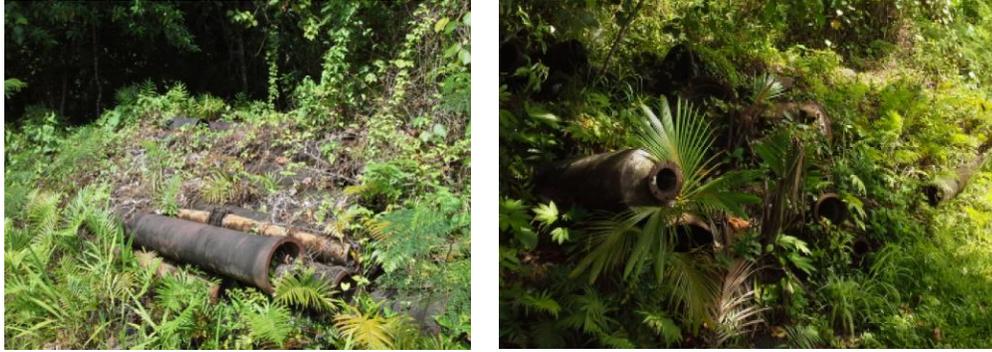
Quite a large number of old asbestos water pipes are stored at the water treatment plant as shown in the photo below. It is difficult to estimate how many as they are covered by vegetation. They appear to be in reasonable condition although some may be broken, in which case a site clean-up will be needed.

Old Asbestos Pipes at Palau Water Treatment Plant

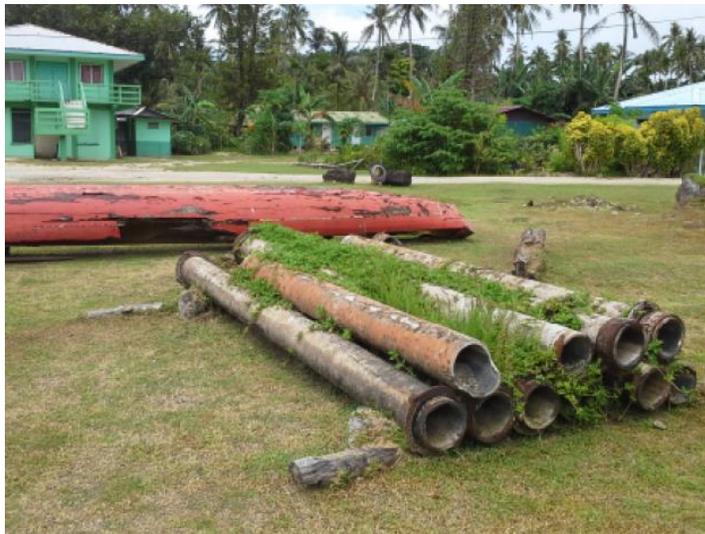
Several asbestos-cement pipes were discovered in roadside locations. They are damaged and in poor condition.

Old Pipes in Reserve in Ngiwai Village

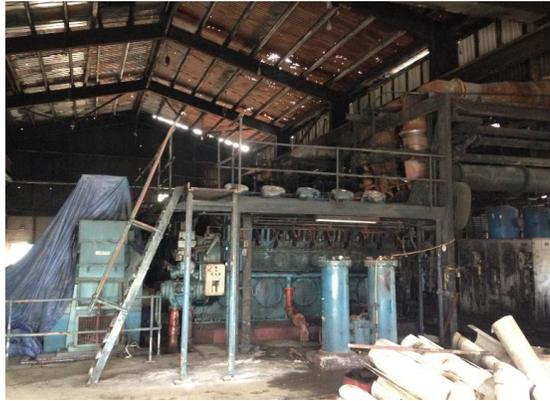
negative except for the gasket sample. The photo below shows the old burnt-out power plant.

Ameliik Old Burnt-out Power Plant

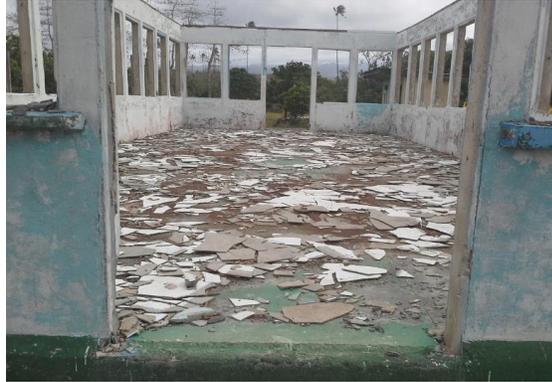
Loose Debris, Fagamolo Village

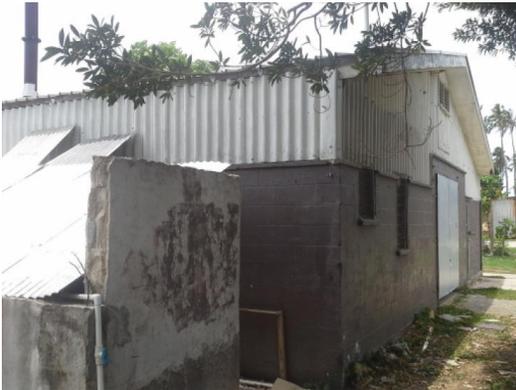
Photo 7 below shows the Industrial 01 Building cladding and Photo 8 shows cladding on the Small Business Centre Office. Both sets of cladding are damaged.

Industrial 01 Building

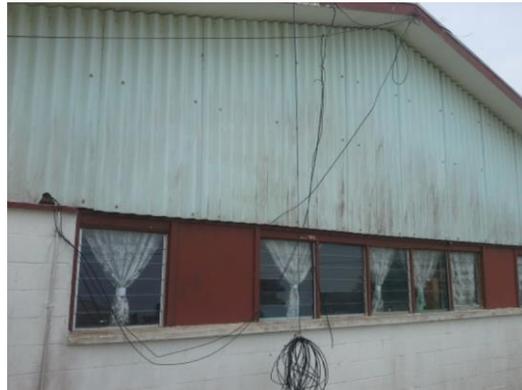
Small Business Centre Office

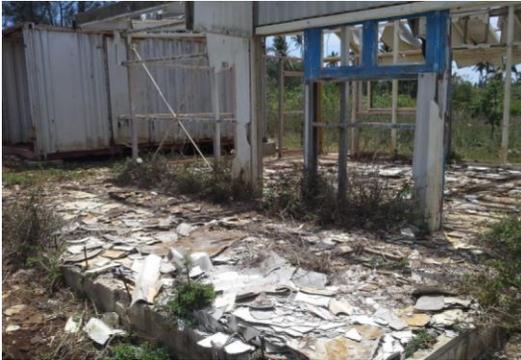
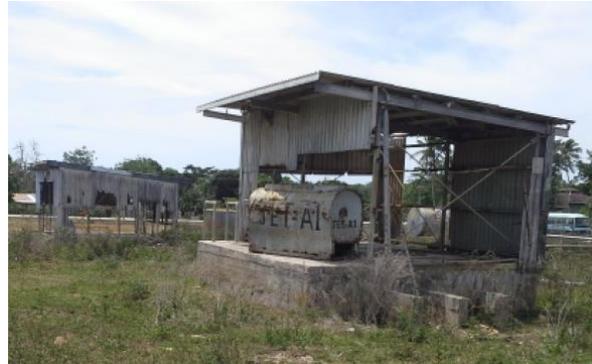
The photos below show the Vava'u Former Bulk Fuel Depot. There is significant damage and signs of vandalism, stock grazing in areas with ACM. There is loose ACM over most of site and off-site towards school and on playing fields. The site has been derelict for at least 15 years and is not fenced. It is relatively exposed topographically, i.e. top of hill, and it receives wind flows directly. There is a school approximately 100m away to east. Residential areas are on two sides within 50m. Discussions with MOI indicated that there is a tender to purchase the land and they were unsure who owns land now.

Vava'u Former Bulk Fuel Terminal

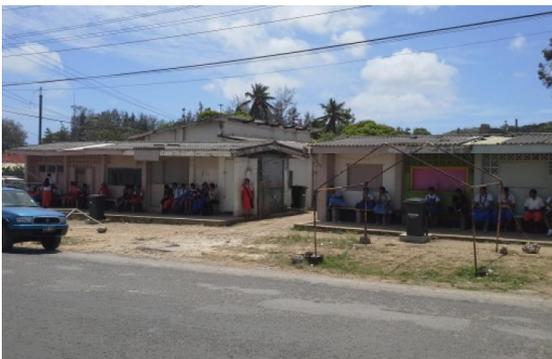
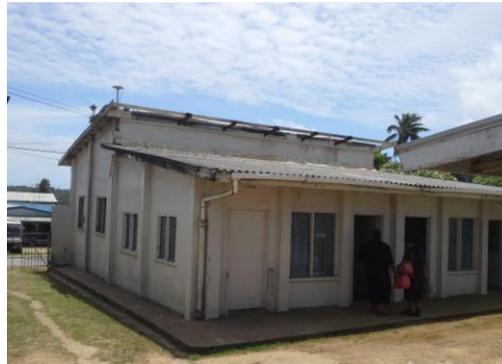
The photos below show the Neiafu former market. There are damaged ACM roofs on several buildings and ACM fragments observed on ground across the road from the southern building. This former market is still widely used.

Former Neiafu Market.

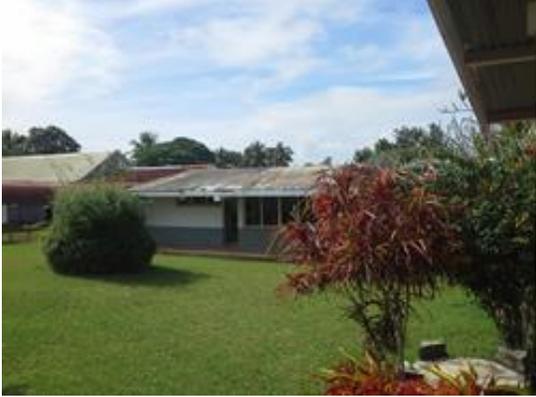
The first photo below shows cladding and roofing at the Malapoa College. The second photo has been taken at the abandoned manganese mine in Forari, and there is AC cladding and roofing on four remaining structures. The site is abandoned and in a rural area.

Malapoa College

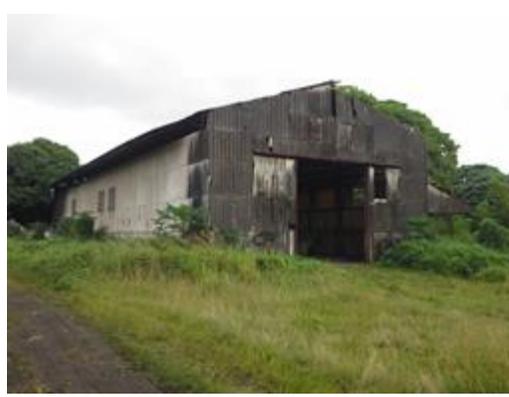
Manganese Mine Forari
