EU-SOPAC (EDF9) Project Report No. 80
Reducing Vulnerability of Pacific ACP States

REPUBLIC OF NAURU
KRA 2 (WATER) TECHNICAL REPORT

RAINWATER HARVESTING:
ASSET CONDITION SURVEY OF DOMESTIC INFRASTRUCTURE

13th February to 23rd February 2007

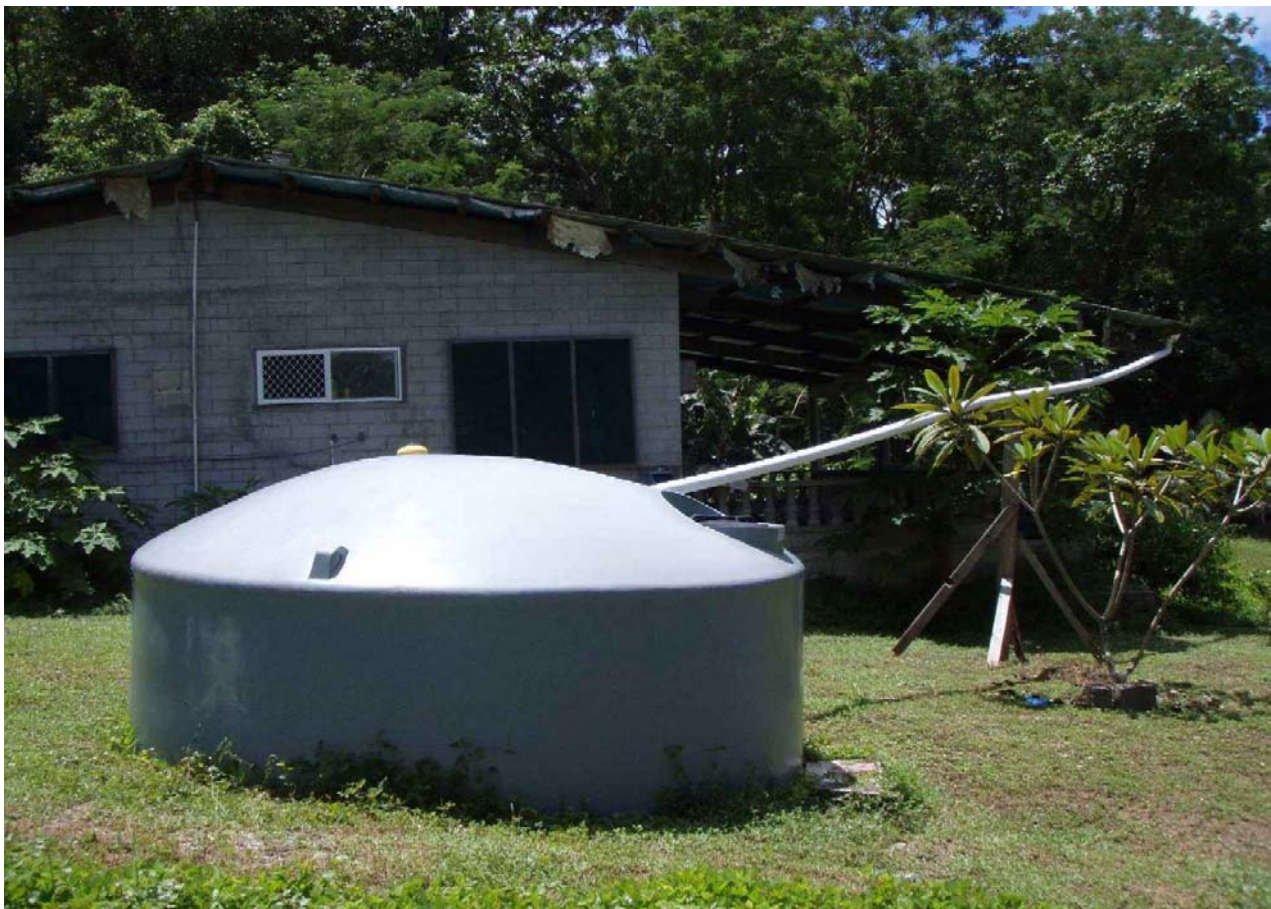
Plastic water storage tank emplaced partially below ground level, Buada, Nauru.

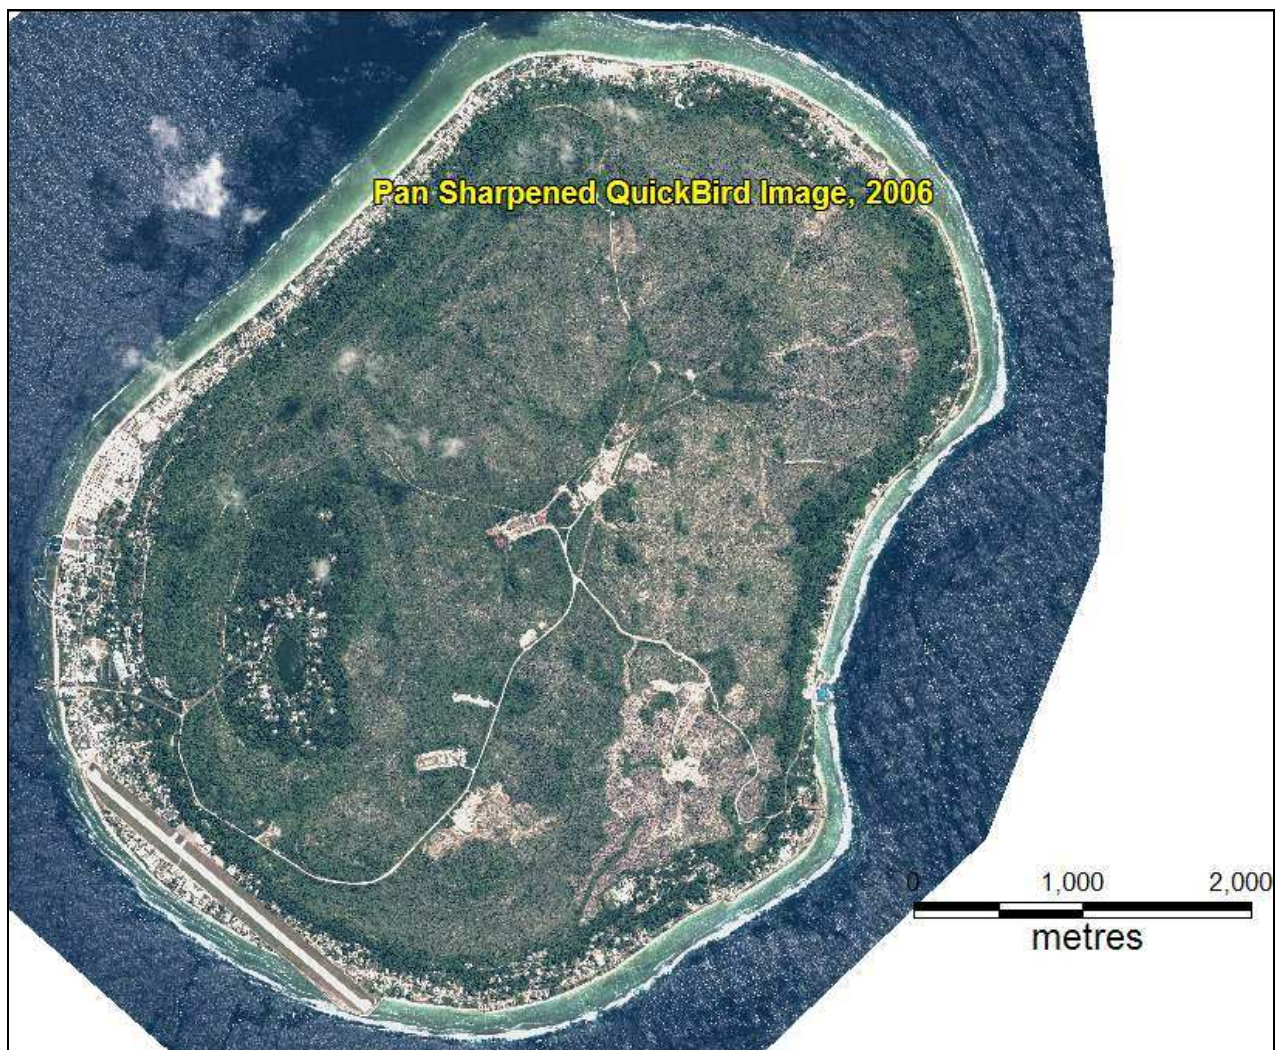
Figure 3.1.1: QuickBird (2006) Satellite Image of Nauru

A recent (2006) QuickBird satellite image (Figure 3.1.1) was ordered for the island and used as a reference map during the survey. The 0.6 metre resolution clearly showed buildings and assisted the field surveyors in accurately identifying areas to be mapped. The actual properties visited and the identifying reference number allocated to each of them for the purposes of this survey are identified in the following sequence of eight Figures 3.1.2(a) through to Figure 3.1.2(h).

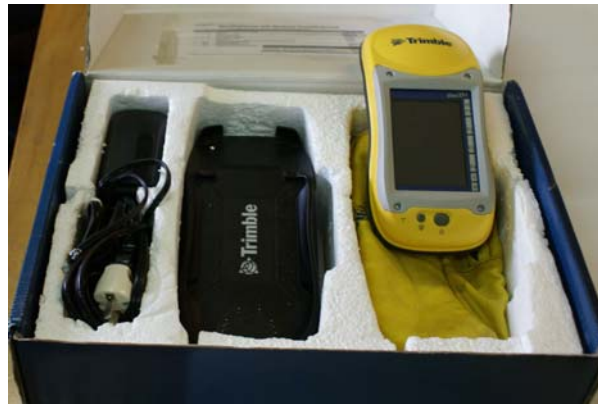
Figure 3.2.1: GeoXM hand held GPS

- Handheld units (mobile): Trimble GeoXM, (Fig 3.2.1) and a
- Base Station (static): Trimble 4600LS (Figure 3.2.3)

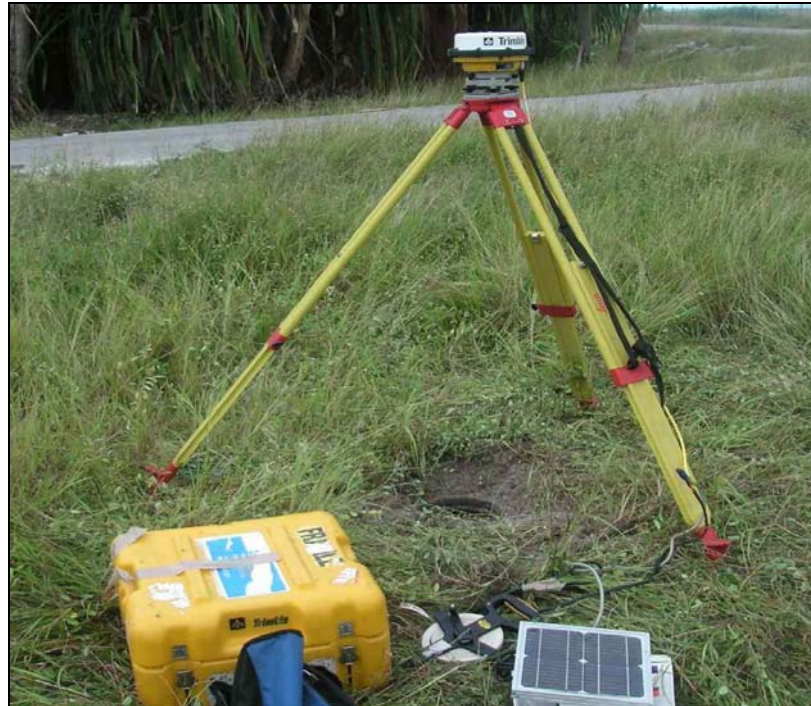
Figure 3.2.3 : Trimble 4600LS base station set up over RM2 at the Nauru CGPS

Approximately one hour before the start of each days field survey work, the 4600LS static unit (Figure 3.2.3) was set-up as a base station on Reference Mark 2 of the Nauru continuous GPS (CGPS) station (Figure 3.2.4). It should be noted that the selected benchmark is referenced to the Nauru Island Datum. The base station is powered by a small solar panel and battery assembly and logs a continuous positional record every five seconds.

The base station files are required for differential correction. This increases the accuracy of the handheld GPS units (GeoXM) from 10m to between 2m to 5m, which is sufficiently accurate for the 1:10,000 scale mapping requirements of this Project. The base station was switched off and dismantled at the end of each survey day, approximately one hour after completion of all the field work and once both field teams handheld GPS units had been collected.

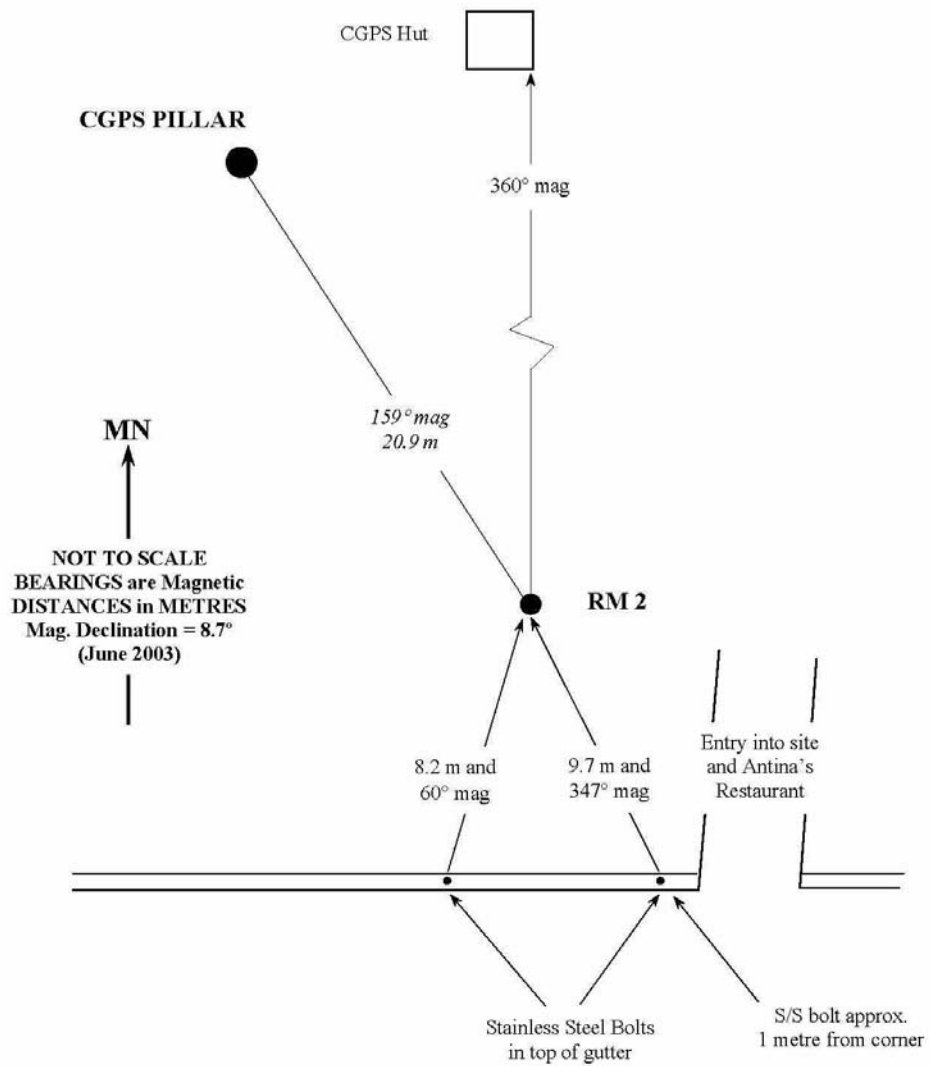
Figure 3.2.4: Location sketch of Nauru CGPS and RM2

All RM's are capped 20 mm stainless steel rods driven to refusal and protected by 150 mm PVC pipe within circular poly carbonate valve boxes. The valve box lids are approximately 50mm below ground level.

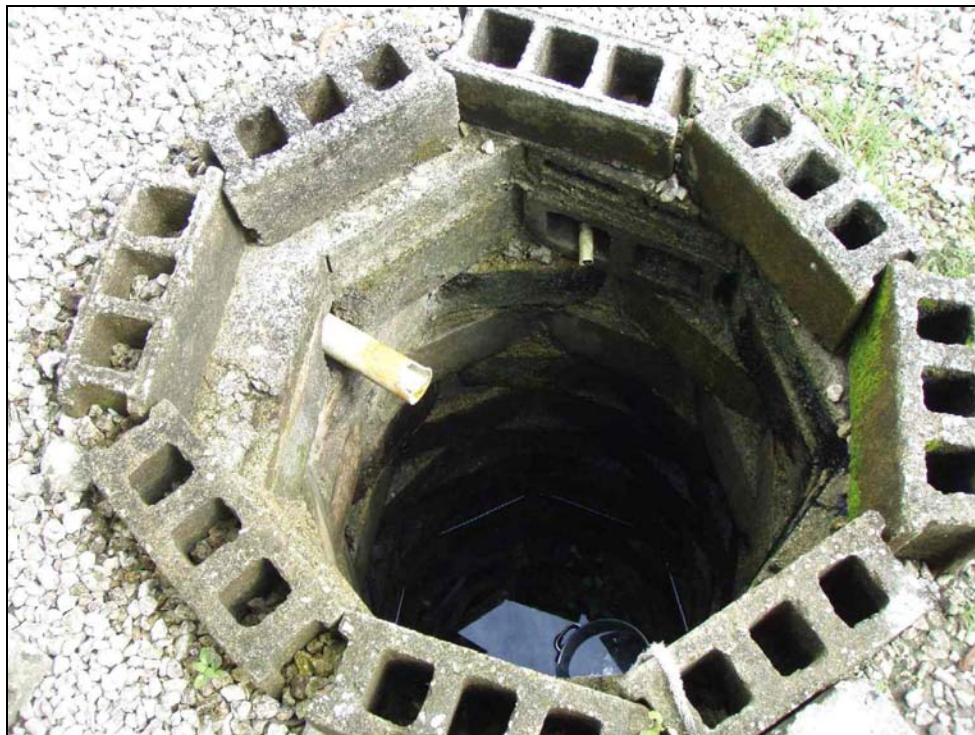
Figure 4.3.6 – Alternative supply well, Buada District.
