# **Report on Oil/Diesel leaking from shipwrecks in Chuuk Lagoon**

**August 17, 2008**

**by Dr Bill Jeffery**

This is a brief report on one aspect of the Team 1, 2008 project work, being a report on the oil/diesel seen to be leaking from two sites, *Hoyo Maru* and *Rio de Janeiro Maru*. A more comprehensive report on all Team 1, 2008 outcomes will be produced and provided to the Chuuk Department of Marine Resources and the Chuuk Historic Preservation Office.

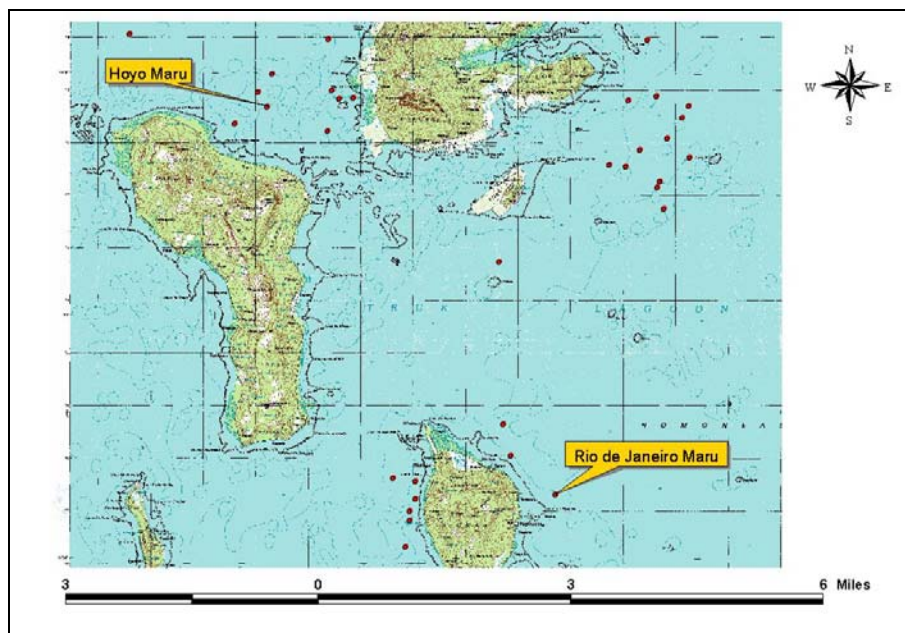
Figure 1: Location of Hoyo Maru and Rio de Janeiro Maru

Of the estimated 52 submerged World War II sites located in Chuuk Lagoon, a sample of sites is selected to help consider the project aims. Requests from the Chuuk Department of Marine Resources and the Chuuk Historic Preservation Office are also considered in deciding on which sites should be investigated. The Chuuk Department of Marine Resources requested that sites known to be associated with leaking oil/diesel should be investigated. The *Kiyosumi Maru* and the *Hoyo Maru* (located between Fefan and Tonoas) were two of these sites and they were investigated on Thursday, August 31 (Figure 1). No oil/diesel was found to be leaking from *Kiyosumi Maru* but a long slick was seen to the south-west of *Kiyosumi Maru* and when tracked back to its source, was found to be coming from *Hoyo Maru* at Latitude 7.37102; Longitude 151.84422 (see Figures 2 and 3). The slick was being pushed by the wind in a north-west direction and estimated to be over 5 kilometres in length.
