**EU-SOPAC (EDF9) Project Report 80
Reducing Vulnerability of Pacific ACP States**

**NAURU TECHNICAL REPORT
RAINWATER HARVESTING:
ASSET CONDITION SURVEY OF DOMESTIC INFRASTRUCTURE
13th February to 23rd February 2007**

August 2007

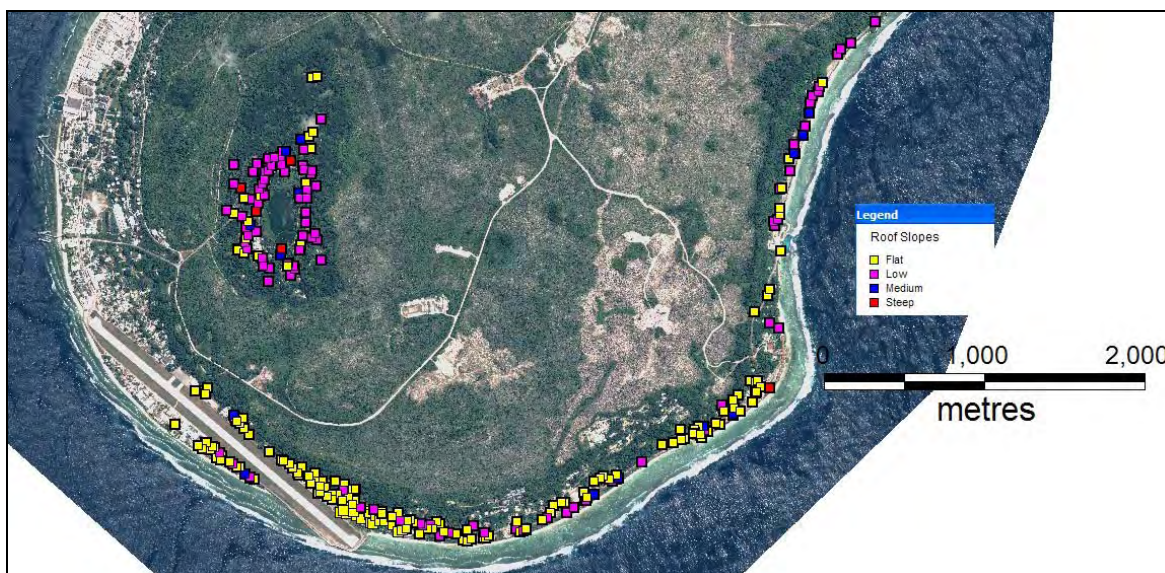
Figure 17. Roofing Slopes.

The pitch, or slope of the roof from a horizontal plane, was also recorded during the survey, and Table 5 indicates that the overwhelming majority (92%) are of flat to low pitch (shallow slope) construction. The spatial distributions of these categories is illustrated in Figure 17.

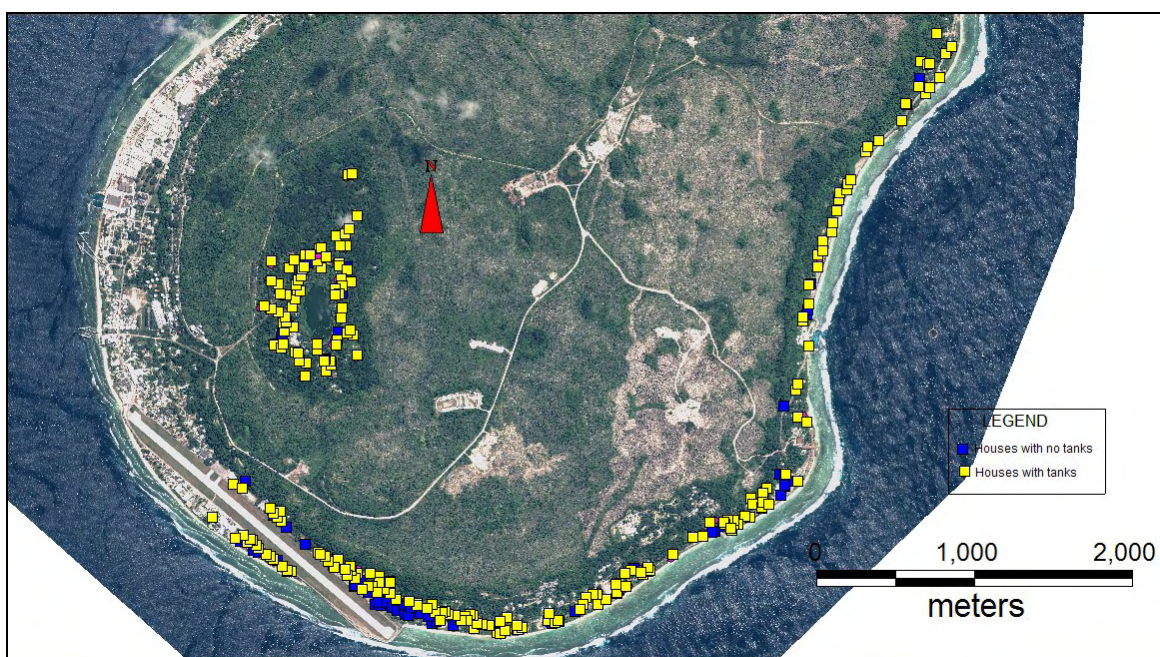
Figure 23. Distribution of properties with and without storage tanks.

The spatial distribution of properties with and without tanks is illustrated in Figure 23, and it is apparent that there is an unusual concentration of properties with no tanks in the south eastern sector of Yaren District – the reasoning for this cluster remains to be explained!

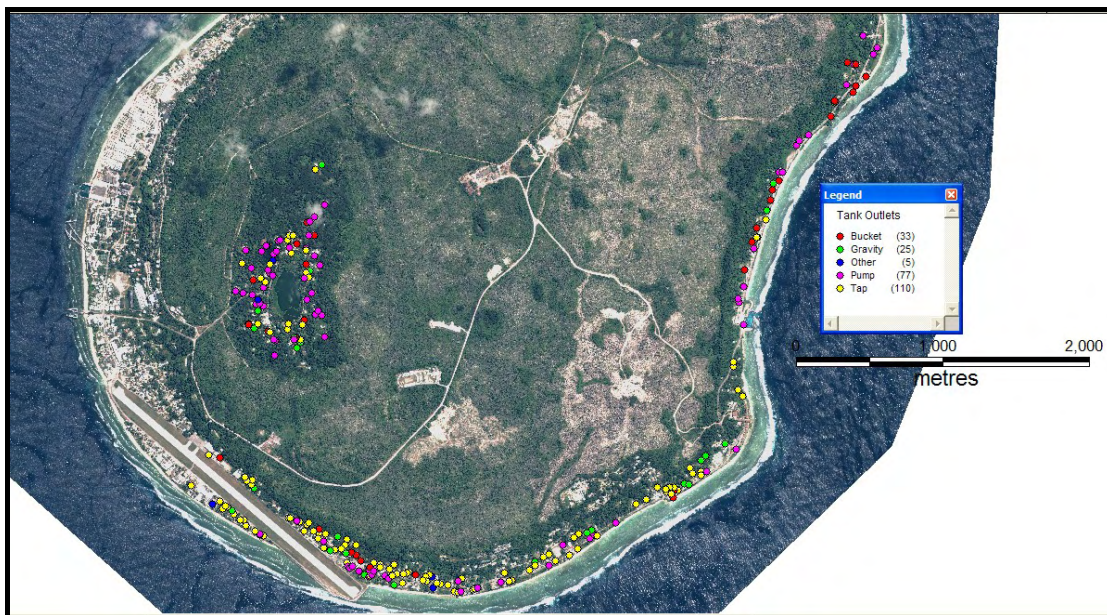
Figure 25. Tank Abstraction Methods.

The spatial distribution of tank abstraction methods is illustrated in Figure 25, seemingly indicating a high concentration of small electrical pump usage in properties around Buada Lagoon and along the coastal strip of Anibare; it is speculated these may relate to a particular Aid package that these Districts selectively benefited from, or perhaps that the residents are generally more affluent(?) In contrast, a (basal) tap appears to be the more common practice utilised in properties along the coastal strip of Yaren and Meneng.

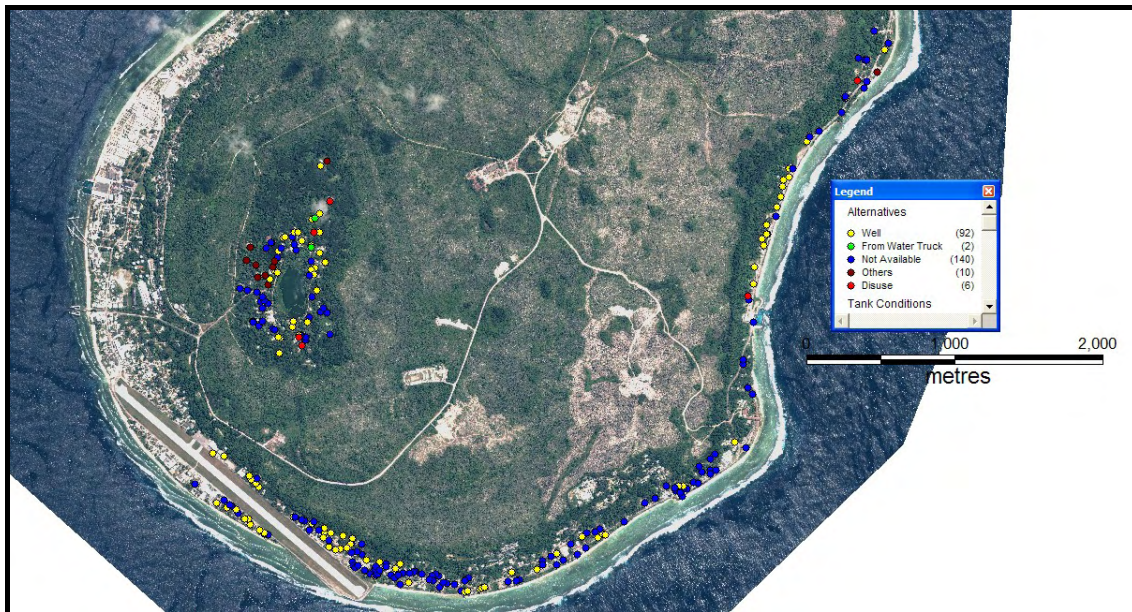
Figure 26. Alternative Supply Methods.

The spatial distribution of alternative supply methods is illustrated in Figure 26. The high concentration of groundwater wells along the coastal strips in the central area of Anibare District and close to the airport runway in Yaren District is immediately apparent. A typical alternative groundwater supply well is shown in Figure 27.

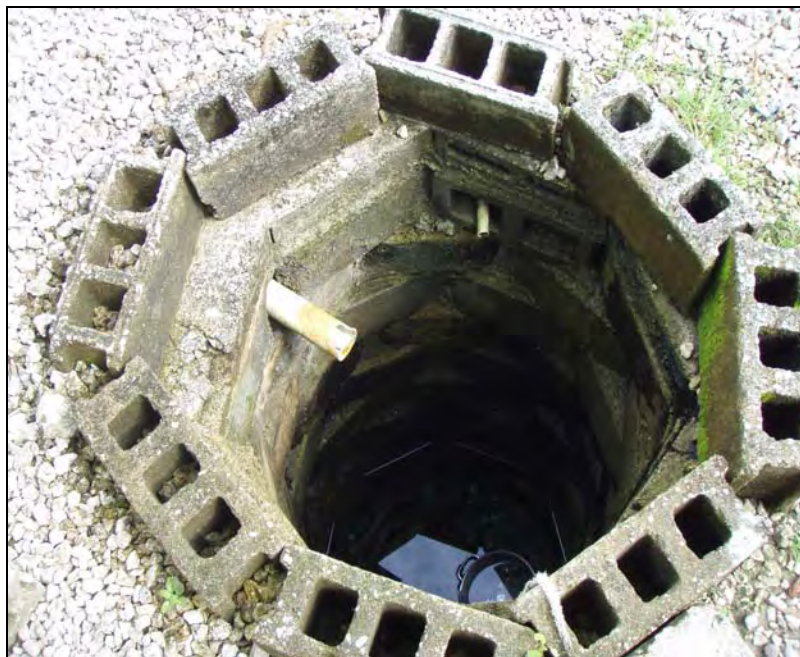
Figure 27. Alternative supply well, Buada District..
