# **Survey of the Regional Distribution and Status of Asbestos-Contaminated Construction Material and Best Practice Options for its Management in Pacific Island Countries**

## **Report for the Republic of Fiji**

**Prepared for the Secretariat of the Pacific Regional  
Environment Programme (SPREP)**

**May 2015**

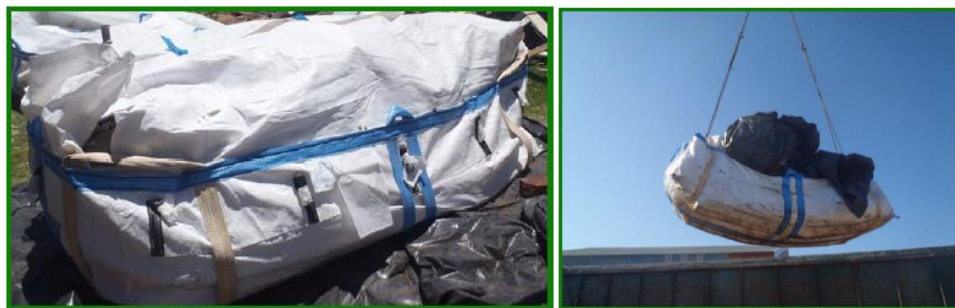
**Photos 13 & 14: Asbags in use**

Asbags are fabric bags in various sizes with lifting strops – see photos below. There are special ones for roofing sizes.

- d) Lay down black plastic sheeting to the floor of each room, remove all ceiling linings and place all rubbish into suitable containers for disposal (plastic lined bins or fabric bags such as "Asbags" – see Photos 13 & 14 below) for correct removal & disposal. All ceiling material will need to be treated as asbestos-contaminated as debris and fibres fall from the roofing with roof movement and wear.

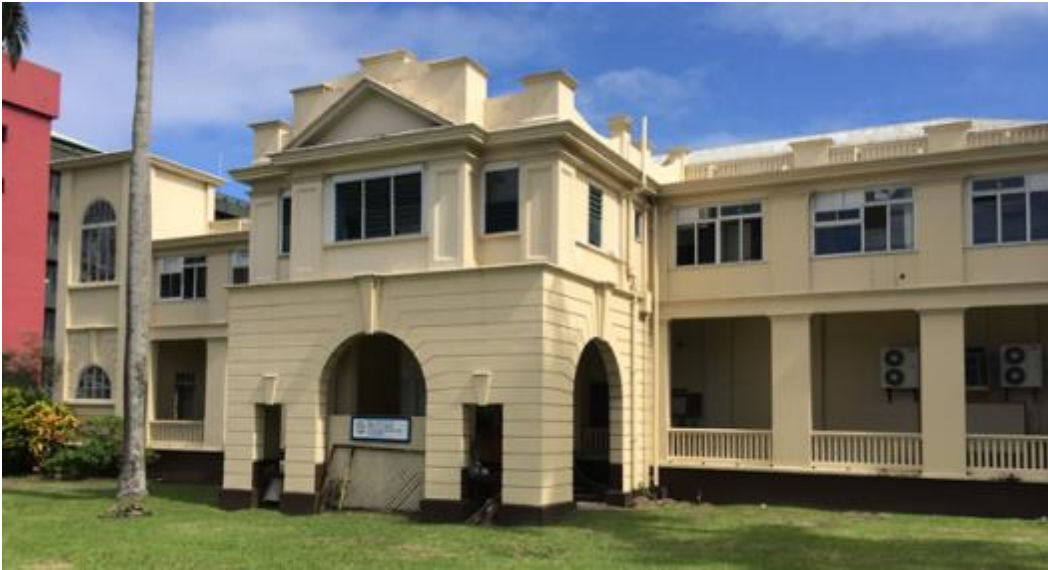
Photograph 1: View South West of St Stephens Building 16 July 2014.

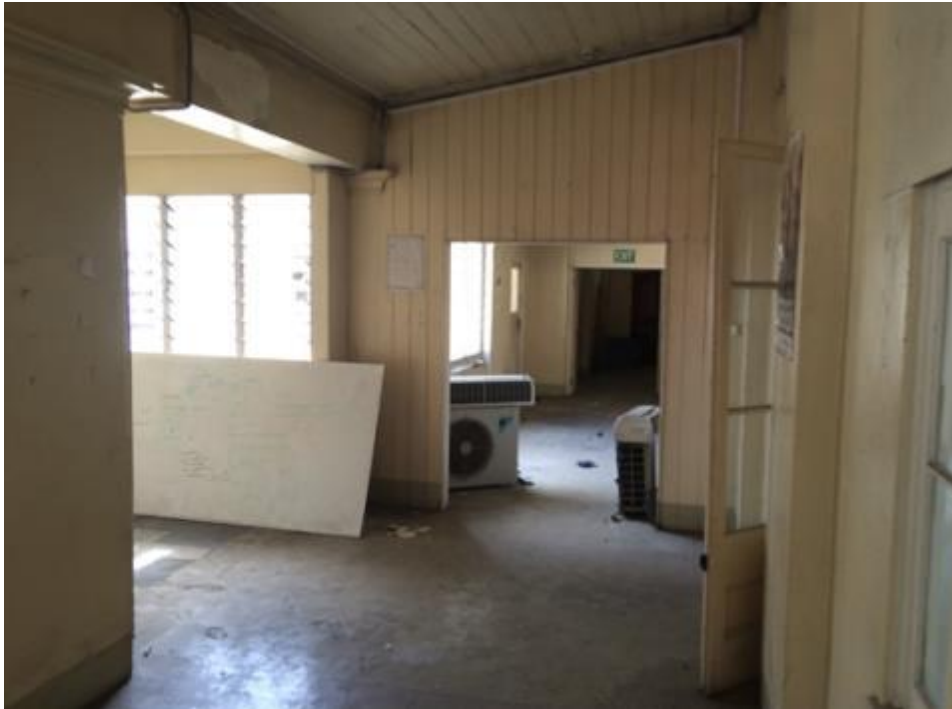
Photograph 3: View of 1<sup>st</sup> floor 16 July 2014.
