# **Survey of the Regional Distribution and Status of Asbestos-Contaminated Construction Material and Best Practice Options for its Management in Pacific Island Countries**

## **Report for the Sovereign Republic of Kiribati**

**Prepared for the Secretariat of the Pacific Regional  
Environment Programme (SPREP)**

**May 2015**

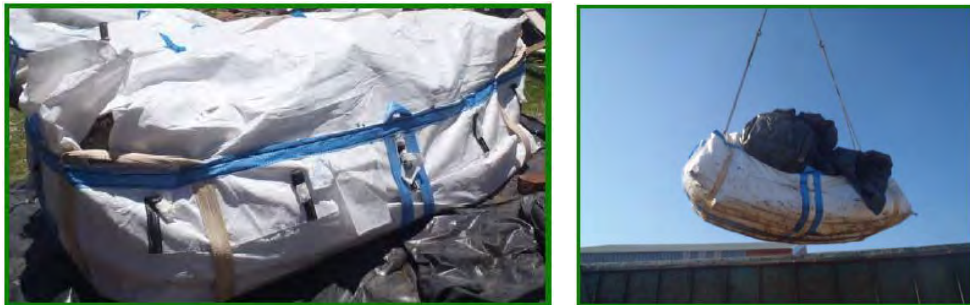
**Photos 27 & 28: Asbags in use**

Asbags are fabric bags in various sizes with lifting strops – see photos below. There are special ones for roofing sizes.

- d) Lay down black plastic sheeting to the floor of each room, remove all ceiling linings and place all rubbish into suitable containers for disposal (plastic lined bins or fabric bags such as "Asbags" – see Photos 27 & 28 below) for correct removal & disposal. All ceiling material will need to be treated as asbestos-contaminated as debris and fibres fall from the roofing with roof movement and wear.
