Survey of the Regional Distribution and Status of Asbestos-Contaminated Construction Material and Best Practice Options for its Management in Pacific Island Countries

**Report for the
Republic of Nauru**

**Prepared for the Australian Department of Foreign Affairs and
Trade (DFAT)**

June 2015

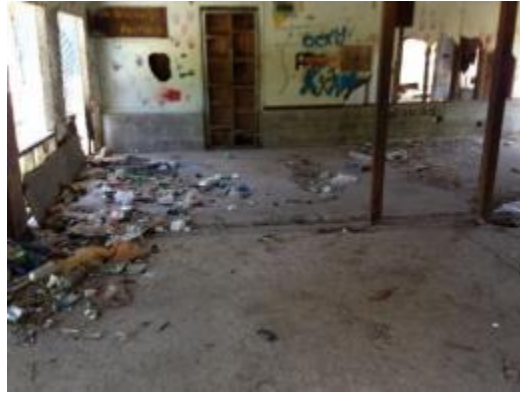
Photo 11 shows a close-up of possible cladding and Photo 12 shows an abandoned house littered with asbestos debris. This abandoned house was close to other houses and children were noted playing in the asbestos debris.

Photo 12 – Asbestos Debris in Old House

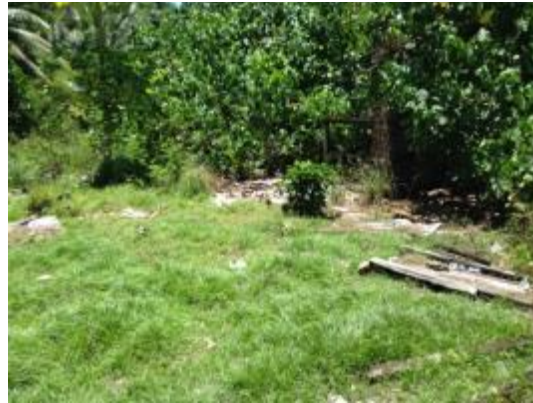
In addition asbestos debris litters sealed and grassed areas around houses, see Photos 13 and 14 below. Such asbestos litter and debris is quite common around houses on Nauru.

Photo 14 – Asbestos Debris in Back Yard

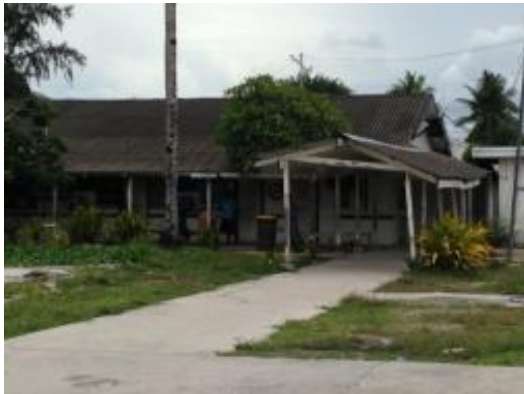
Numerous photos of the RON Hospital are shown in Appendix 8. Three more are shown below, namely part of the old Block and the parapet ceiling. Both the roofing and the parapet ceiling have been confirmed as asbestos – see Section 5 below.

Photo 15 – Old Hospital Block

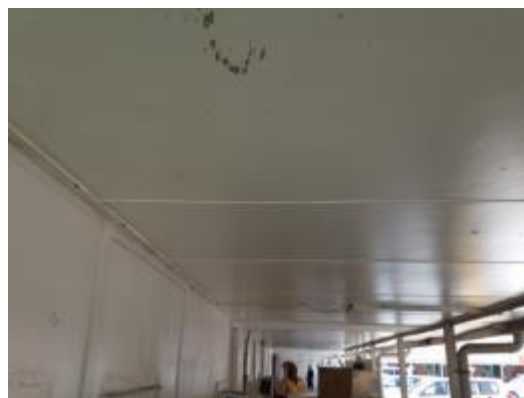
Photo 17 – Parapet Ceiling

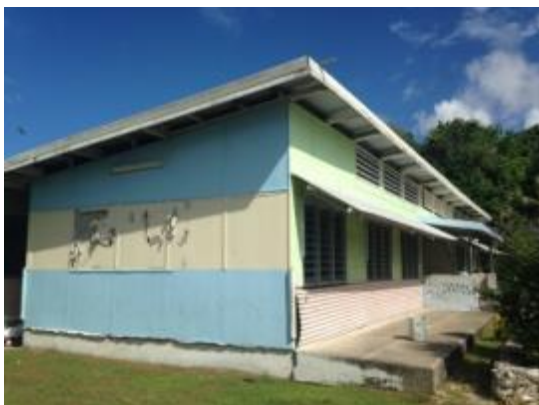
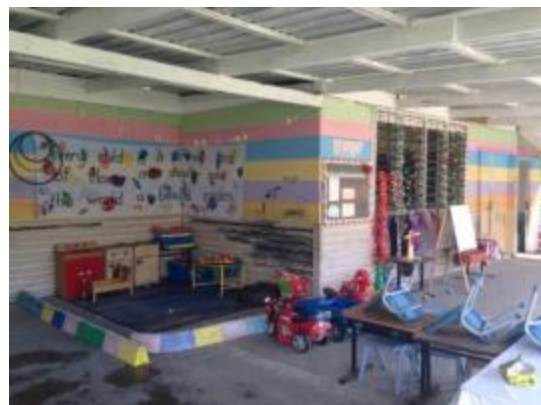
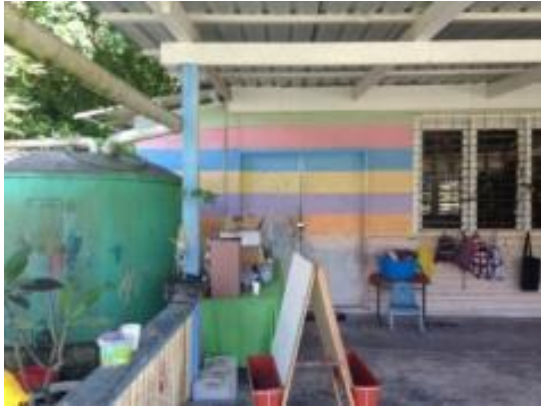
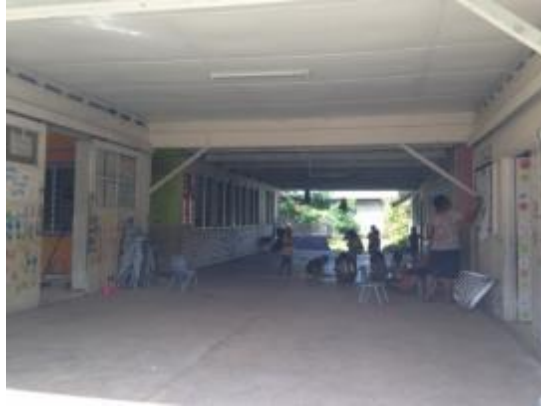
Photos 23-26 – Nibok Infant School Asbestos Cladding and Suspected Ceiling

16/3/12/Bulk	Boe Infant School	Old School - Cladding mid area	EMS / PacWaste	Chrysotile 7%
17/3/12/Bulk	Nauru College	Cladding	EMS / PacWaste	None Detected
1/4/12/Bulk	Kayser College	Old Block Cladding	EMS / PacWaste	None Detected
2/4/12/Bulk	Nibok Infant School	Cladding	EMS / PacWaste	Chrysotile 7%
3/4/12/Bulk	RonPHOS Workshop	Roofing	EMS / PacWaste	Chrysotile 65%
4/4/12/Bulk	Nibok Infant School	Vinyl Floor Tiles	EMS / PacWaste	None Detected
5/4/12/Bulk	Old NPC House (was Bakery)	Cladding	EMS / PacWaste	None Detected
6/4/12/Bulk	RonPHOS Workshop	Cladding	EMS / PacWaste	Chrysotile 5%
	Power Station Building	Gable / Main Eastern Entrance Cladding	GHD Survey 2007	Chrysotile, Amosite, Crocidolite
	Power Station Building	Edge of Roof, Northern Side	GHD Survey 2007	Chrysotile
	Power Station Building	West Wall, Northern End	GHD Survey 2007	Chrysotile
	Power Station Building	Wall Entrance to Switchboard Corridor, (North Side)	GHD Survey 2007	Chrysotile

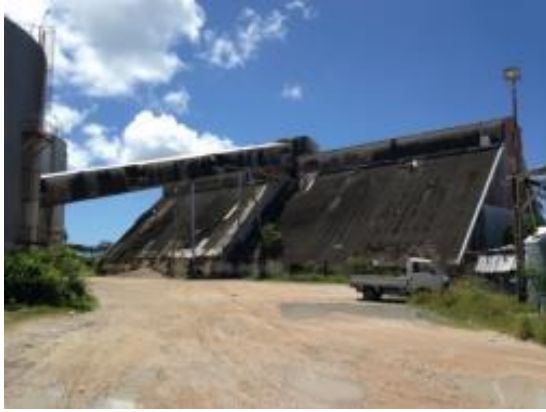
Photo 42 - Phosphate Storage Bin by Sea

My Store (DHL) Yaren	Cladding	Not Sampled Likely Asbestos	4	12	16
Kauwan - Kibaba Trading Menen	Roof, Cladding	Not Sampled Likely Asbestos	4	14	18
Petrol Station / Chinese Restaurant	Roof and Cladding	Not Sampled Likely Asbestos	5	16	21
TAB Menen	Cladding	Not Sampled Likely Asbestos	4	14	18
Green Tiled Building Sea Side Menen	Cladding	Not Sampled Likely Asbestos	4	14	18
I J Store	Cladding	Not Sampled Likely Asbestos	4	11	15
RonPHOS Areas					
Old Phosphate Store by Sports-ground	Roof	Chrysotile 10%, Amosite 5%	7	14	22
Phosphate Storage Bin by Sea	Roof	Chrysotile 20%	6	15	21
RonPHOS Workshop	Roofing	Chrysotile 65%	6	20	26

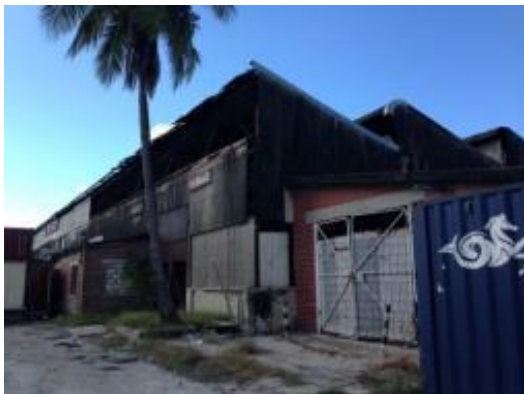
Photo 45 - RonPHOS Workshop

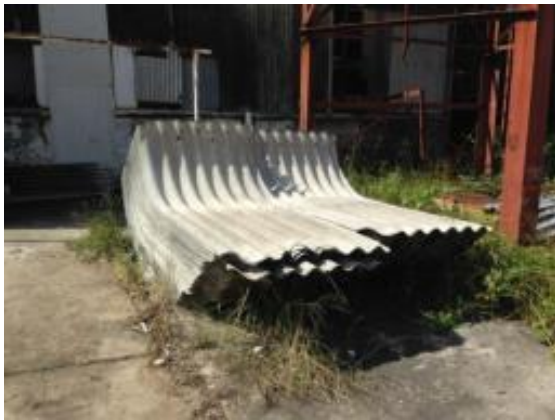
There is also some asbestos stockpiled at RonPHOS as per Photos 49-50 below:

Photo 49 - Stacked Asbestos Sheets

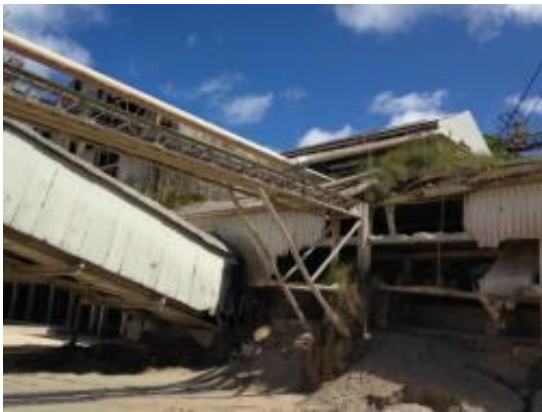
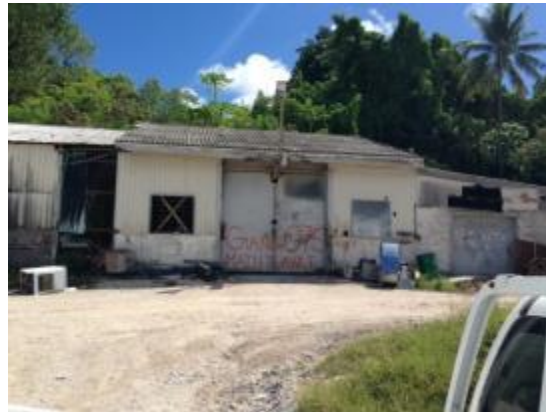
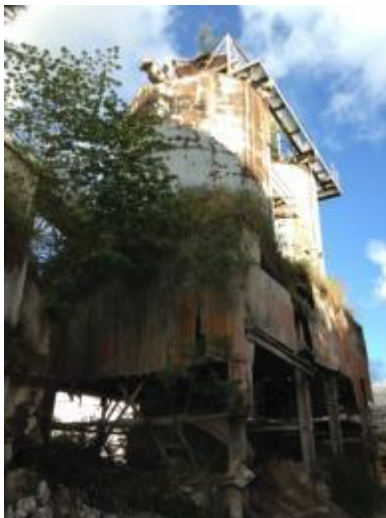
Photos 51-56 show some of the various components of the phosphate processing plant, which is still partly operational although some sections are not used now and are falling into disrepair. The first photo shows the conveyor from the processing area to the storage area.

Photos 51-56 – The Old RonPHOS Processing Area

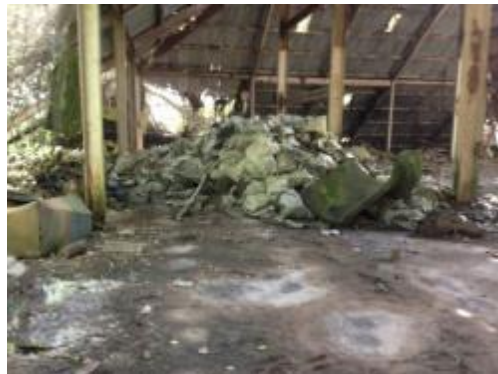
Photo 57 below shows the stockpile of insulating material in 2B storage area near the processing area. This material is also in a nearby storage area and both locations were sampled (three samples from each). All samples demonstrated that the insulating material was fibreglass.

Photo 57- Abandoned Insulating Material

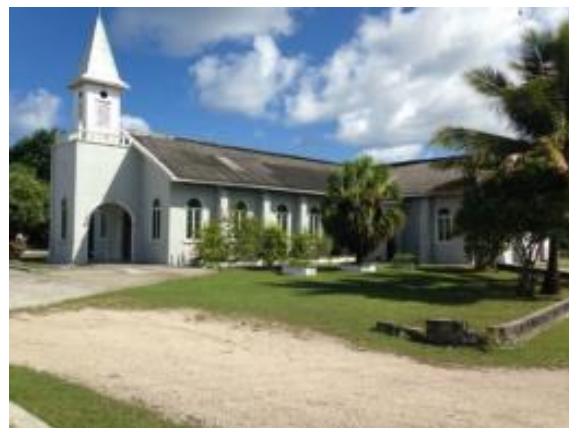
Photo 72 - Orro Church

Boe Infant School	Old School - Cladding mid area	Chrysotile 7%	4	17	21
Nibok Infant School	Cladding	Chrysotile 7%	4	17	21
Small Miscellaneous Buildings					
Bridge Rd Trader – Aiwo	Roof	Not Sampled Likely Asbestos	4	14	18
Orro Church – Aiwo	Roof	Not Sampled Likely	4	15	19

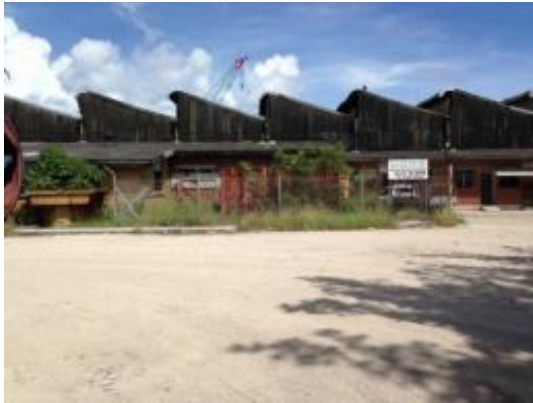
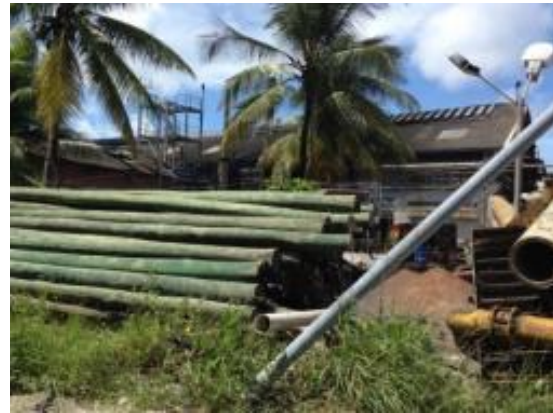
The Power Station has asbestos roofing and cladding in several locations – see Photos 79-80 below. It was the subject of a separate GHD investigation in 2007.

Photo 79-80 – Power Station Asbestos Roofing and Cladding

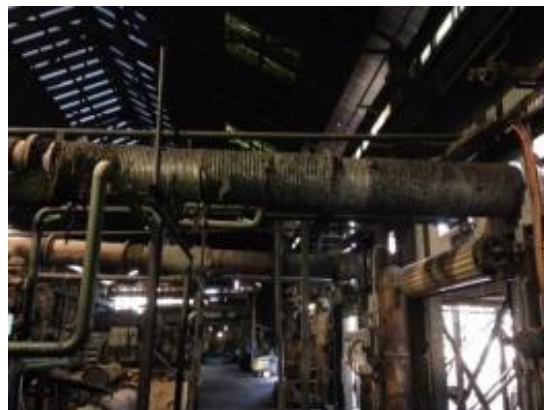
There was rope insulation on the exhaust from one of the generators and it was suspected of being asbestos. Subsequent testing has established that this is fibreglass – see below.

Photo 81 – Fibreglass Rope Lagging

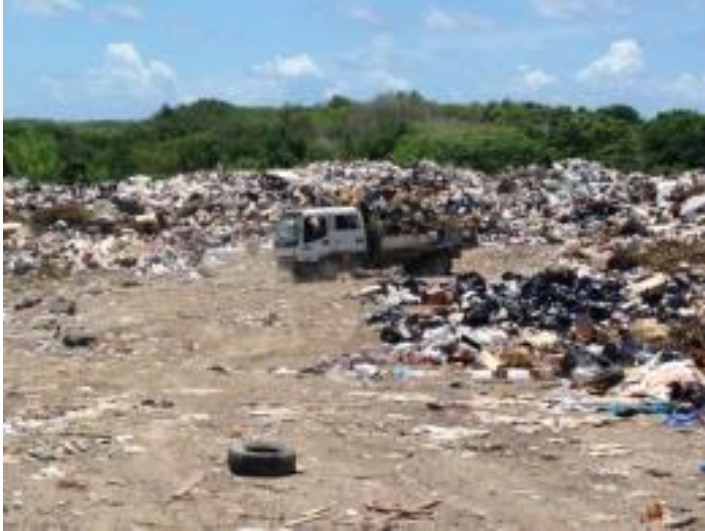
Photo 82 - Nauru Dumpsite

Large amounts of asbestos are reported to have been buried in the landfill from time to time from various re-building projects including schools but no records have been kept as to how much was buried, when it was buried and where it was buried.

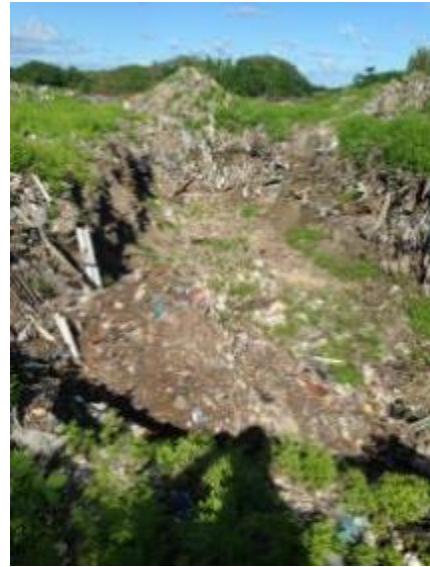
The NRC has recently dug a hole about 30m x 10m x 8m deep, partly to bury the asbestos and asbestos contaminated soil from the hospital clean-up reported in Appendix 8. The hole was oversized to allow for additional asbestos waste generated in Nauru and so may become the unofficial dumping location for asbestos. This hole is shown in Photo 83 below. In fact even with the asbestos waste deposited from the hospital and allowing for ample cover material and 100% voids, probably about 700 cubic metres of asbestos could be buried in this hole. A total of 1325 m³ of asbestos has been estimated by this survey to exist on Nauru so this hole could easily receive at least 50% of the total Nauru asbestos.

Photo 83 - Asbestos Burial Hole

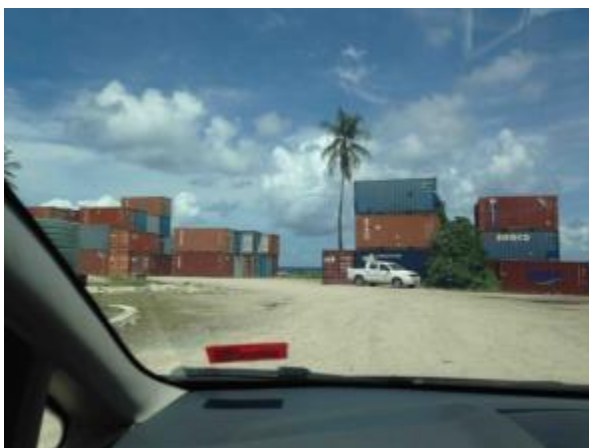
Photo 7 – Containers at the Port

We discussed storage of the asbestos in containers until the issue of disposal could be sorted out. There are certified containers on island and plenty of uncertified containers – see Photo 7 taken at the Port. Many old containers are scattered around the island.

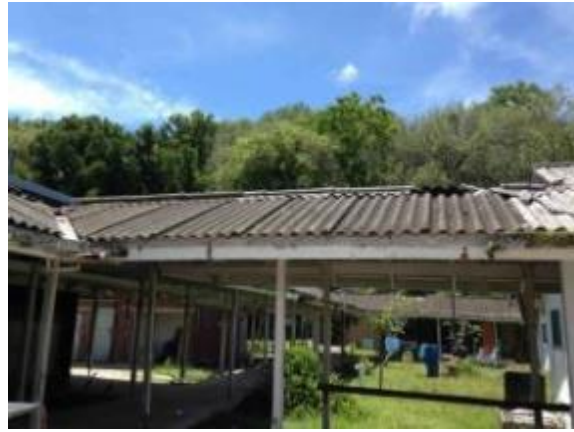
The newer hospital (still old) had a large amount of asbestos roofing and walkway panels (Photos 8 and 9). There had been a fire at this hospital in Aug 2013 which would have caused the distribution of large amounts of asbestos fibres around the hospital grounds (Photos 10 and 11). Also some burnt asbestos-contaminated debris was still in place. The fire also destroyed lots of medical records.

Photo 9 – Asbestos on Hospital Roofs

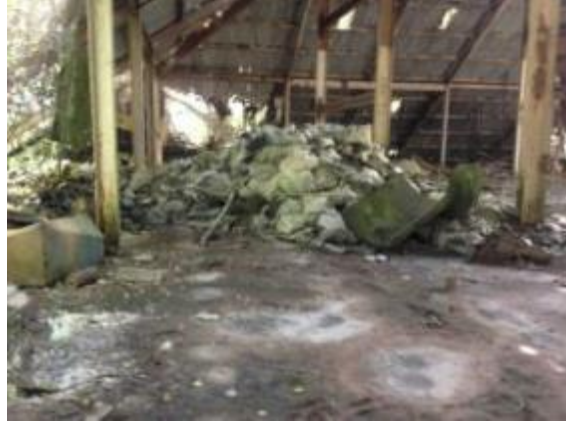
Photo 14 – Another View of the Bags

We all went to inspect this stockpile of reported pure asbestos and found it to be a potentially serious issue. There was a large pile of bags in a building in very poor condition (see Photos 13-15 below). We were also advised that there was a nearby tunnel that contained an even large number of such bags (see Photo 16 below). Possibly around 100 tonnes is stored there.

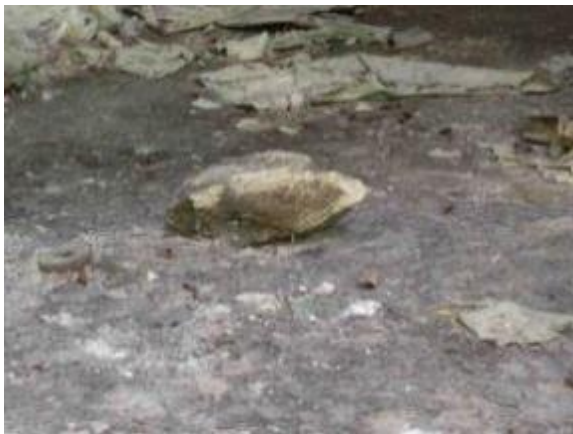
Photo 15 – Lump of Reported Asbestos

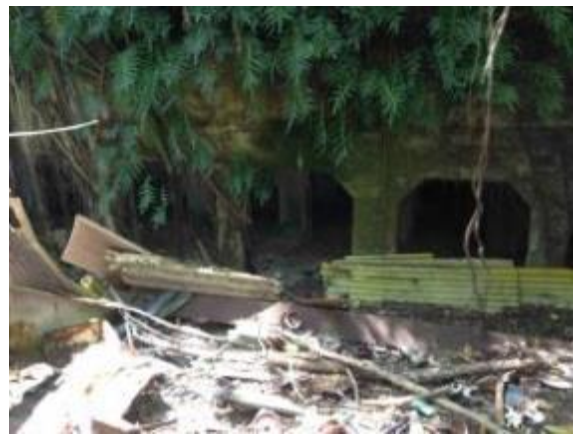
Photo 16 – Tunnel Reported to Contain More Bags
