# **Survey of the Regional Distribution and Status of Asbestos-Contaminated Construction Material and Best Practice Options for its Management in Pacific Island Countries**

## **Report for the Republic of Fiji**

**Prepared for the Secretariat of the Pacific Regional  
Environment Programme (SPREP)**

**May 2015**

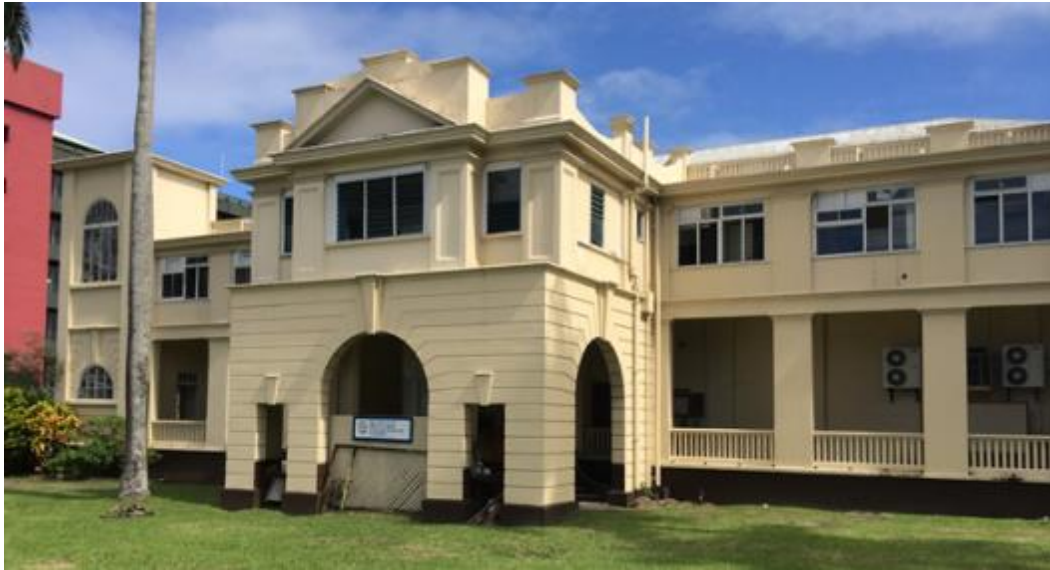
Photograph 1: View South West of St Stephens Building 16 July 2014.

The initial survey was conducted by Gareth Oddy of Geoscience Consulting (NZ) Ltd and John O'Grady of Contract Environmental commencing at approximately 11:50am on 16 July 2014. The survey included a review of the external building cladding and internal building material easily accessible and visible to the surveyors. During the survey, the building construction was noted to be a concrete two storey structure with metal roof. Internal cladding included vinyl flooring throughout with wall cladding consisting of recycled cardboard panels with fibreglass insulation between the concrete.

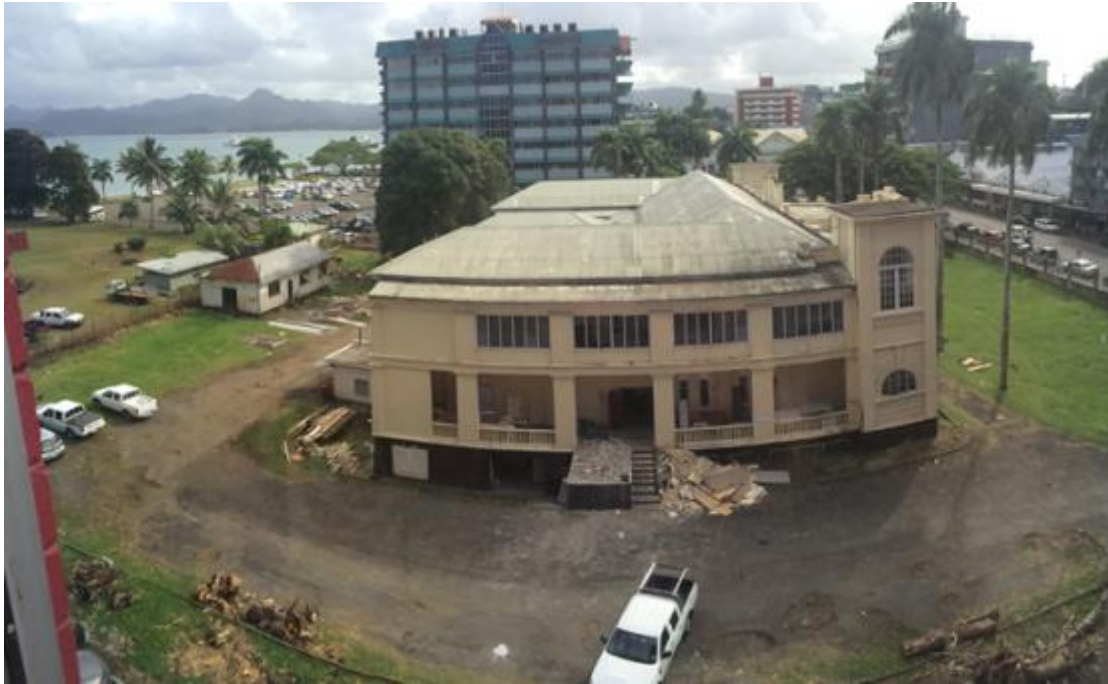
Photograph 5: View of site on 1 August 2014.

Pieces of floor tiles varying in size from approximately 5 - 150 mm were observed on the ground (see photograph 4) on all four sides of the building covering an area of approximately 100m<sup>2</sup>. A small downstairs room was observed to still contain vinyl floor tiles. No renovation staff were observed to be wearing suitable PPE for a site containing damaged asbestos materials.
