Survey of the Regional Distribution and Status of Asbestos-Contaminated Construction and Waste Material and Best Practice Options for its Management in Pacific Island Countries

Report for the Republic of Vanuatu

**Prepared for the Secretariat of the Pacific Regional
Environment Programme (SPREP)**

May 2015

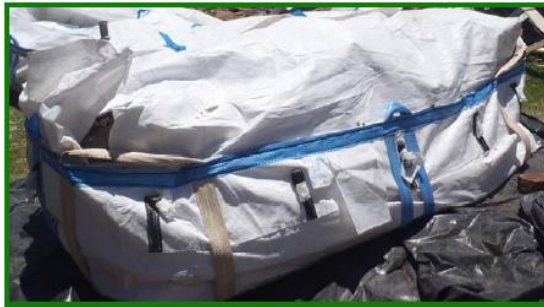
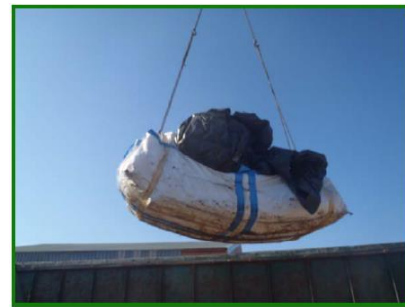
Photos 17 and 18: Asbags in Use

Asbags are fabric bags in various sizes with lifting strops – see Photos 10 and 11 below. There are special ones for roofing sizes.

- d) Lay down black plastic sheeting to the floor of each room, remove all ceiling linings and place all rubbish into suitable containers for disposal (plastic lined bins or fabric bags such as "Asbags" – see Photos 17 & 18 below) for correct removal & disposal. All ceiling material will need to be treated as asbestos-contaminated as debris and fibres fall from the roofing with roof movement and wear.
