Prospects and Challenges for Reconstruction after Tropical Cyclone Harold in Vanuatu

Dr Iftekhar Ahmed

Associate Professor - Construction Management/Disaster Resilience
School of Architecture and Built Environment
University of Newcastle, Australia

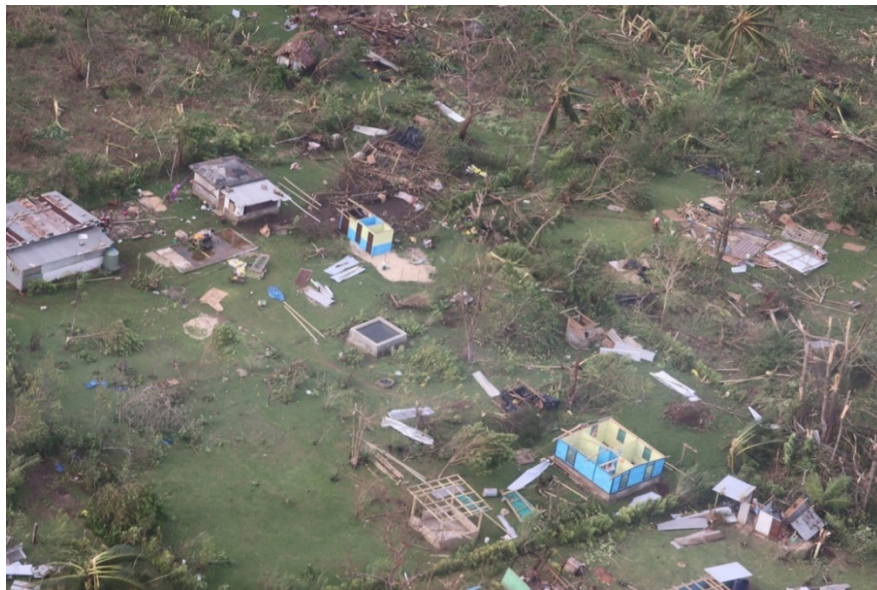
Aerial photos taken after the cyclone show houses with their corrugated iron (CI) sheet roofs blown off while those few houses with reinforced concrete (RC) roofs survived (Figure 1). The obvious approach would be to rebuild with concrete roofing, but affordability can be an issue and perhaps cultural preference too. There are other constraints to building with concrete in this island nation such as low strength of the typical coral aggregate, corrosion of steel reinforcement in the marine environment and risk during earthquakes. If concrete roofs are not built properly with quality materials and specifications, they can also fail. Nevertheless, whatever the constraints, some people in Vanuatu do build RC roofs and the photo in Figure 1 clearly demonstrates that they survived relatively unscathed in the cyclone, which cannot be said for the CI roofs that flew off. Perhaps the trade-off needs to be explored more carefully and other options need to be looked at.

Figure 1: This aerial photo shows houses that lost their CI sheet roof in the cyclone; the house in the top left with a RC roof survived (source: Tony Deamer).

In cyclone-prone areas RC roofing should be encouraged as much as possible, and cheaper options (such as hollow roofing blocks) should be explored. However, it is also important to note that if concrete roofs are not built properly with quality materials and specifications, and good connections with the structural frame and/or wall, they can also fail, though perhaps not to the extent of CI sheet roofs.

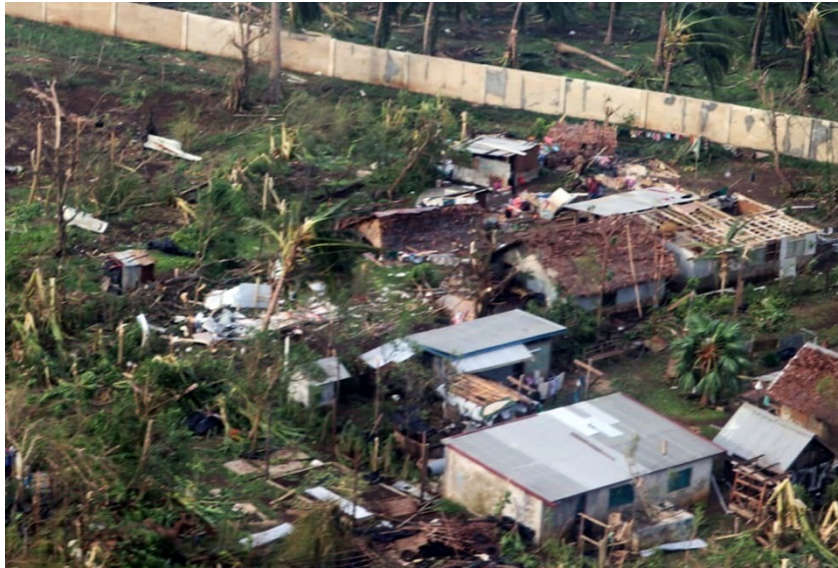
On the other hand, many houses with thatch roofs made of *natangura* leaves survived (Figure 2). There are many such houses on the outer islands of Ambae, Maewo and Pentecost that survived the cyclone. Vernacular architecture, as in the thatch houses, have been time-tested and have usually developed in response to the local context, so it is not surprising that they have withstood the cyclone's impact. They are unfortunately becoming unpopular and in some places such organic materials have become scarce, hence industrial products are replacing them. But often people do not

Figure 2: Many houses with thatch roofs survived in the cyclone (source: Tony Deamer).

There are also guidelines for building stronger and safer houses with CI sheet roofing. If at all concrete is not affordable, following these guidelines would help to some extent. There are also guidelines for treating thatching materials with non-toxic preservatives, so that they are more durable and last longer. The list below includes a few relevant manuals, which are indicative, and can be made available upon request; these have already been disseminated to stakeholders in Vanuatu. There is a vast amount of such publications on disaster resilient construction, the challenge is to implement them. Hopefully, the reconstruction in Vanuatu and other affected Pacific countries will utilise this knowledge.

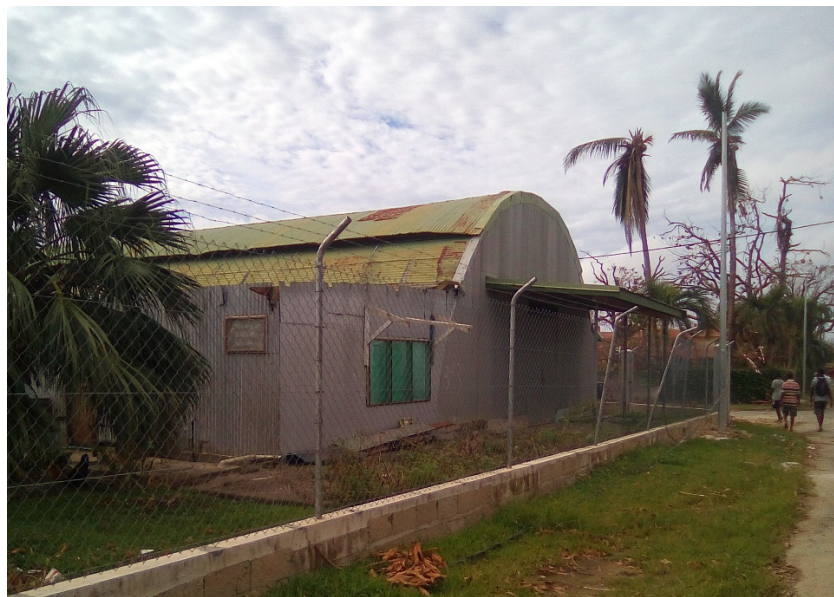
Figure 3: This building on Santo island with a curved CI sheet roof survived the cyclone (source: Renata Netaf).

Figure 3 shows a house with a curved roof of CI sheet that also escaped relatively undamaged. Curved structures tend to be aerodynamic and often offer good resistance to lateral forces, such as strong wind and earthquakes. Hence the curved metal roofing survived. Would this be widely and culturally accepted in Vanuatu so that it could be an affordable ‘build-back-better’ solution? This is an option that should be explored during the reconstruction process.
