Regional Distribution and Status of Asbestos-Contaminated Construction Materials and Best Practice Options for its Management in Pacific Island Countries

Status Report

**Prepared for the Secretariat of the Pacific Regional
Environment Programme (SPREP)**

June 2018

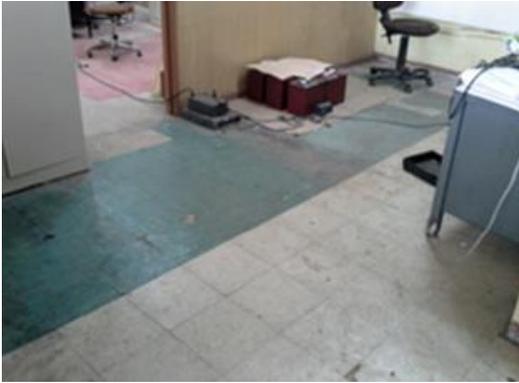
Yap – Education Dept Floor Tiles

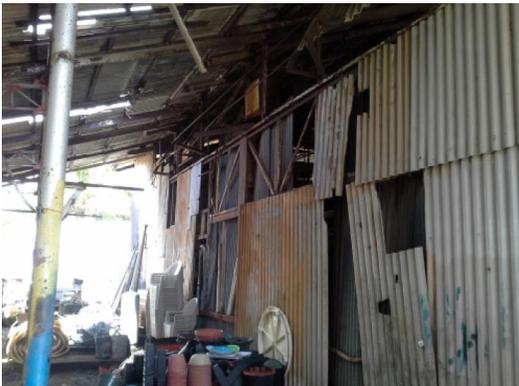
Pohnpei – LPG Gas Corporation

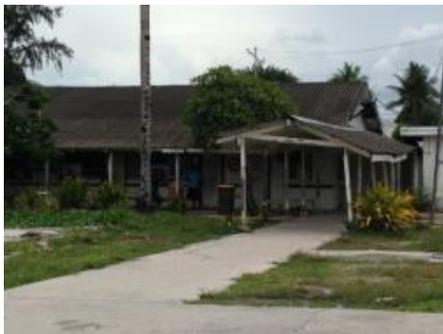
Old Hospital Block

Most of the hospital has now been remediated and the photos below are therefore historical.

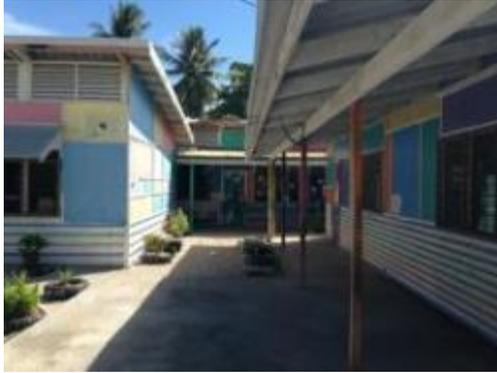
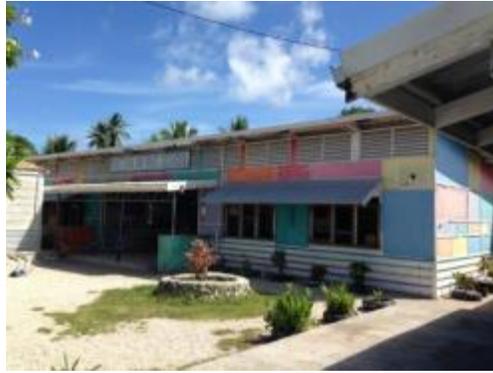
Anetan Infant School Asbestos Cladding

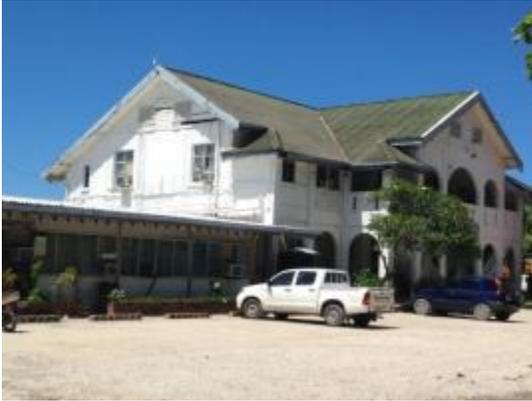
Central Office Building

The RonPHOS buildings cover a wide area, including the administration and workshops and the phosphate processing area. The photos below are illustrative of the large number of buildings that have asbestos roofs and cladding.

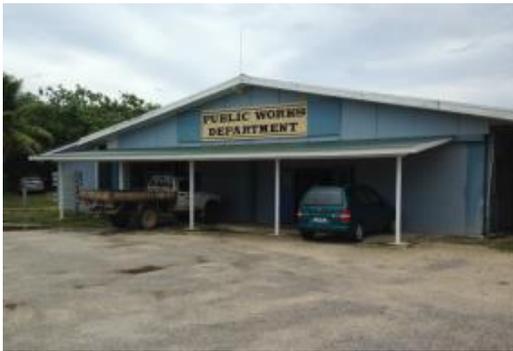
Public Works Department Cladding

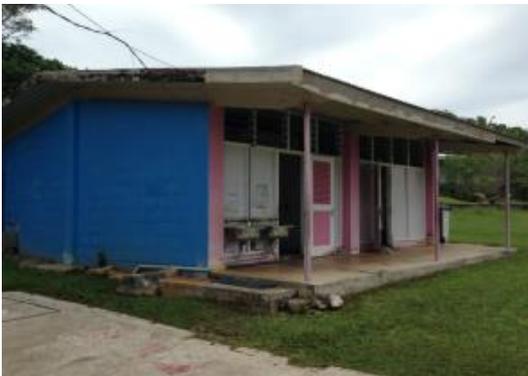
Primary School – Cladding and Soffits

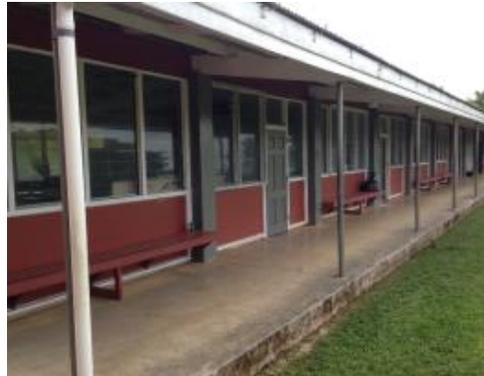
Secondary School Cladding

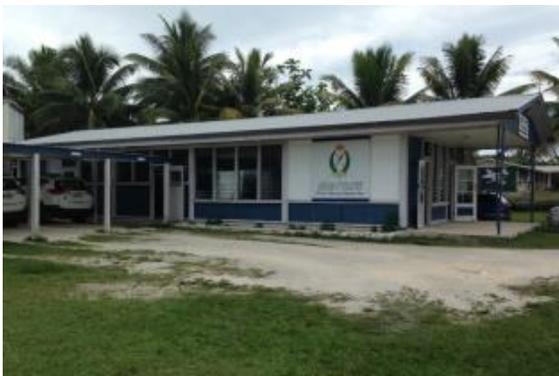
Police Station Cladding

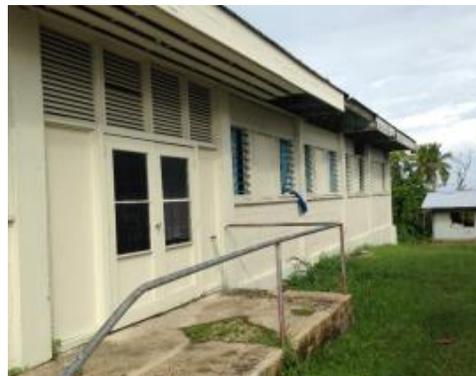
Alofi South Hall Cladding

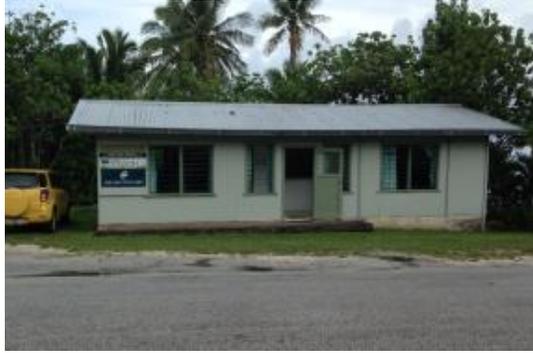
Photo 21: Peleni's Travel Cladding

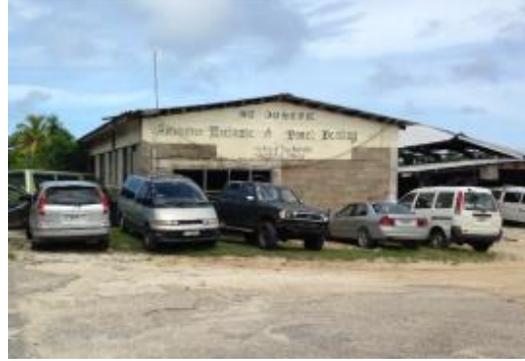
On the first visit four wipe samples were taken and two further wipe samples were taken on the second visit including an additional one in Peta Paints where a high wipe result was obtained on the first visit. The high Peta Paints result was confirmed on the second test. The wipe tests also revealed high results for other areas in contact with the public.

Photo 22: St Joseph's/Peta Paints Roof/Cladding

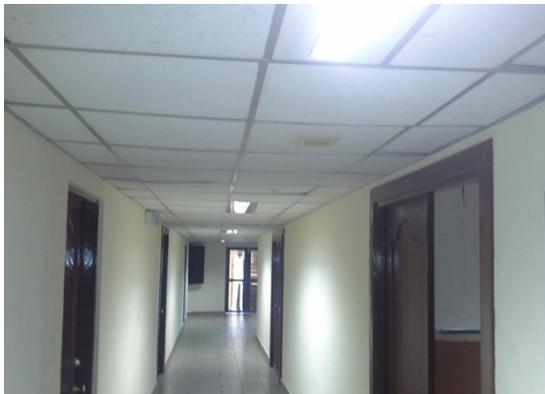
Office of Statistics (ceiling panels)

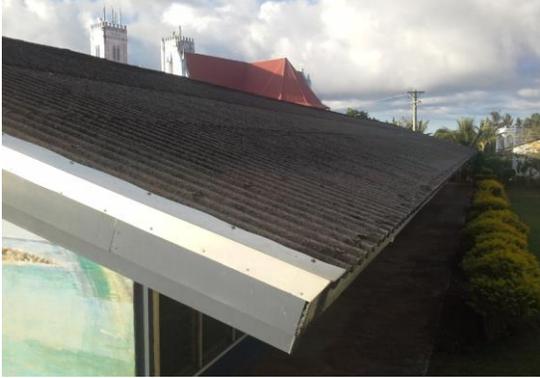
Paul VI College (Roof)

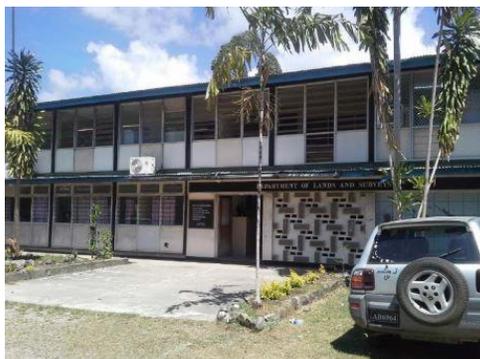
Lands & Survey Building – AC Panels

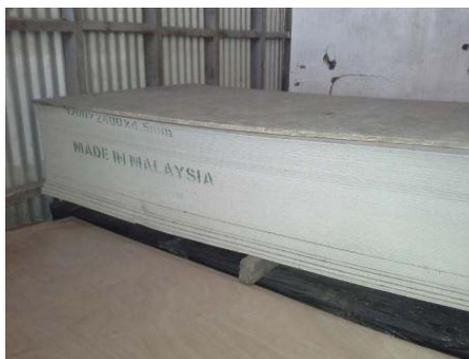
About 50 sheets of asbestos board were also identified in a hardware store in Gizo. The photos below show the asbestos that was identified in the Lands and Survey Building and also in the Gizo Hardware Store.

Asbestos cladding for sale in Gizo

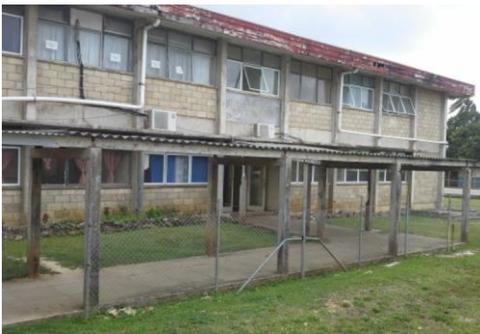
Viola Hospital

The photos below show the Vaiola Hospital Walkway Roof in Tongatapu and the Prince Ngu Hospital Roof in Vava'u. This hospital has four asbestos roofs as well as some loose asbestos. The total roof area is about 3100 m².

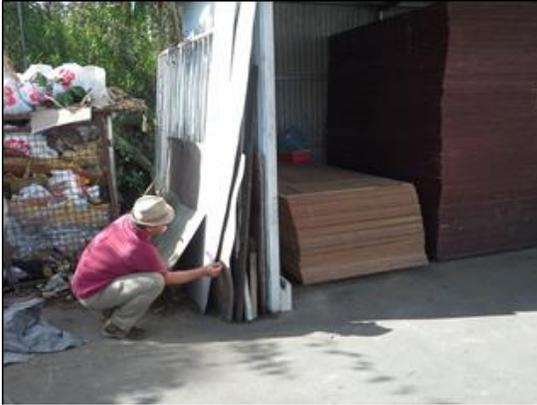
Hardware Store New Sheeting

The following photos below illustrate the positive sample locations identified above. The first photo below shows an AC sheet at the entrance to a Chinese Hardware Store (MOK 3) in Elluk Rd. The shop manager had previously reported that he sometimes sells asbestos cement sheeting but that he did not have any in stock at the moment. The above panel was then found and sampled. The second photo shows AC cladding on the Ministry of Land and Natural Resources building at Port Vila.

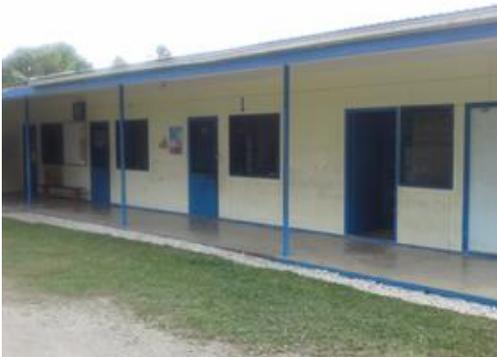
Paonangisu Health Centre

The first photo below shows AC cladding on the Paonangisu Health Centre. The sample was collected at the reception area but ACM has presumably been used on all the five structures present at the site. The second photo below shows at the Port Vila Central Hospital. Photo 6 shows services and heating pipes running the length of the covered walkways connecting the buildings at the Port Vila Central Hospital.
